**CONSENT ORDER  
ISSUED UNDER THE  
WATER POLLUTION CONTROL ACT  
WEST VIRGINIA CODE, CHAPTER 22, ARTICLE 11**

TO: Mountain Valley Pipeline, LLC

DATE: April 19, 2019

ORDER NO.: 8951

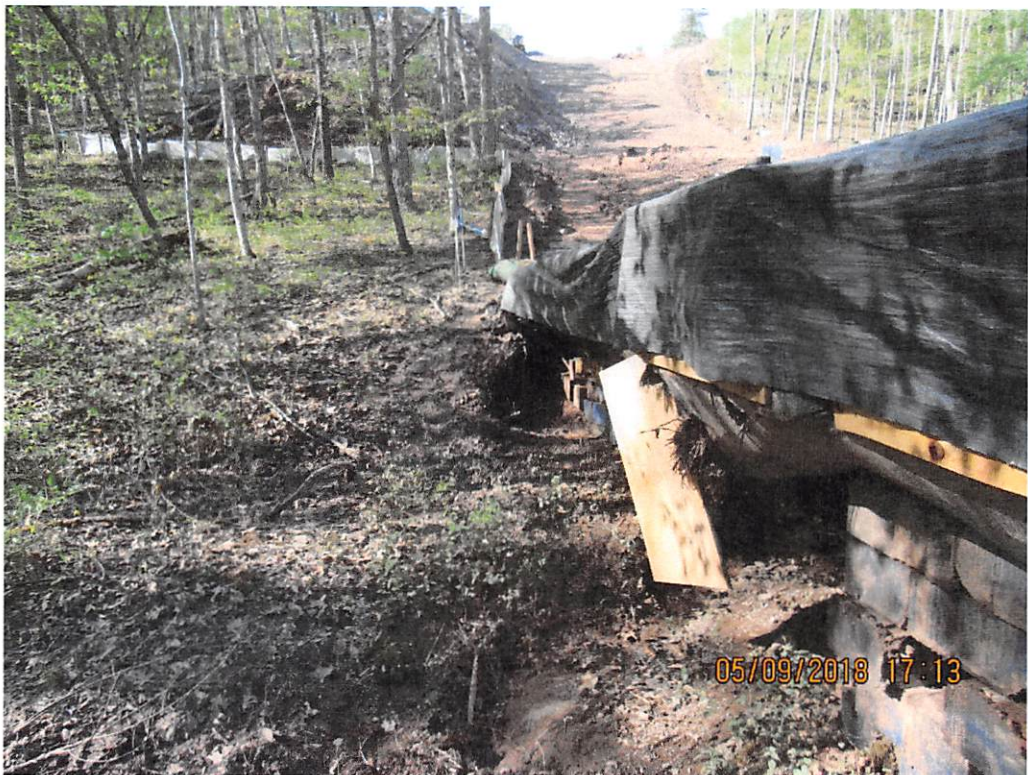
Photo 4: Downslope view of site of sediment laden water leaving site- erosion gullies observed on slope. (view south)

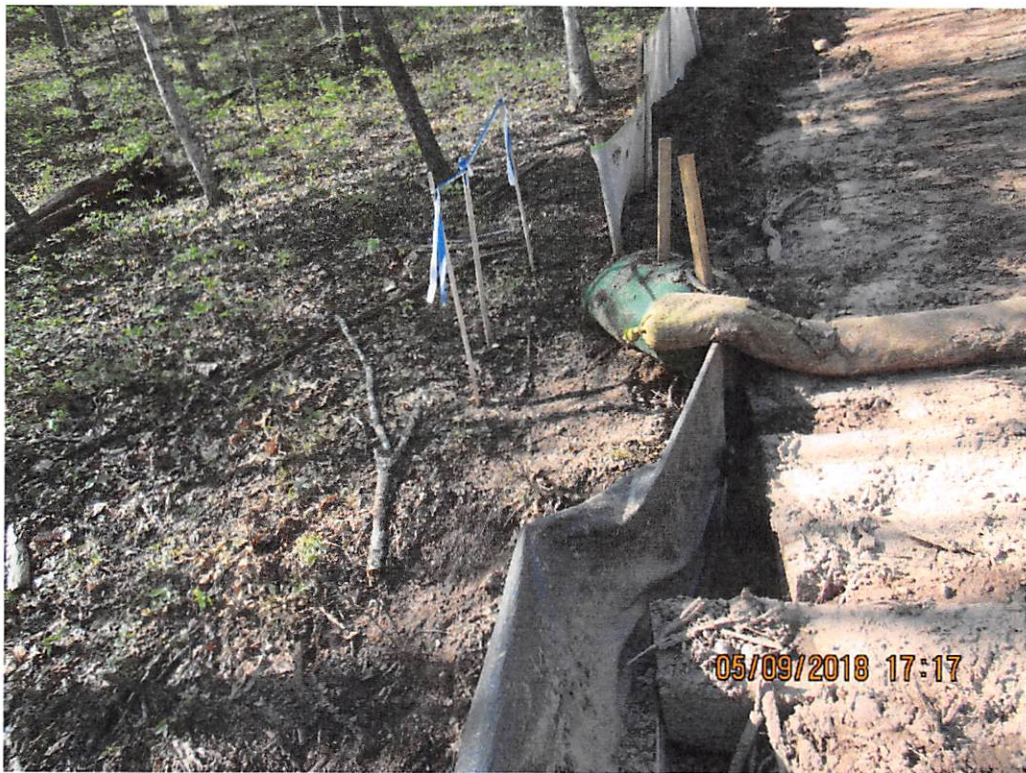
Photo 5: Stream crossing where sediment laden water left site after controls failed at stream S-IJ65 (view north). Additional controls added prior to re-building of bridge.

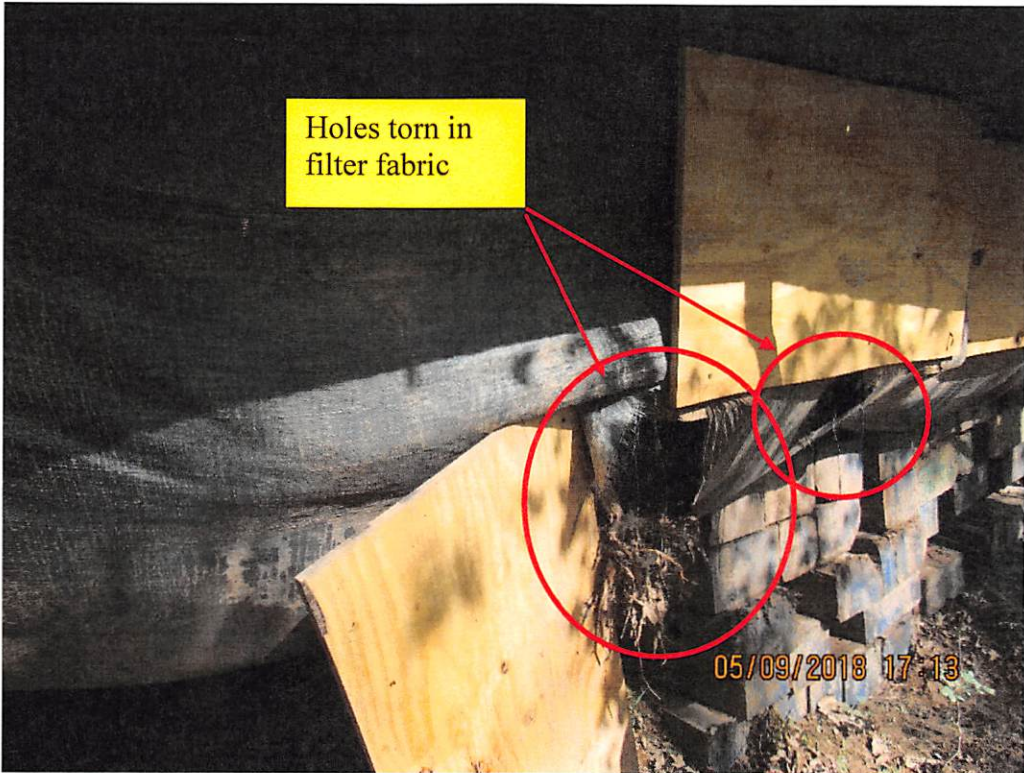
Photo 6: Location of control failure and breach allowing sediment laden water to leave site. Additional control (larger silt sock) added prior to bridge re-build.

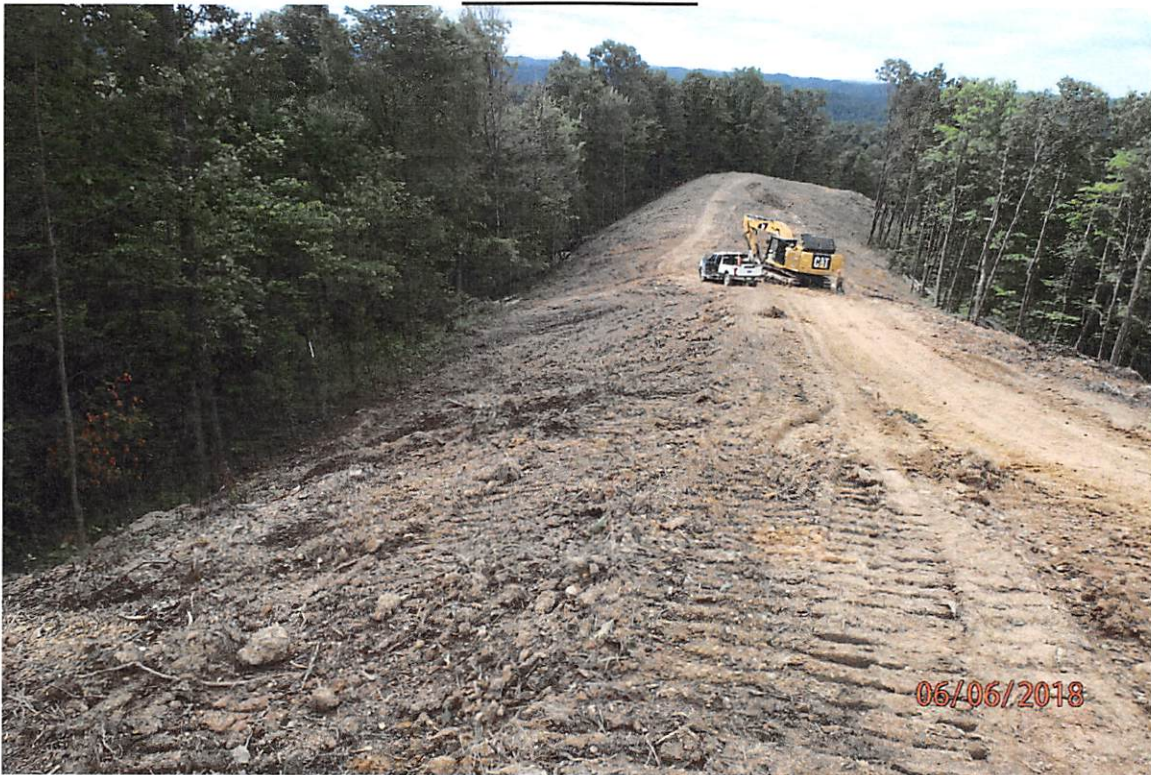
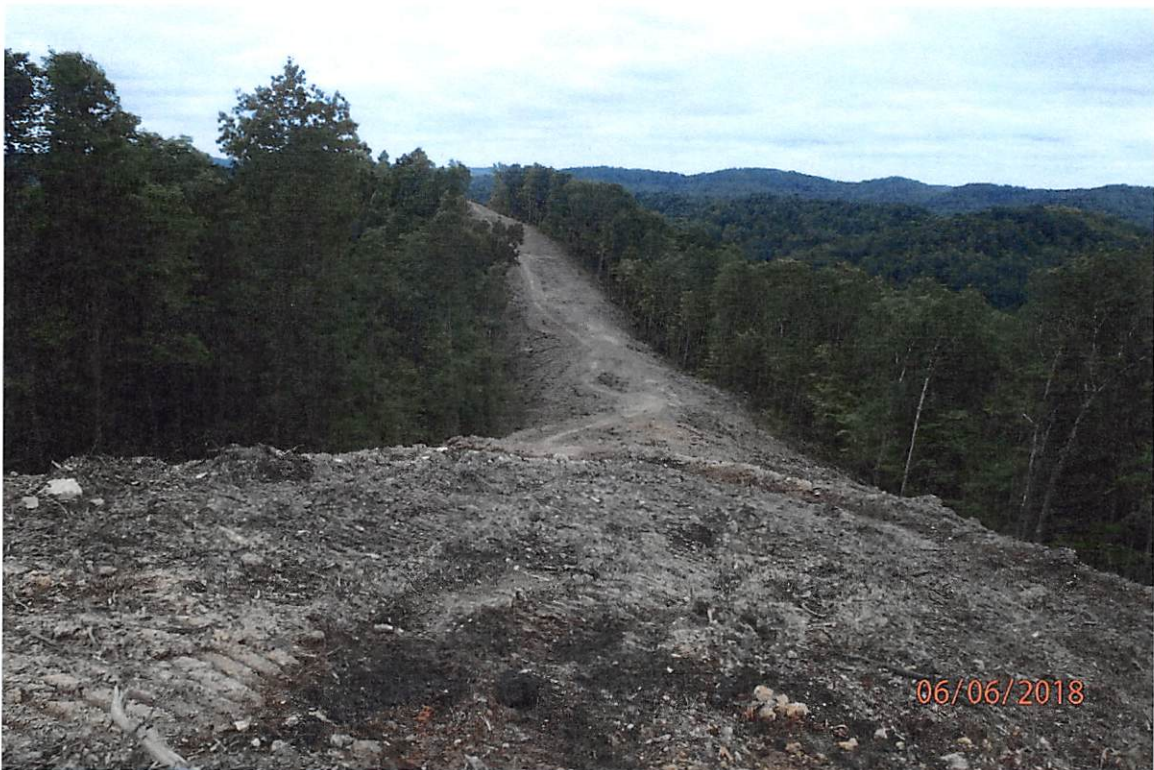
Areas of the project that have been cleared to mineral soil and BMPs are not in place as indicated in the SWPPP.

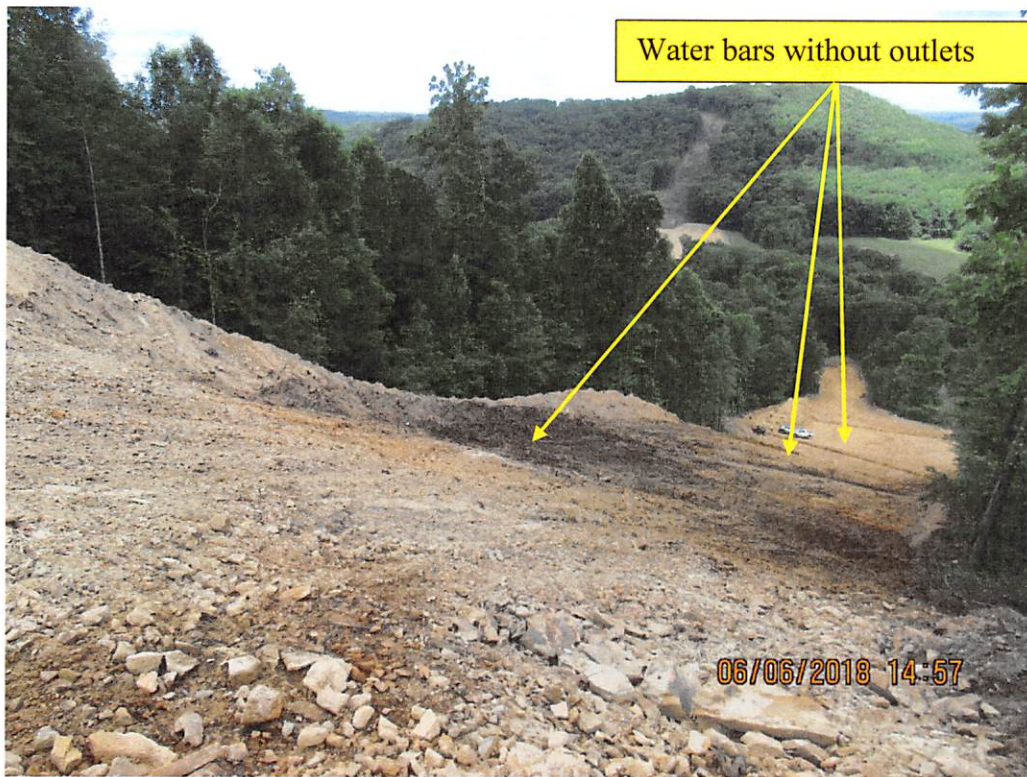
Photo 2: Station 6782+00 control failure repair but additional controls not added.

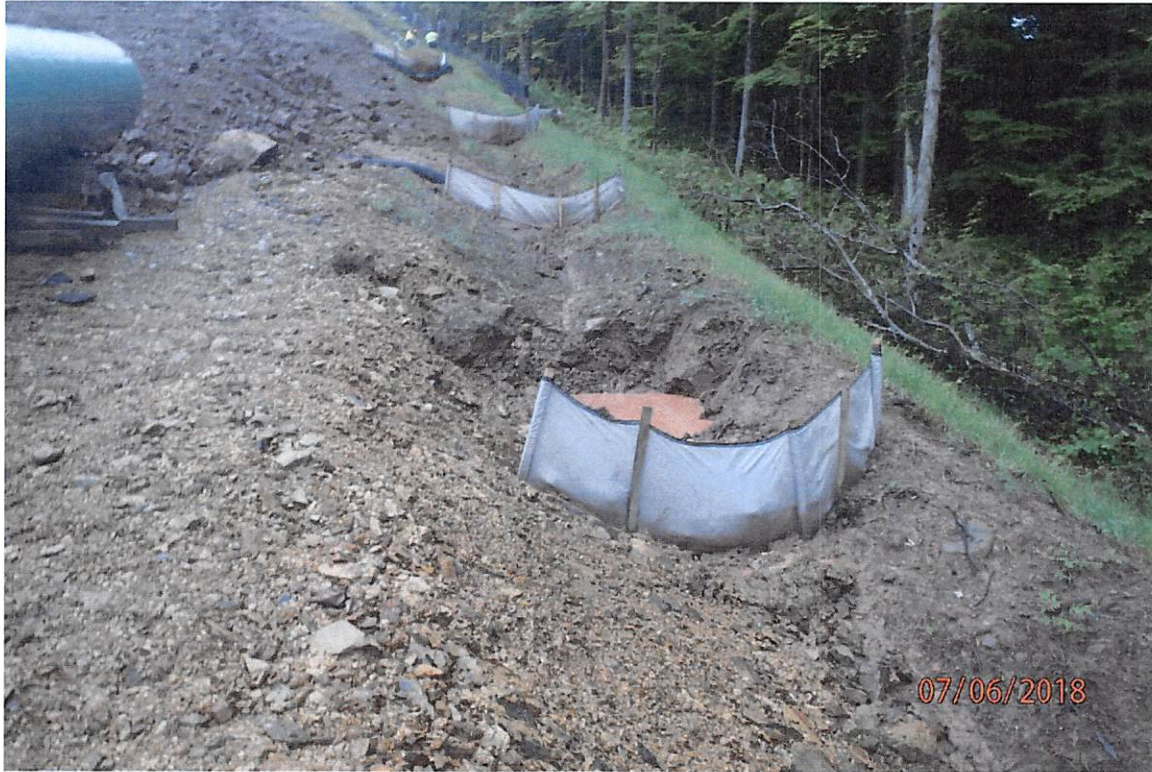
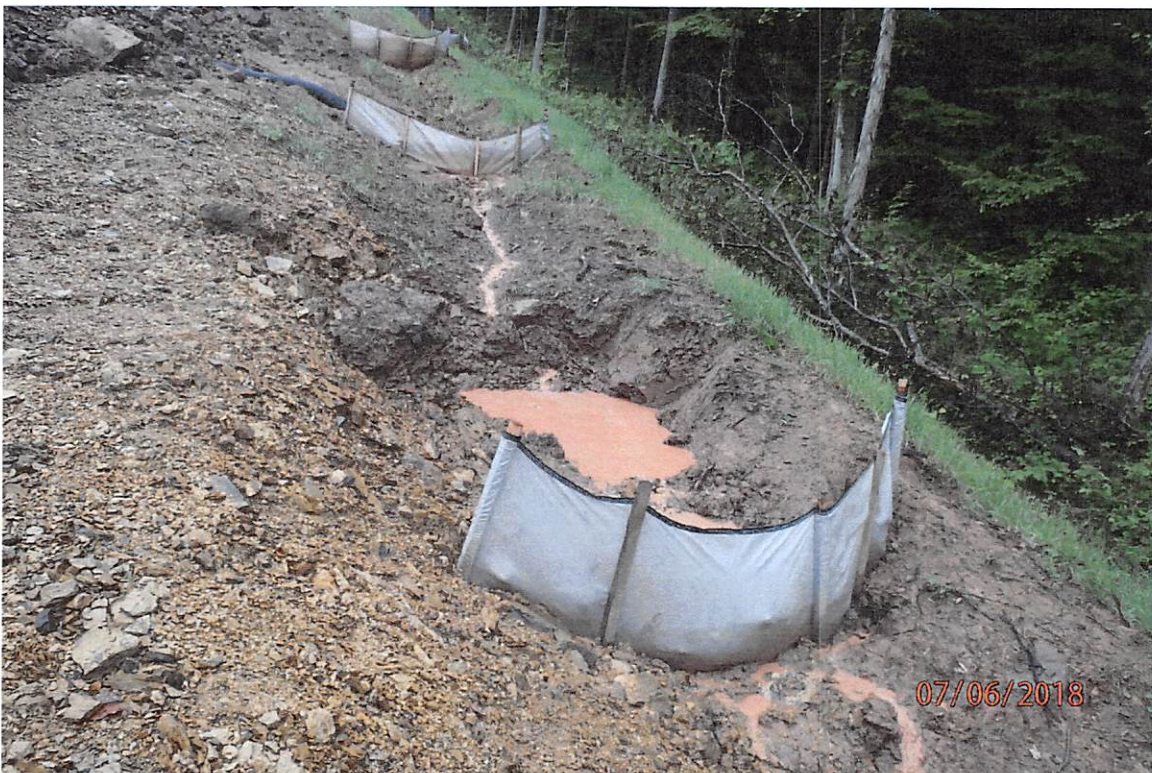
Photo 8: Control failure near station 6854+00 where sediment laden water left site.

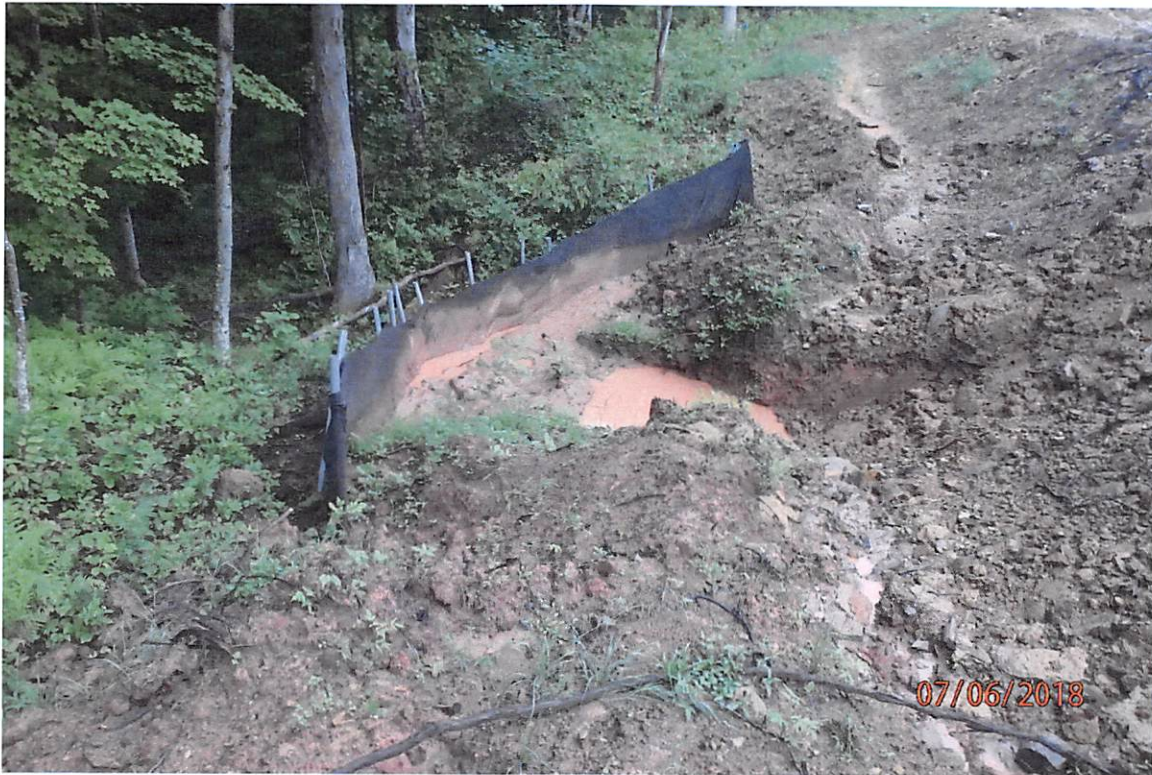
The installed temporary right of way diversion and outlet adjacent to 1851+00 that was collecting stormwater from multiple water bars without adequate outlets. This caused concentrated flow to overwhelm the installed BMP at the base of the slope.

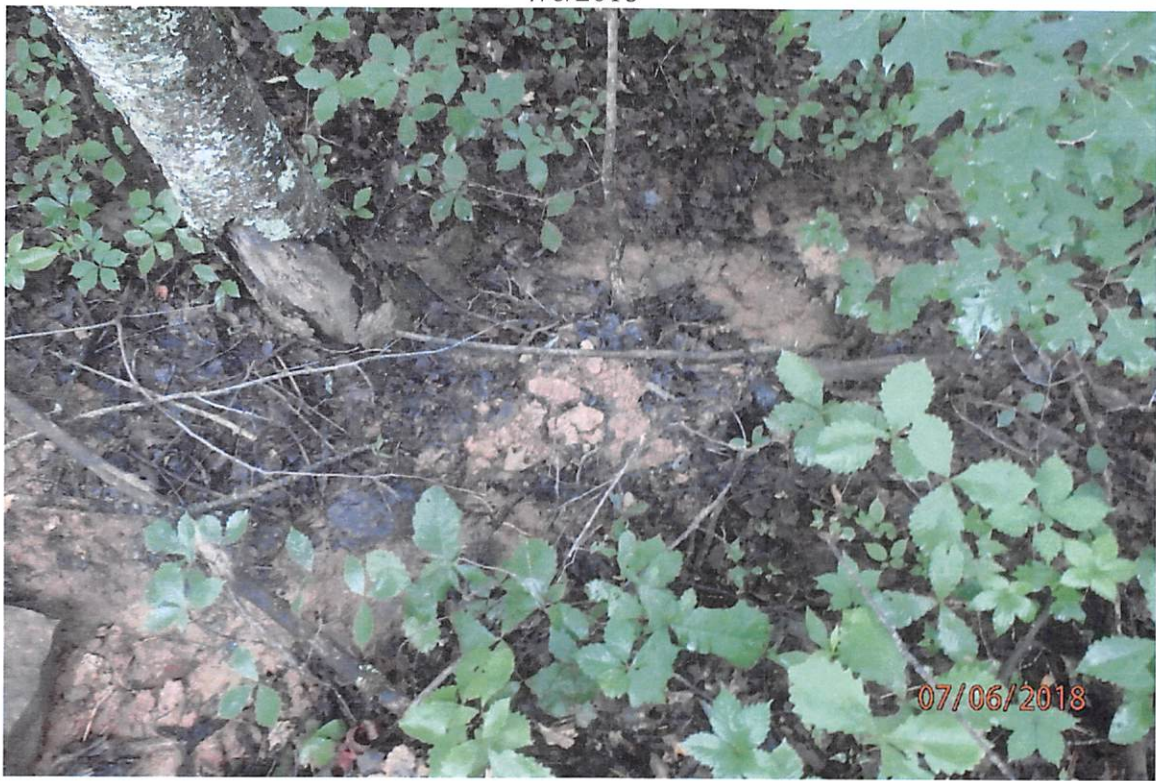
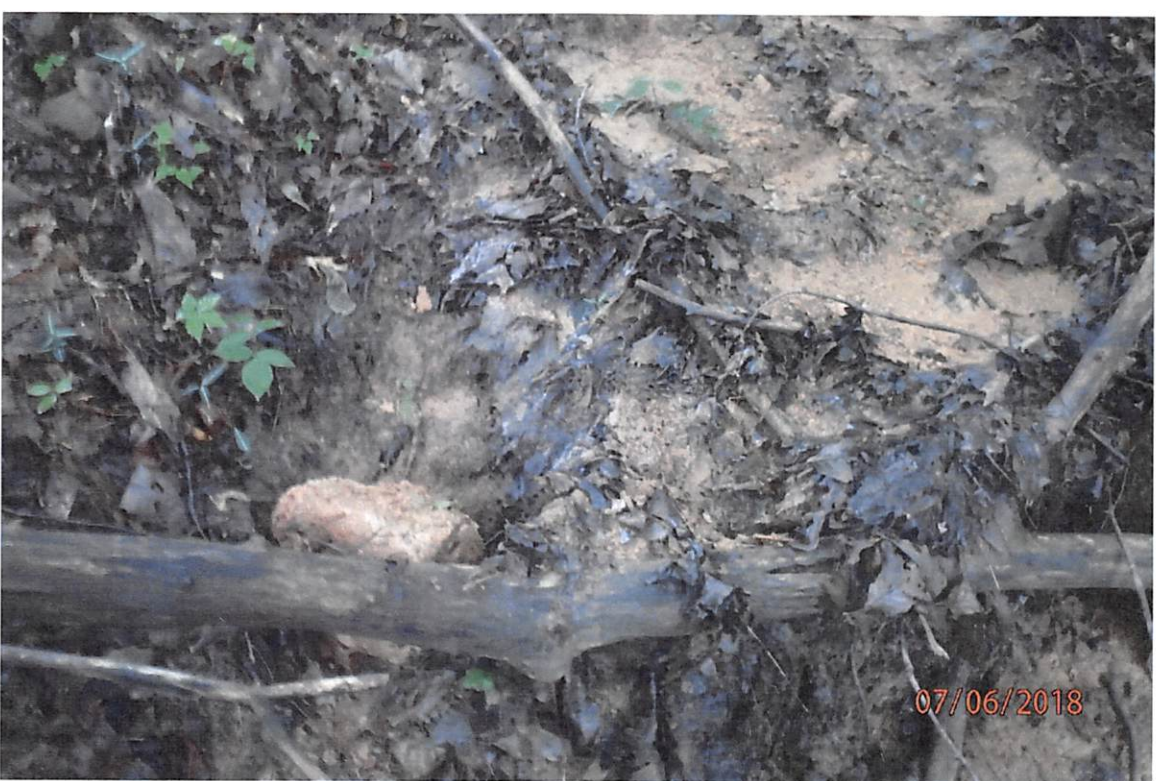
Improperly installed BMP at the terminus of a water bar adjacent to MVPDO-049 (1891+00) that allowed sediment laden water to leave the site and caused CNA in UNT Dry Fork.

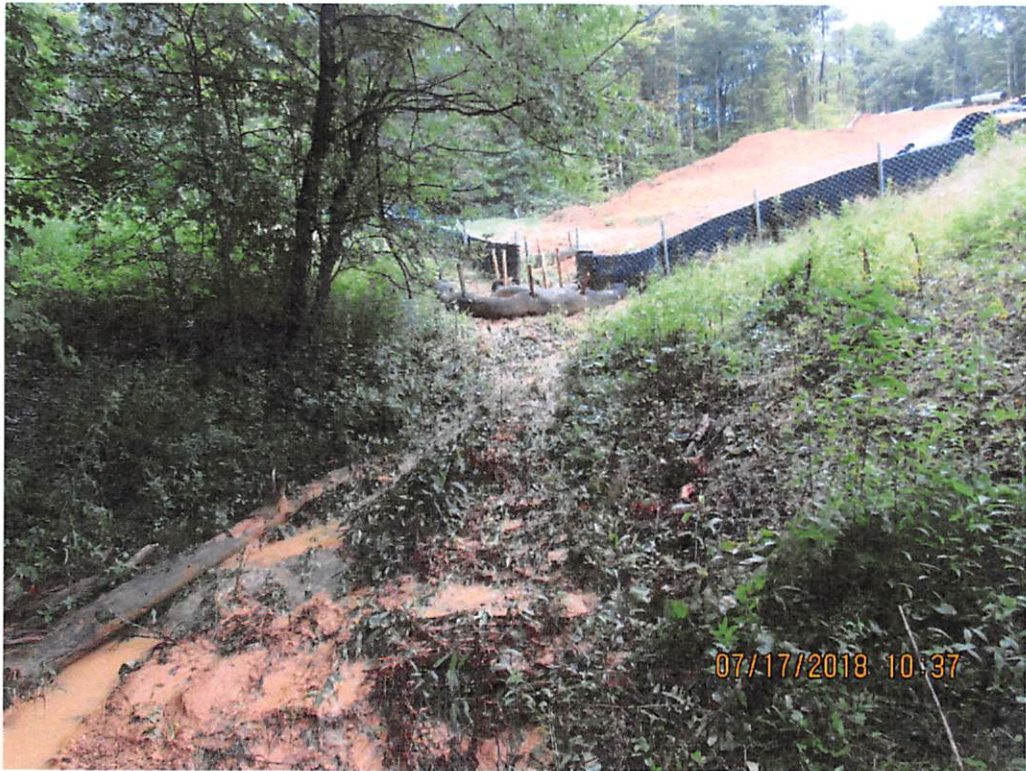
Photo 9: Sediment deposits in UNT of Birch River (S-F34)

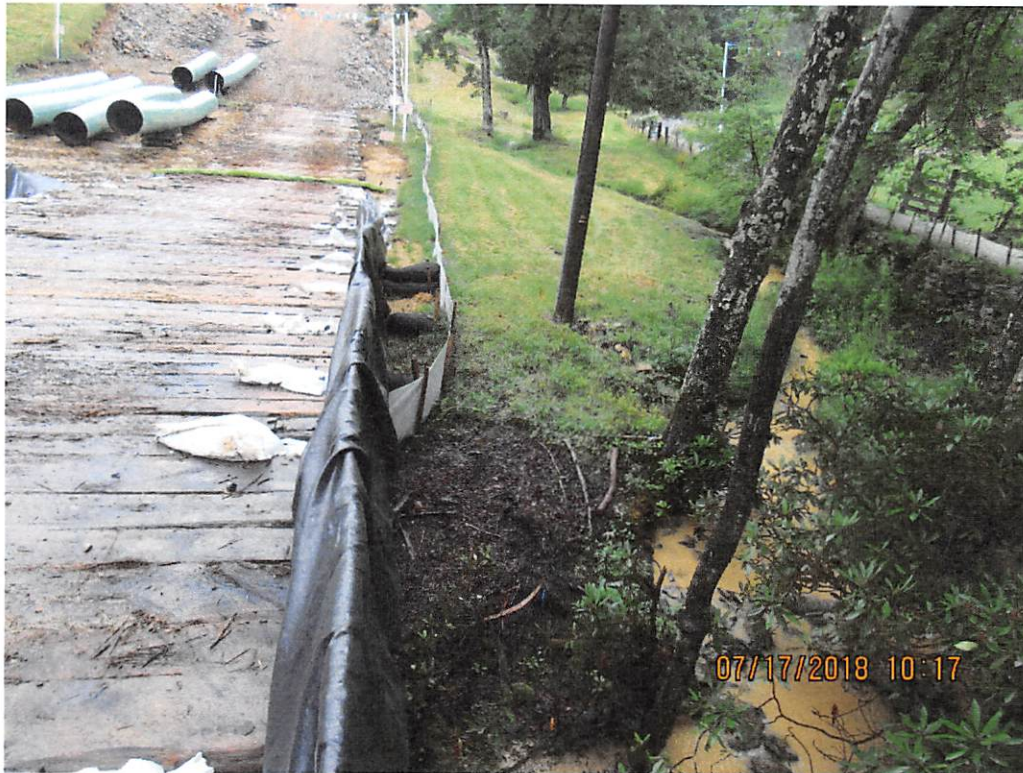
Photo 10: Upslope view of sediment deposits from control failure.

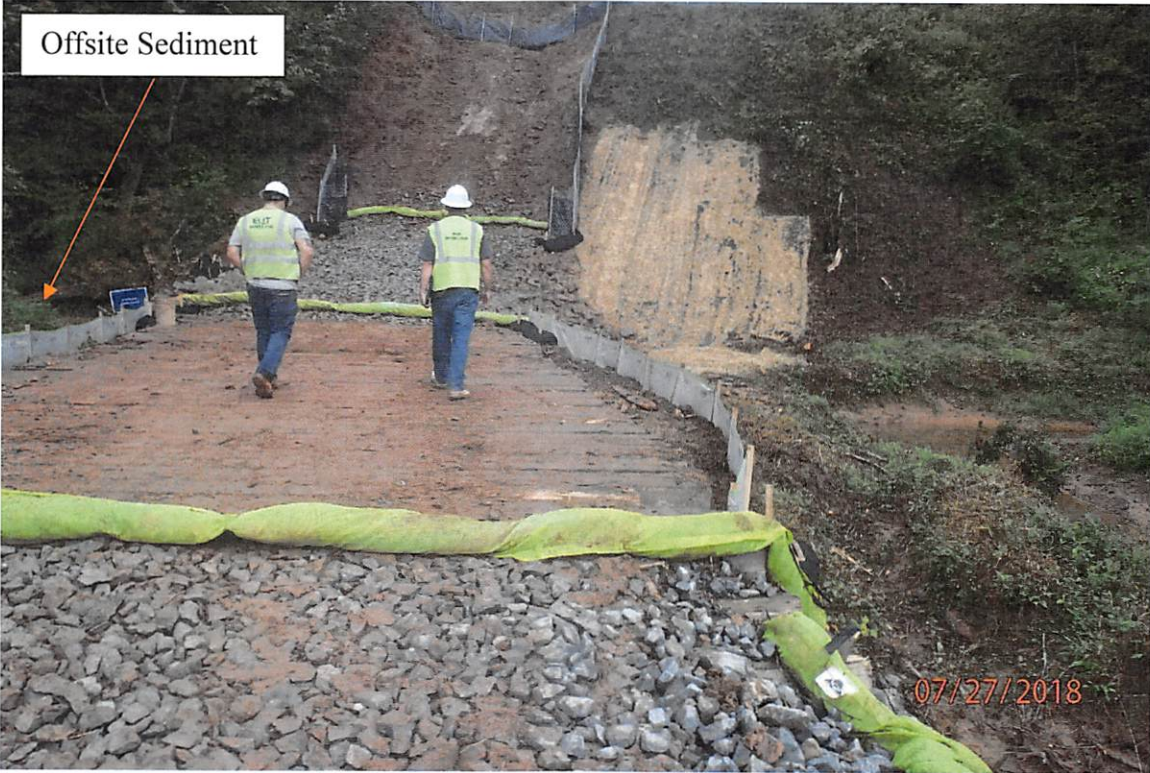
Photo 18: Installed controls at end of water bar proved inadequate and failed allowing sediment laden water to leave site.

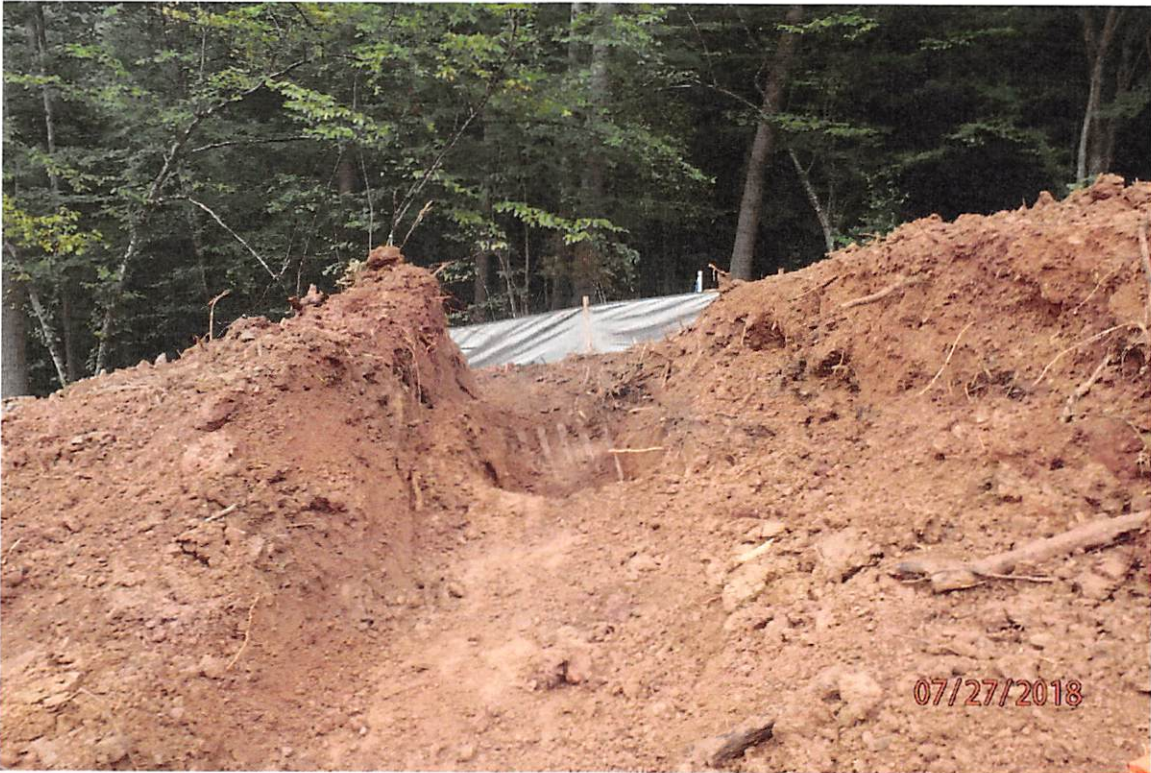
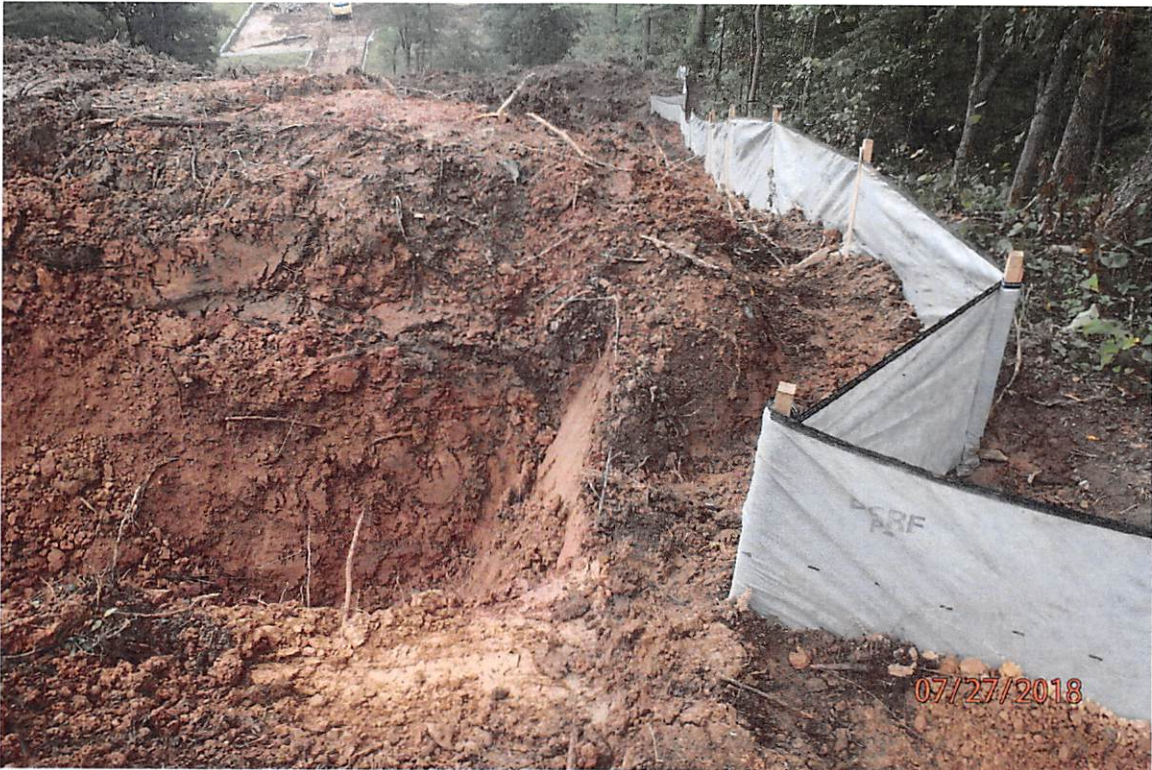
Offsite sediment deposits in Grass Run (S-A11a) that originate from site.

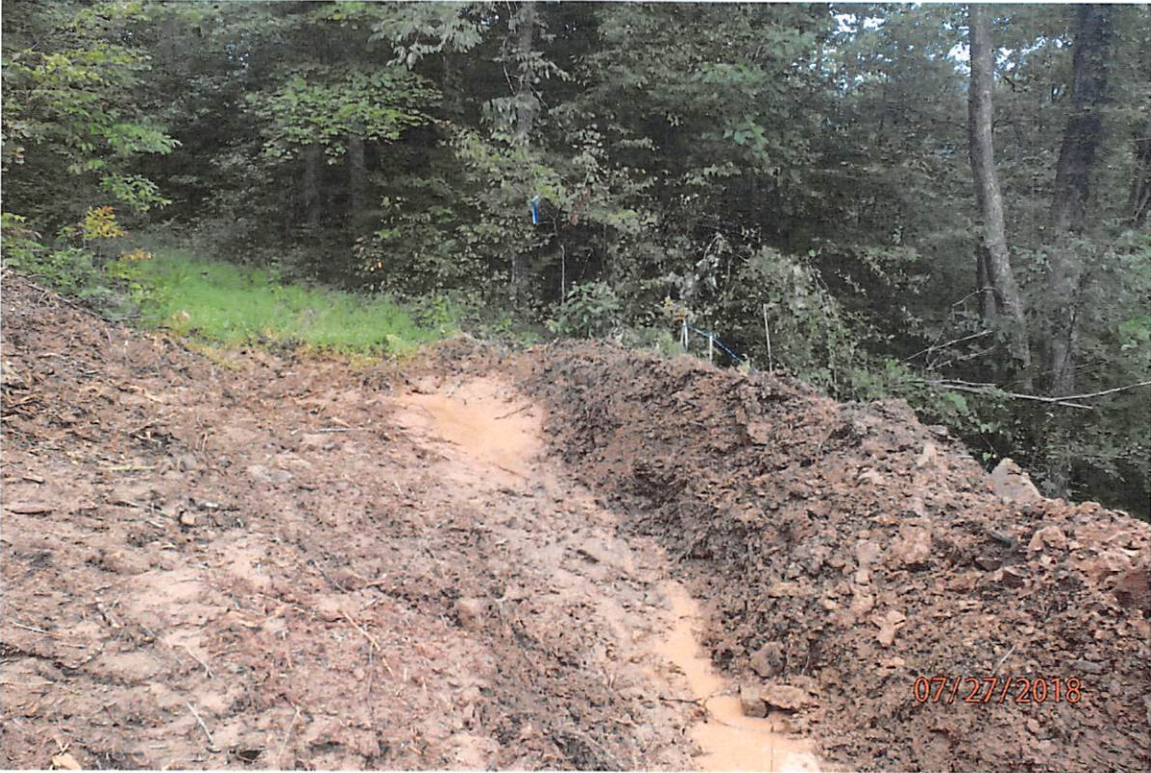
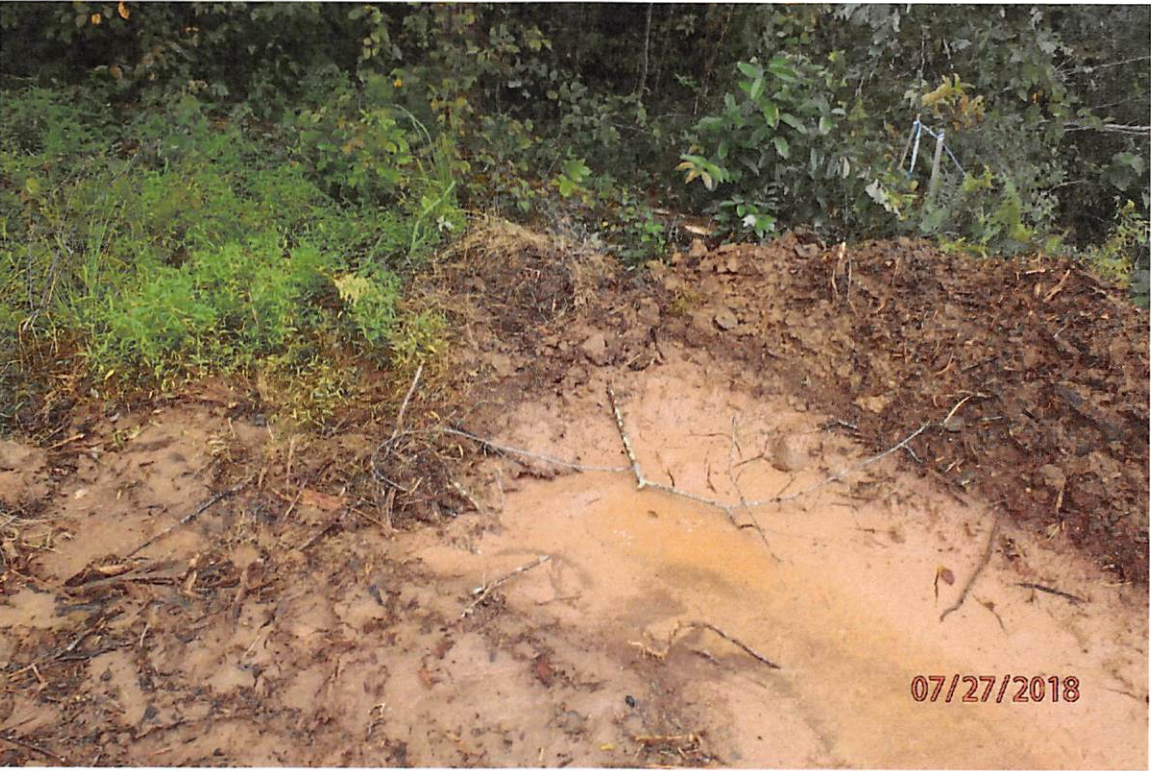
Improperly installed water bars that do not shed stormwater off site as designed.

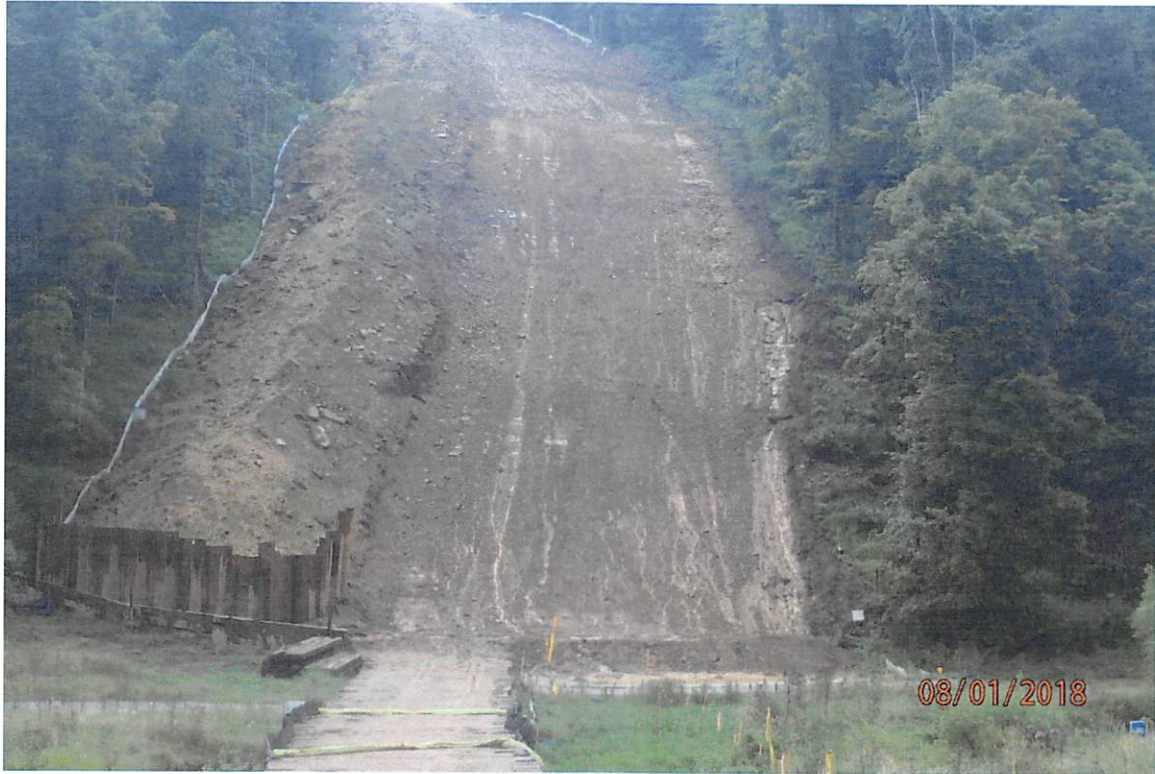
Water bar that lacked outlet protection was noted upslope of grass run adjacent to 1142+00.

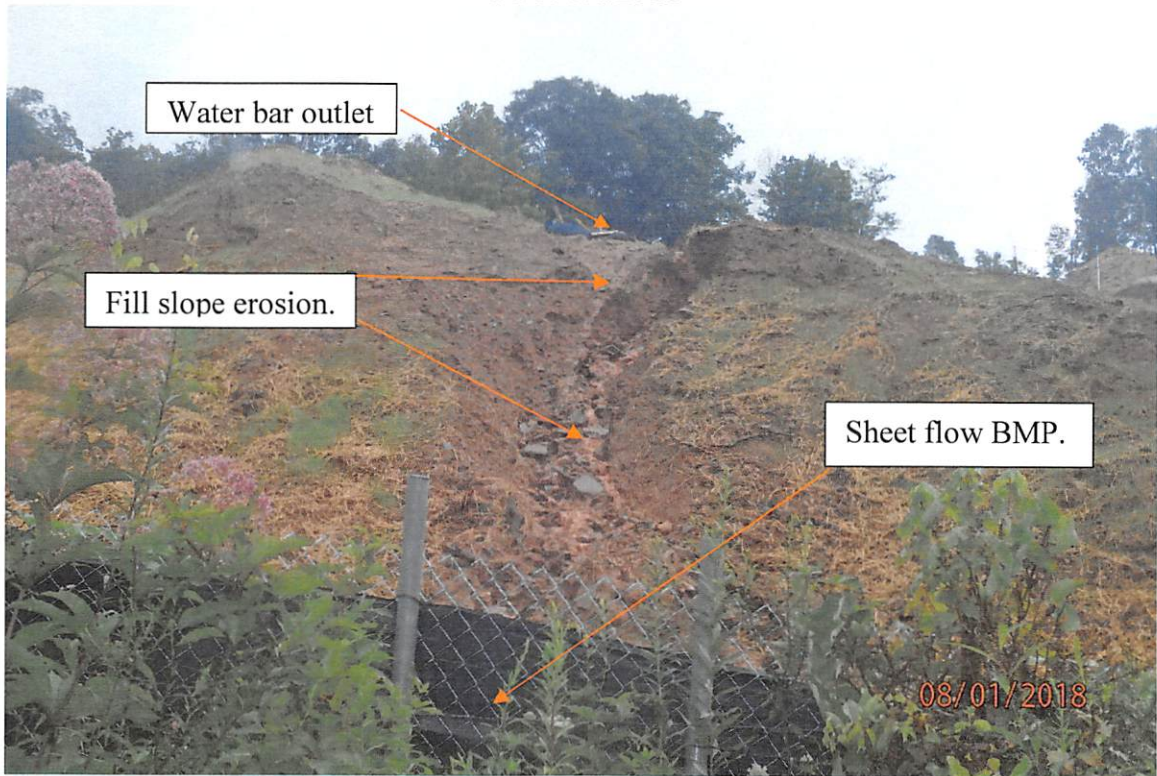
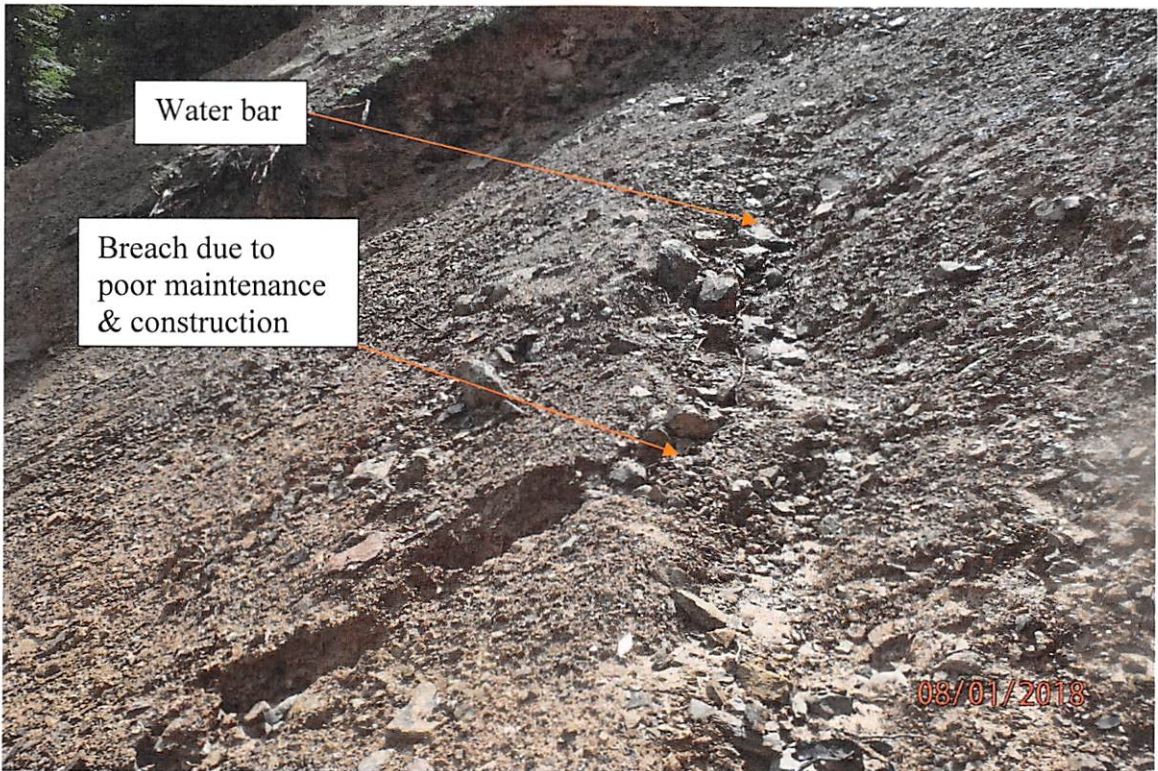
Improperly installed water bars that have caused fill slope erosion in the Big Elk Creek watershed.

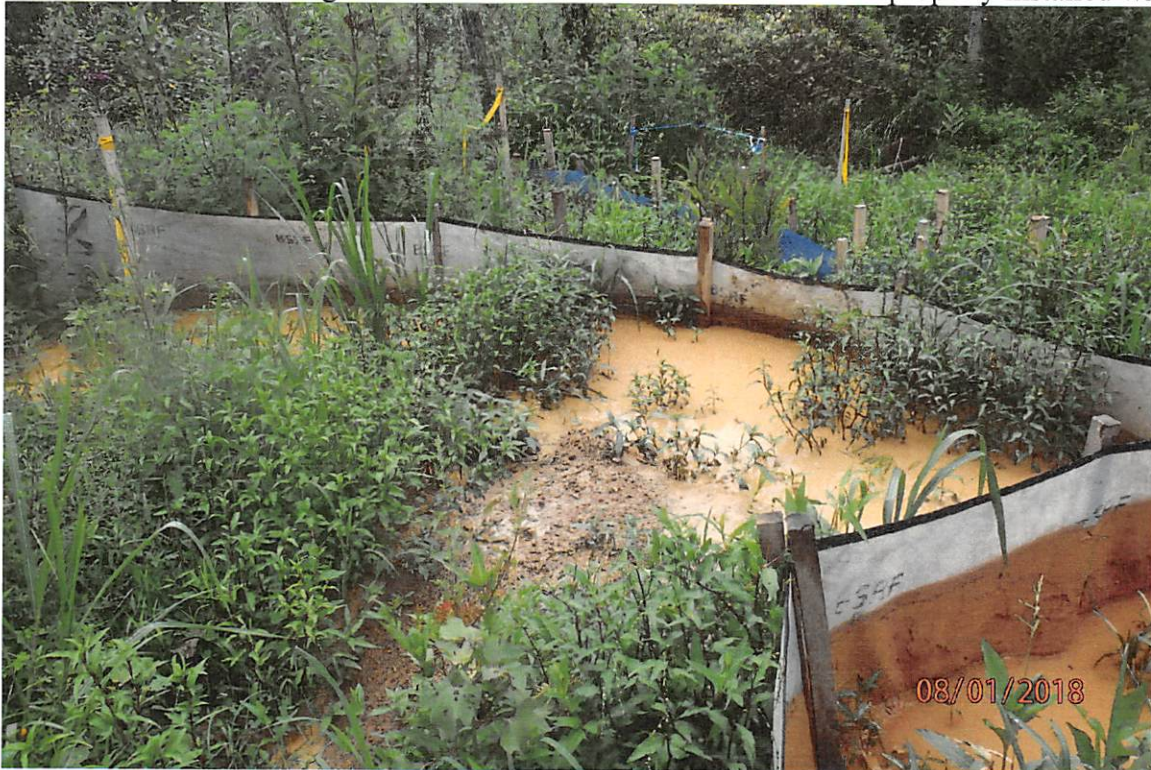
Perimeter controls adjacent to Big Elk Creek that are overwhelmed due to improperly installed water bars.

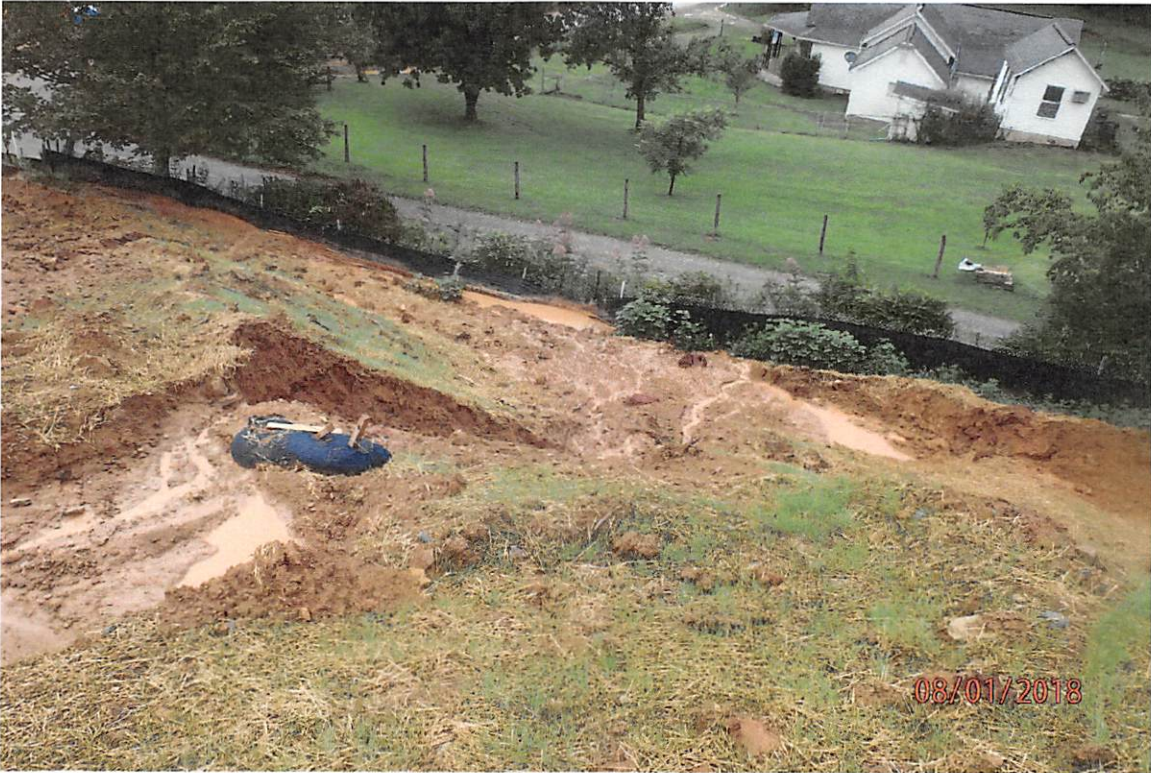
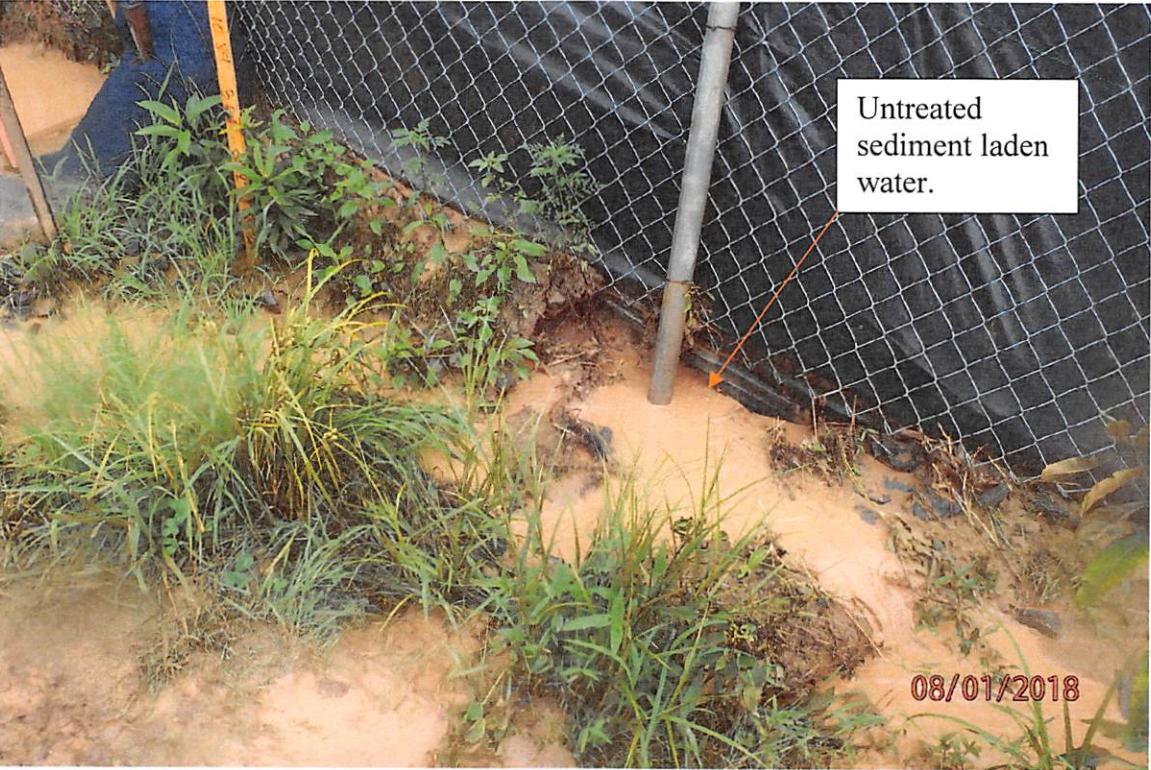
Perimeter controls adjacent to Goose Run that are overwhelmed due to improperly installed water bars.  
Both pictures show BMPs that are being undermined and overwhelmed due to excessive flow that is caused by improperly installed water bars.

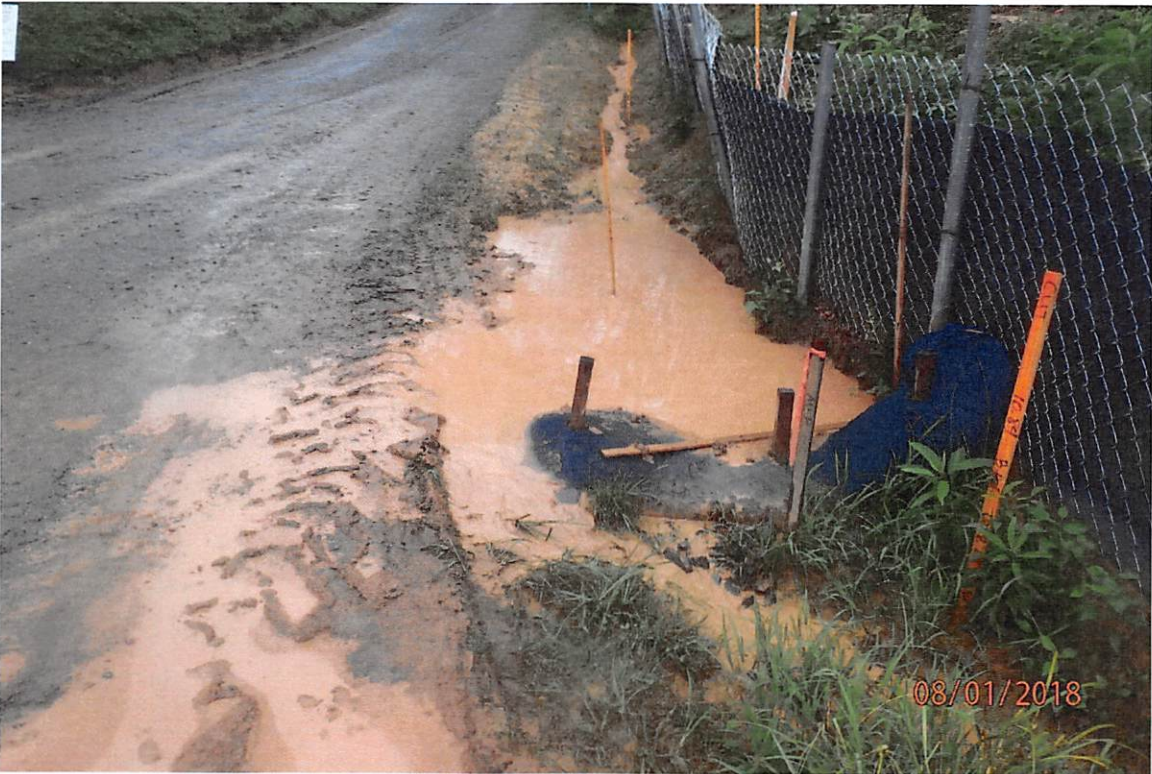
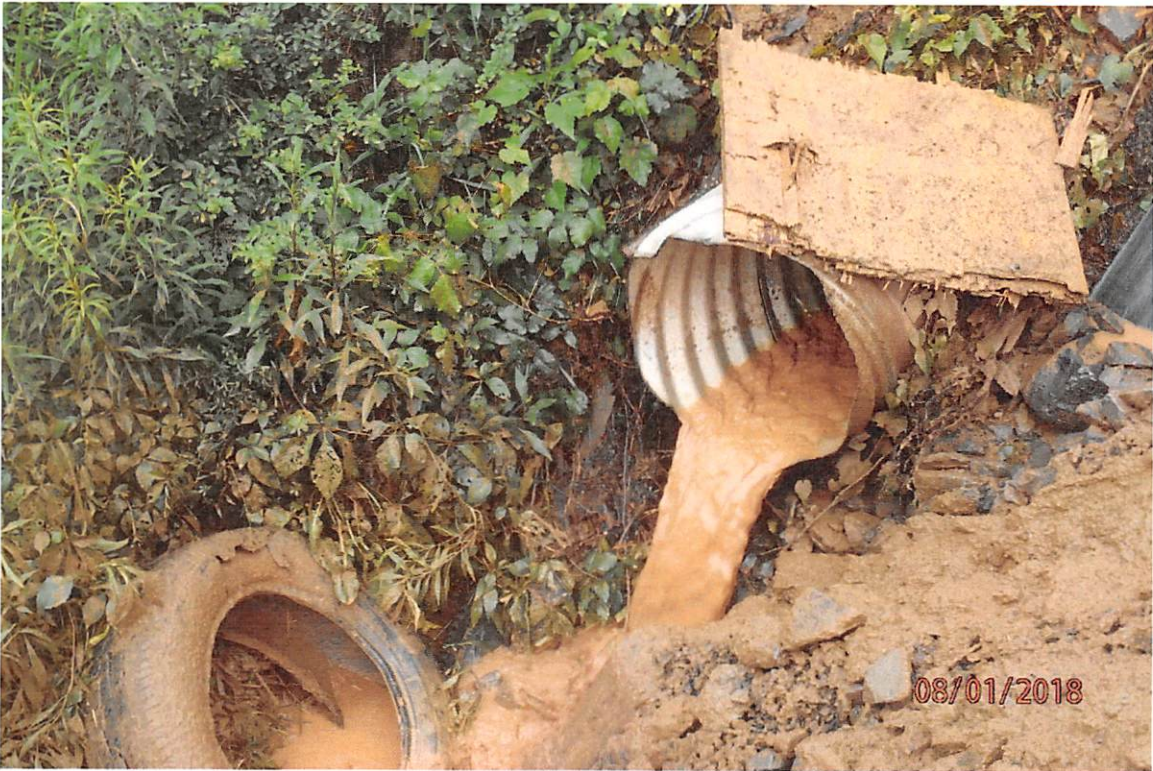
Concentrated flow from water bar outlet that is being treated by sheet flow BMP in the Big Elk Creek watershed.
