**CONSENT ORDER  
ISSUED UNDER THE  
WATER POLLUTION CONTROL ACT  
WEST VIRGINIA CODE, CHAPTER 22, ARTICLE 11**

TO: Mountain Valley Pipeline, LLC

DATE: April 19, 2019

ORDER NO.: 8951

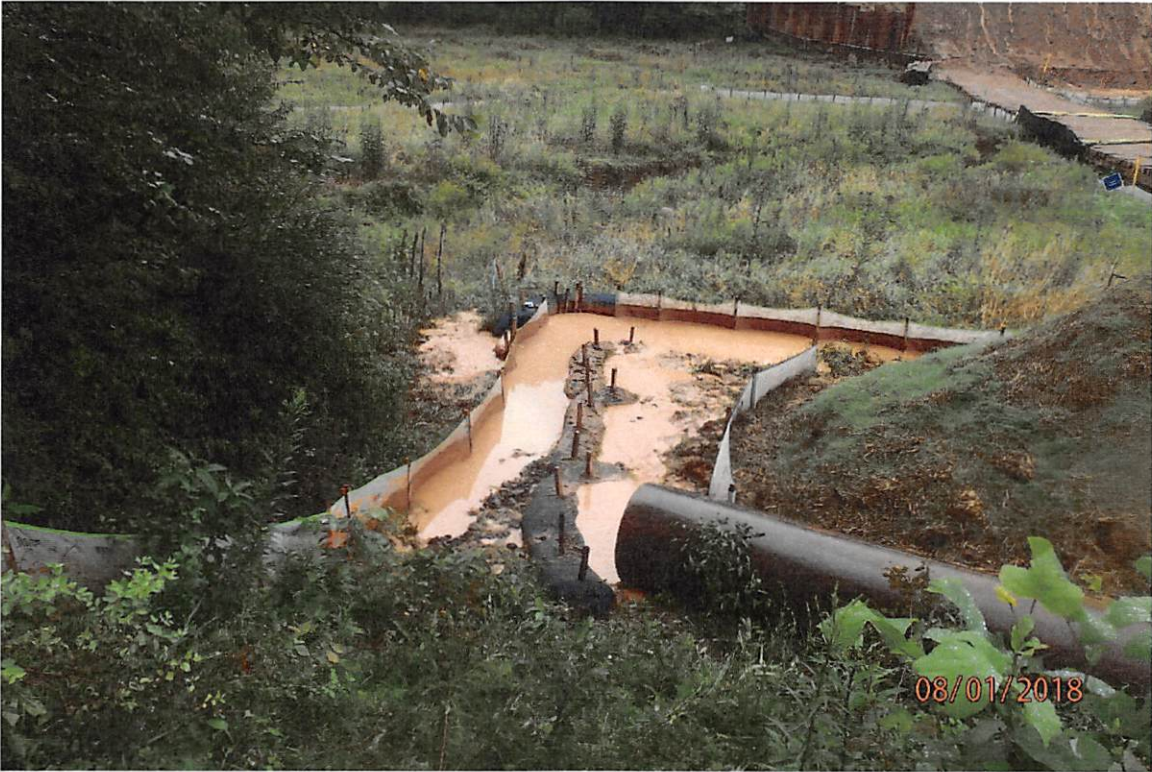
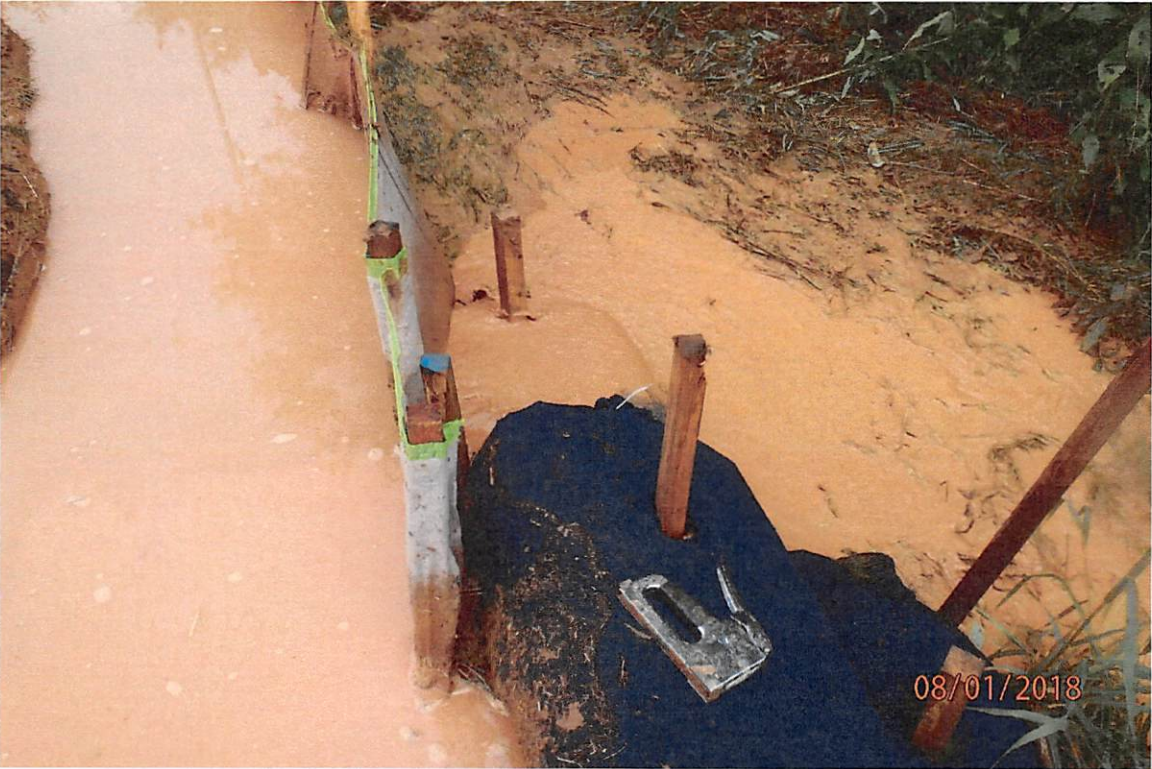
Sediment laden water that is bypassing the installed BMPs due to improper BMP operation and installation.

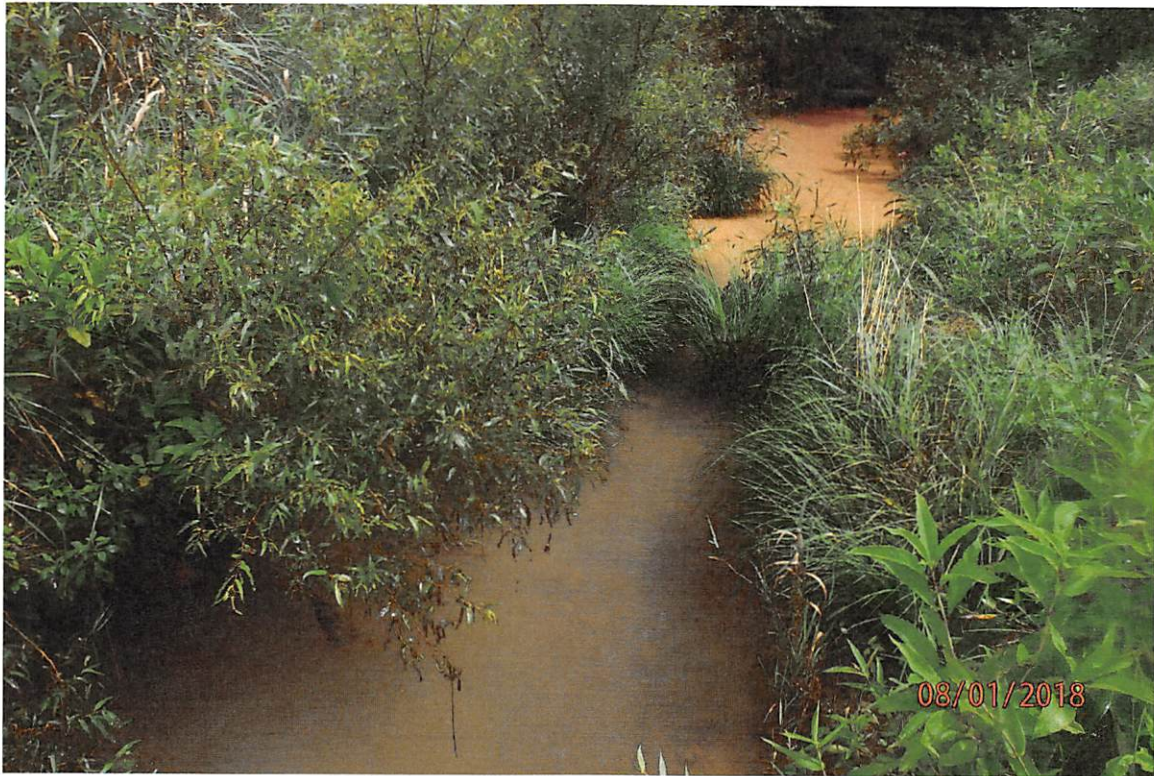
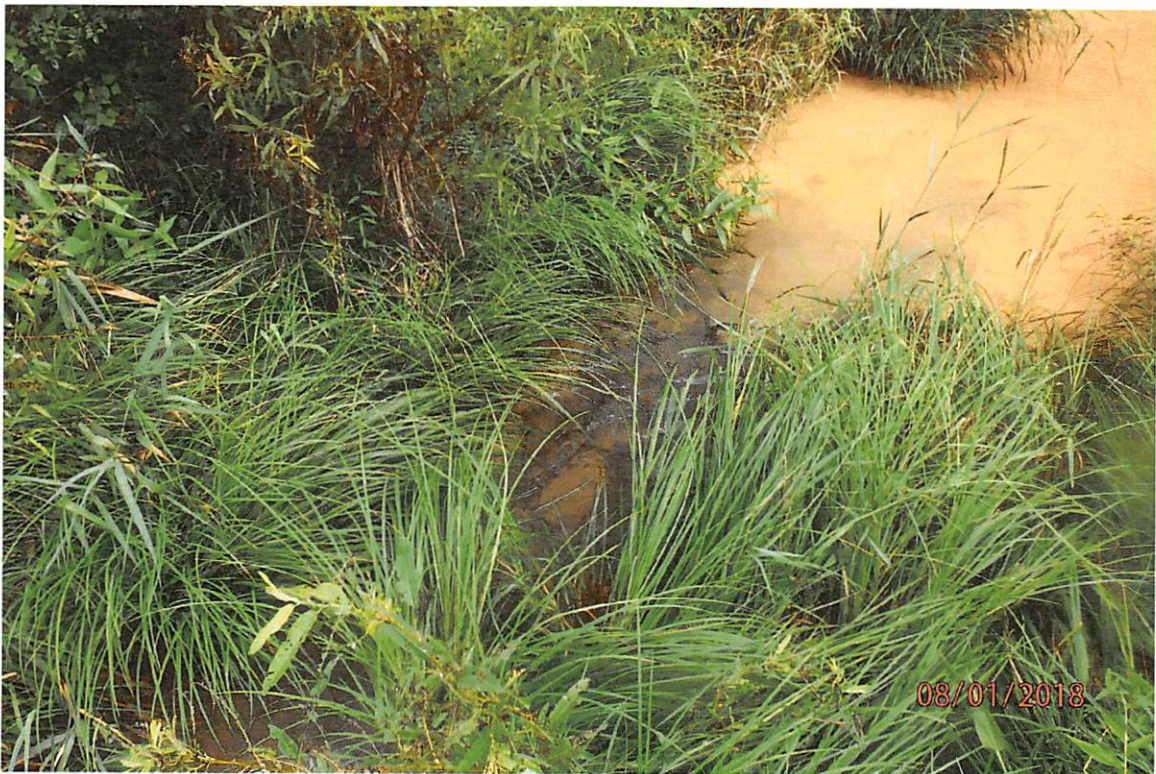
Improperly operated BMP that is causing sediment laden water to leave the site and CNA visible in Big Elk Creek.

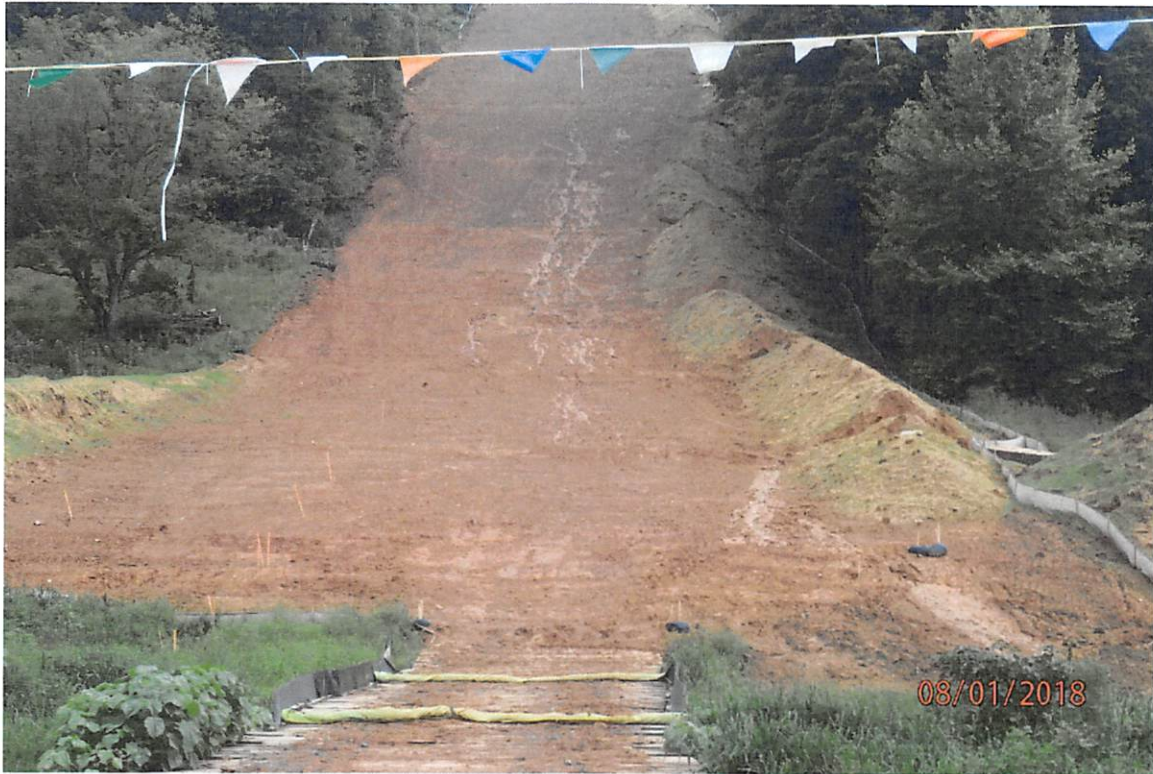
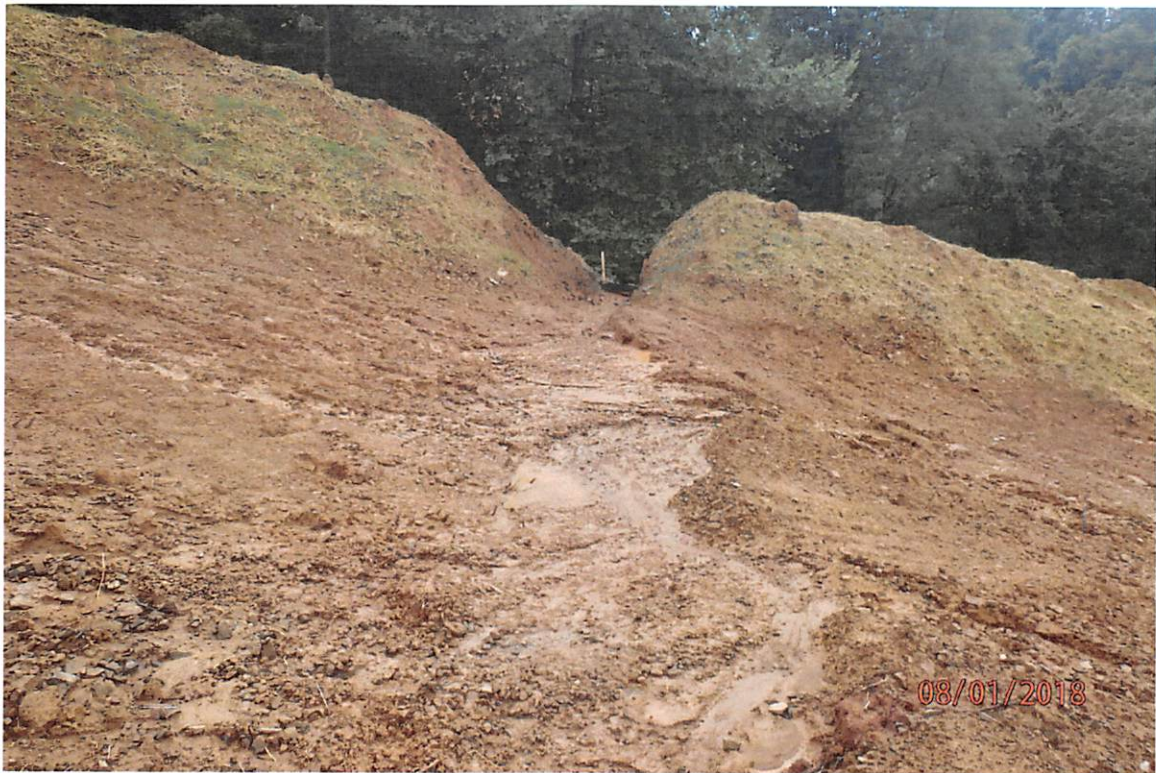
CNA visible plume in in Right Fork of Big Elk Creek (39° 26.6589' X 80° 28.9724').

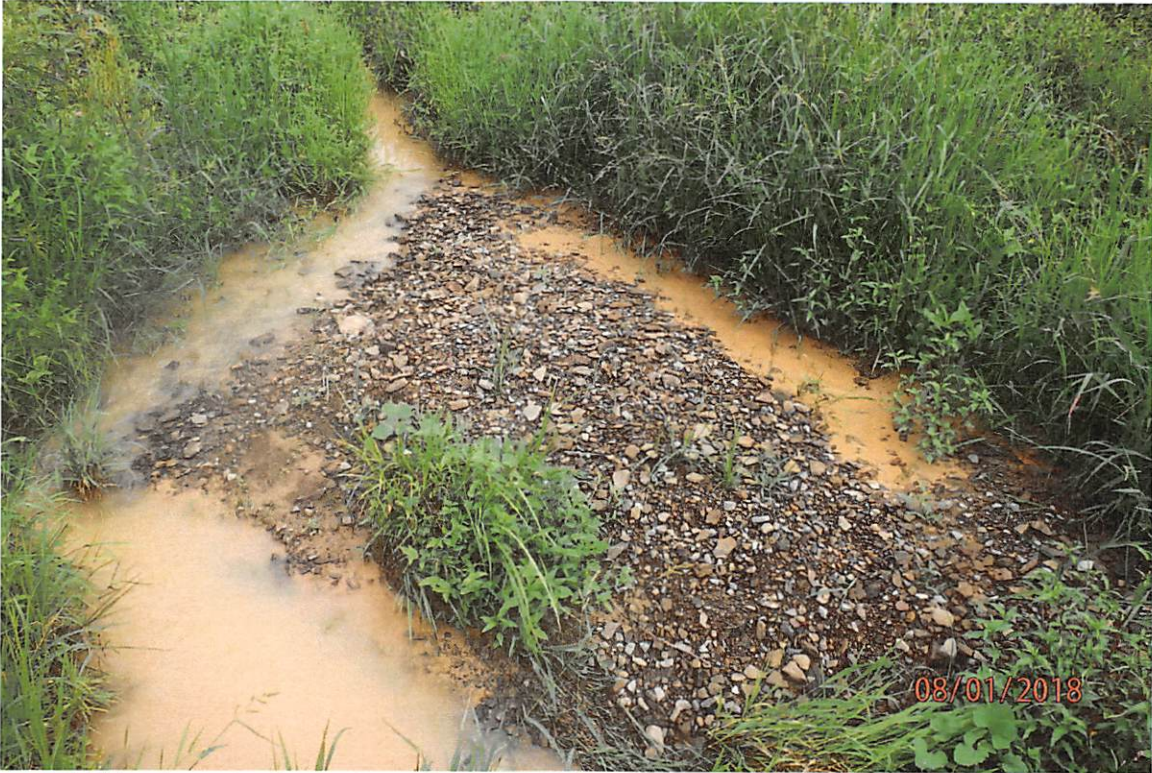
Perimeter control that has been overwhelmed due to concentrated flow from improperly installed water bars in the Goose Run watershed.

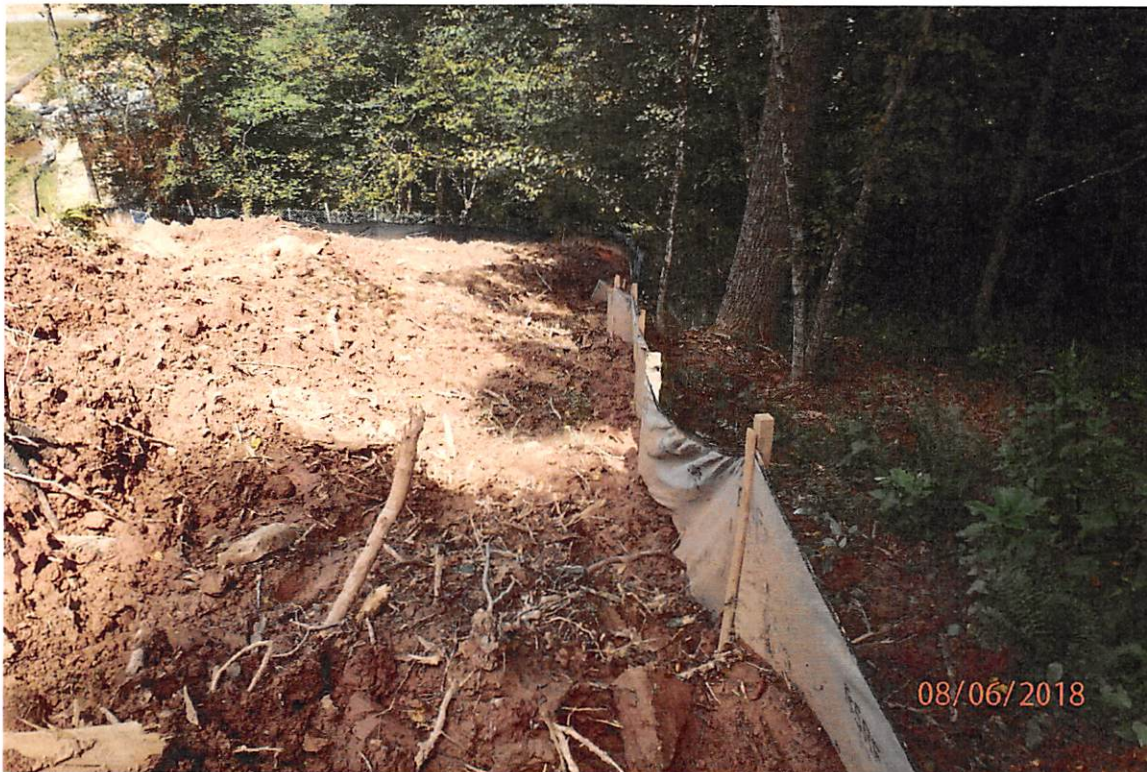
Water bar in Grass Run watershed that is improperly installed and led to CNA deposits in the stream.

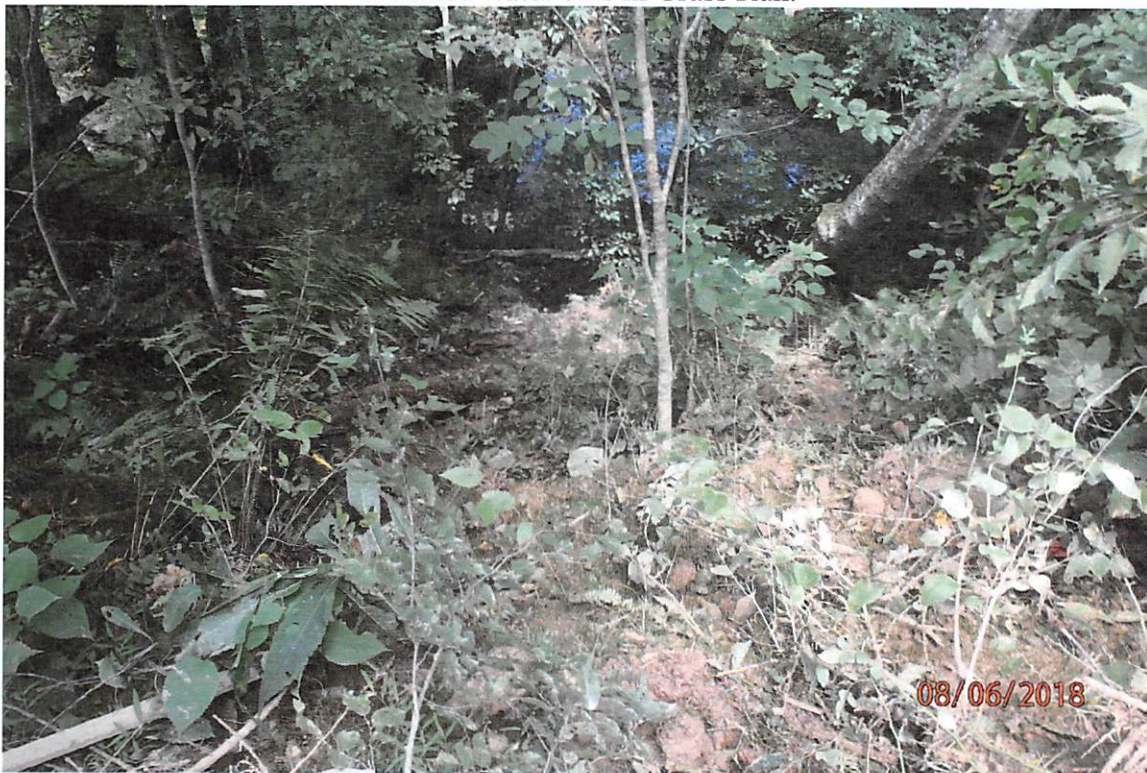
Concentrated flow being directed over fill slope into a sheet flow super silt fence from improperly installed water bars in Grass Run.

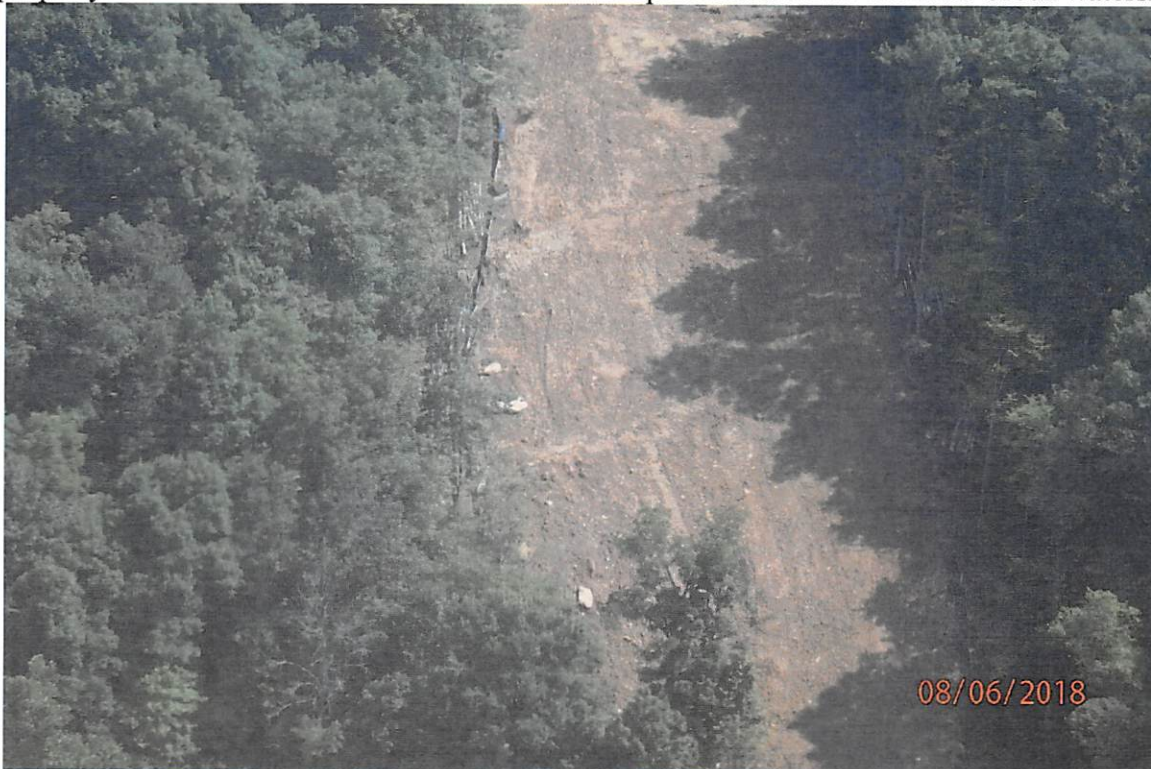
Improperly installed water bars and associated fill slope erosion in the Tenmile Creek watershed.

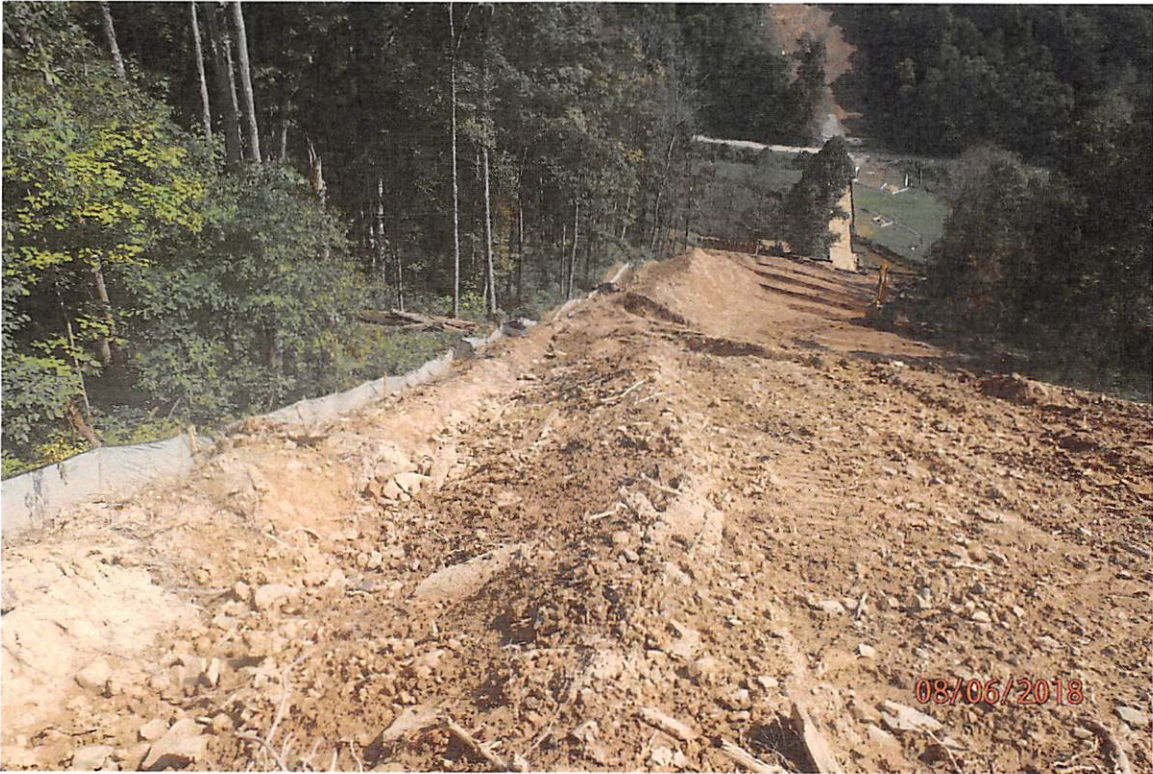
Improperly installed water bars and associated fill slope erosion in the Little Rockcamp Run watershed.

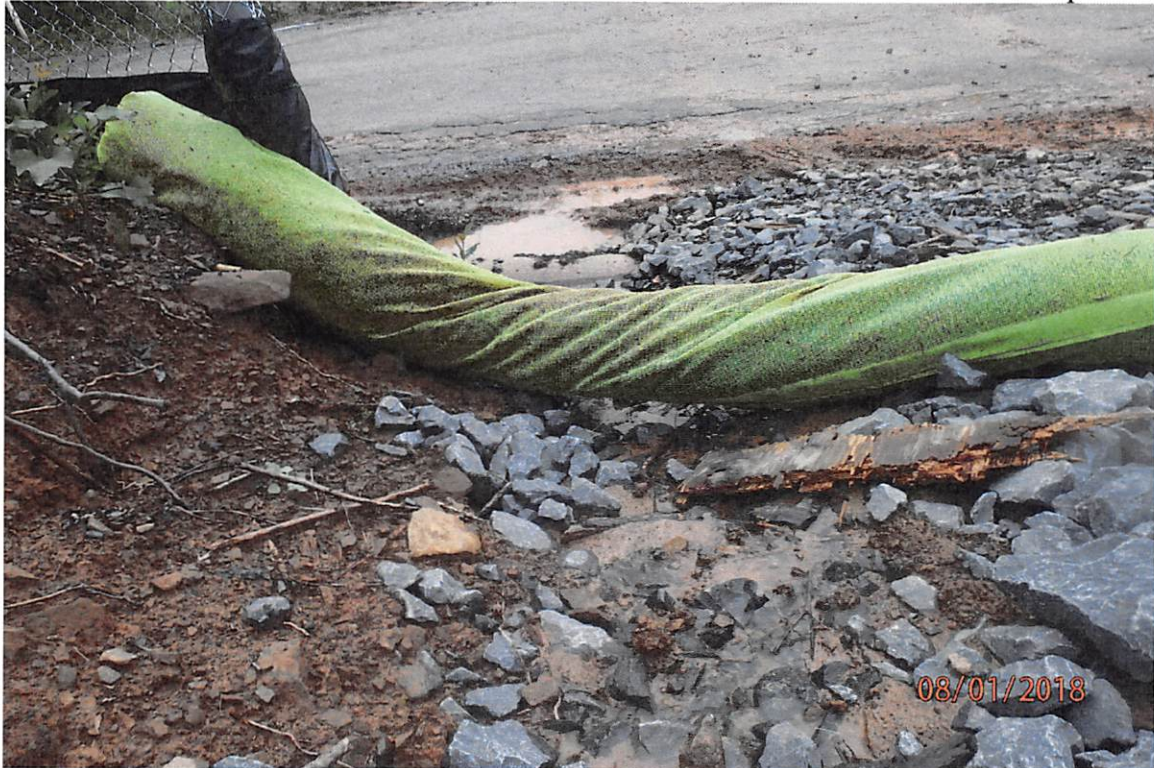
BMP in Seal Run watershed in need of maintenance that led to offsite sediment deposits.

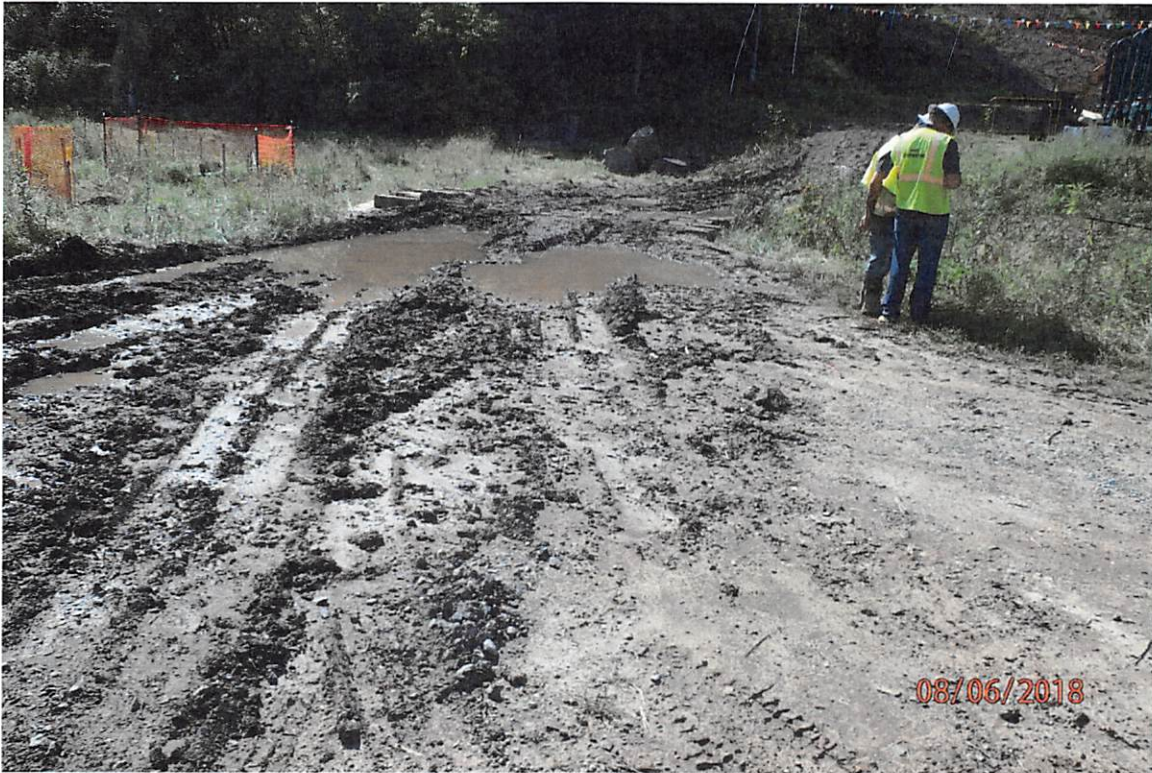
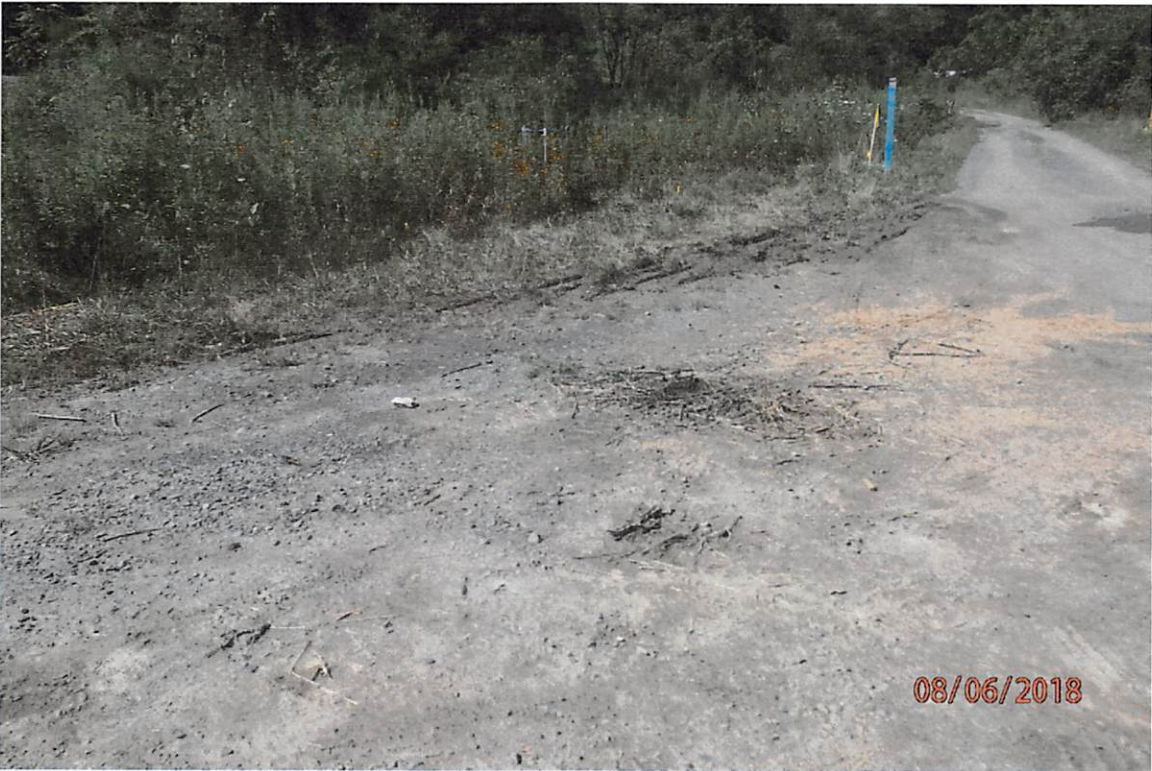
Improperly operated BMP in Right Fork of Big Elk watershed.

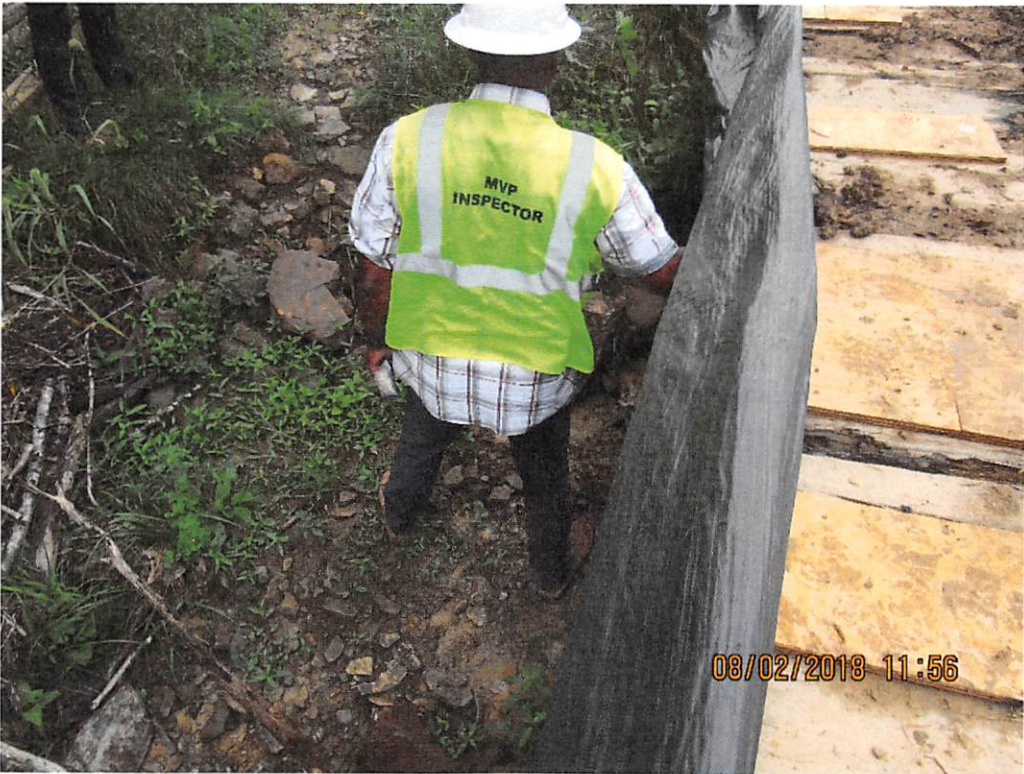
Stony Creek below sediment plume entering stream.

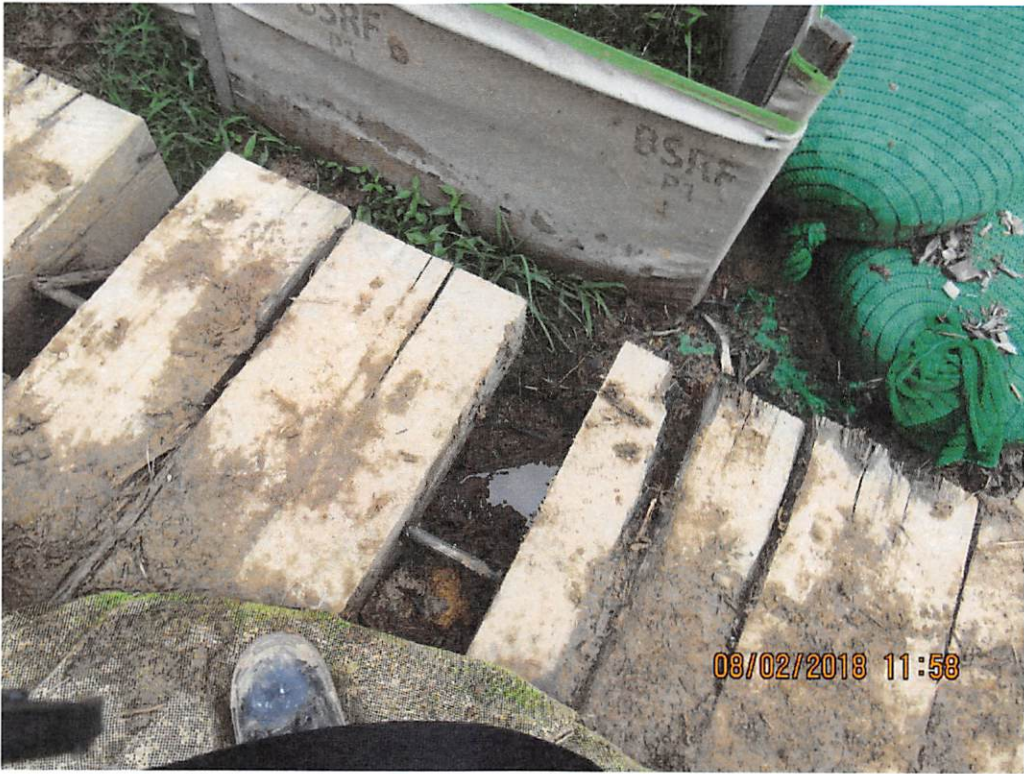
Sediment deposits observed below base of Slate Run bridge.

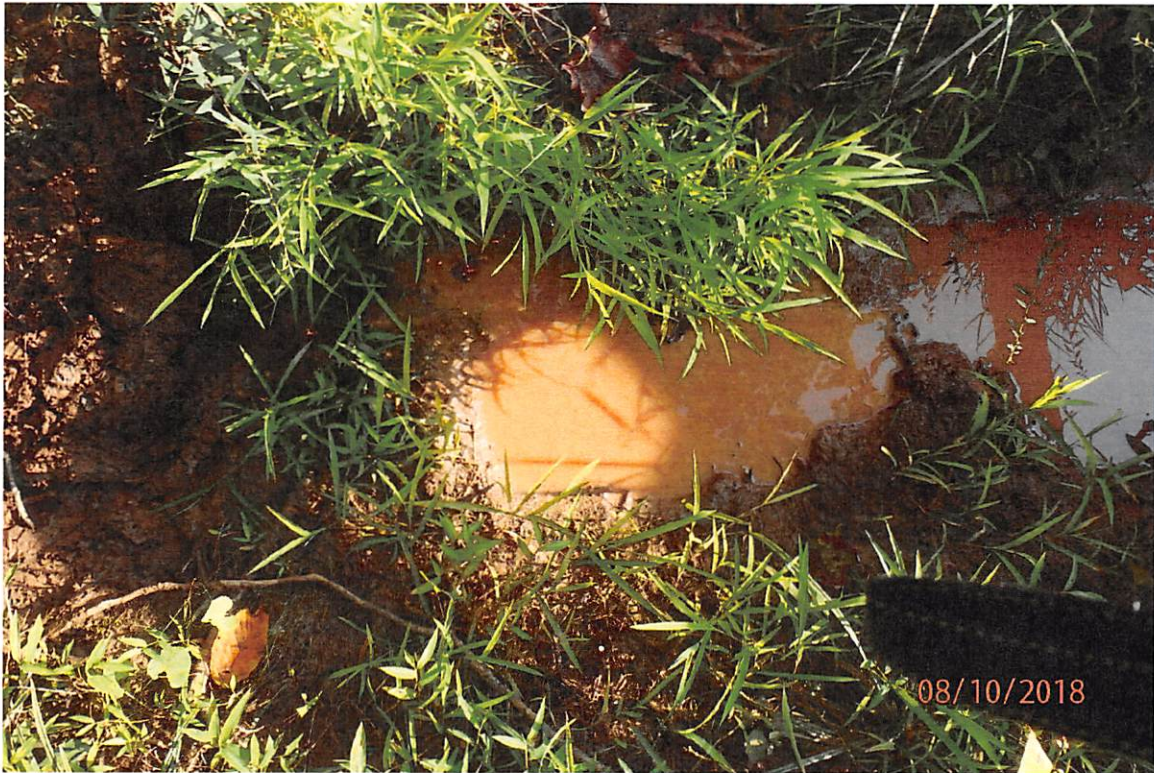
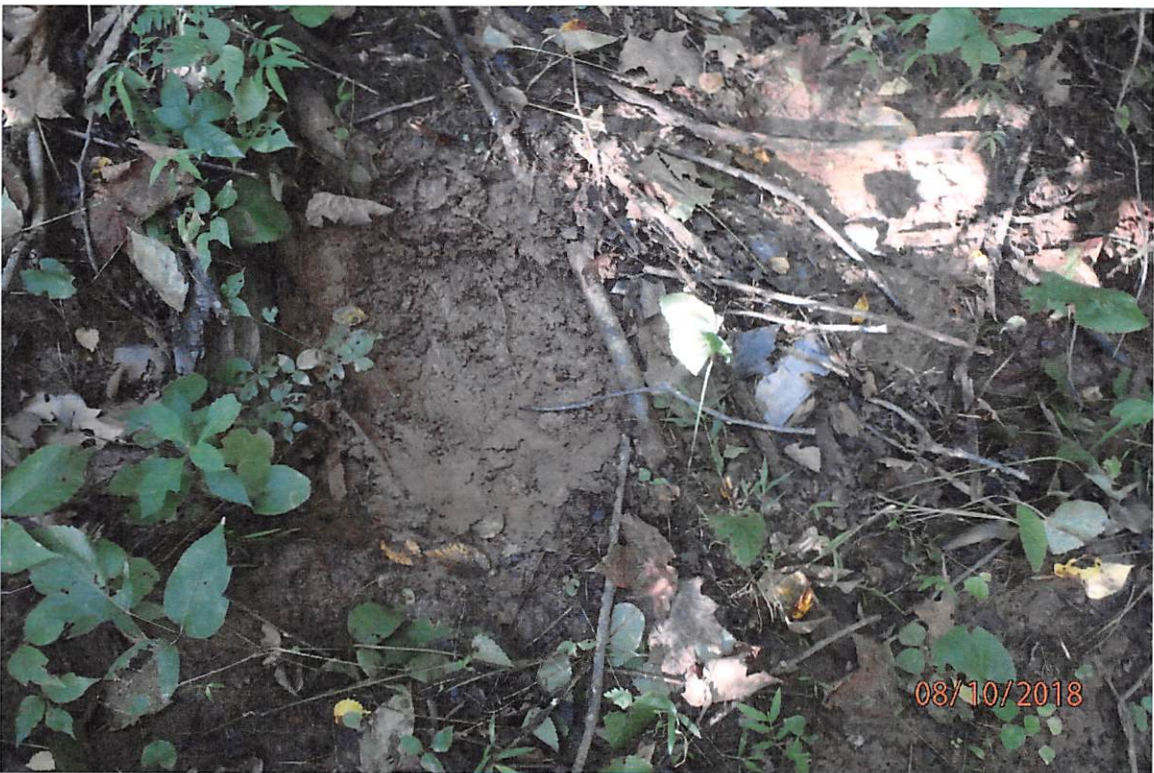
Improperly operated and maintained BMP at a water bar terminus in the Meathouse Fork watershed that led to CNA deposits and distinctly visible settleable solids in UNT Meathouse Fork (39° 11.891' X 80° 33.209').

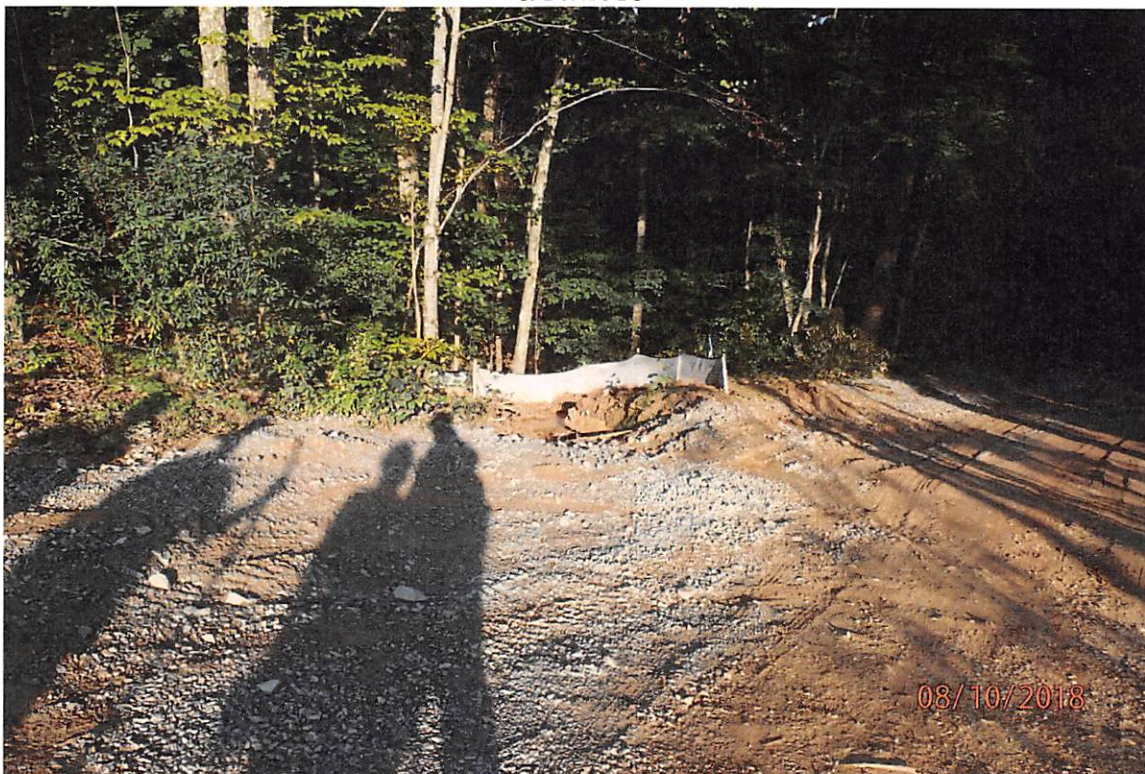
Overview of drainage area leading to BMP that is continuously overwhelmed due to the amount of flow at access road MVP-DO-049. Recent CNA deposits in UNT Dry Fork (39° 11.377' X 80° 33.566') were noted as a result.

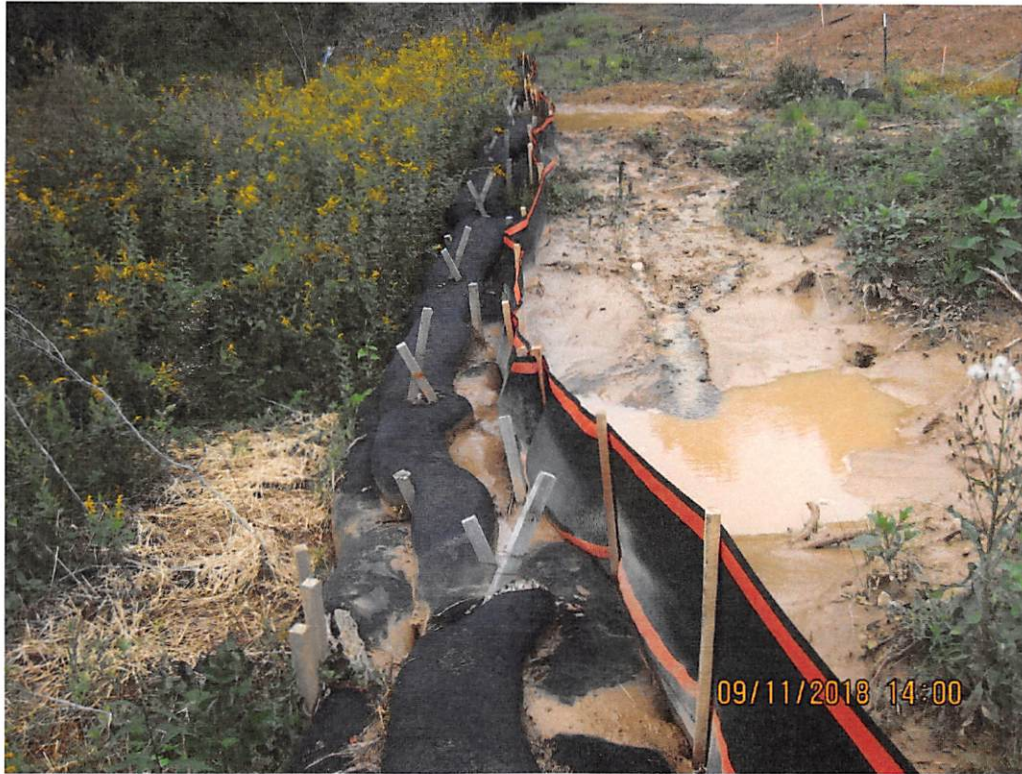
Photo 8: Improperly implemented control for concrete wash out area.

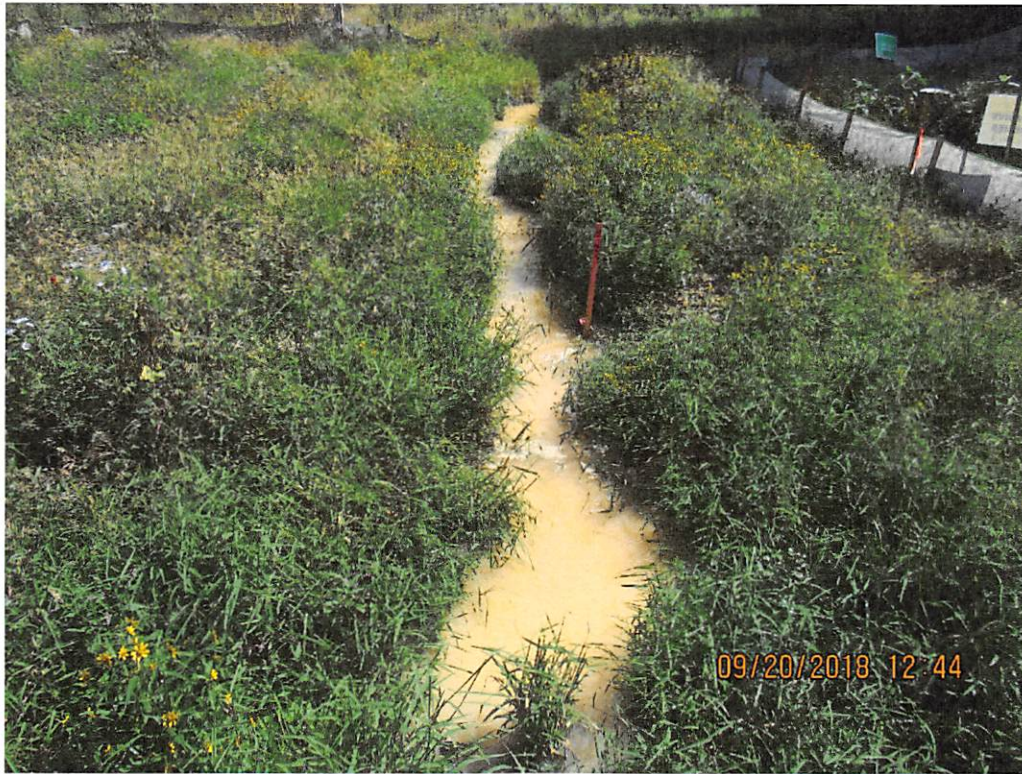
Photo 10: Station 900 (approximately)- upslope view of controls and sediment laden water leaving site.

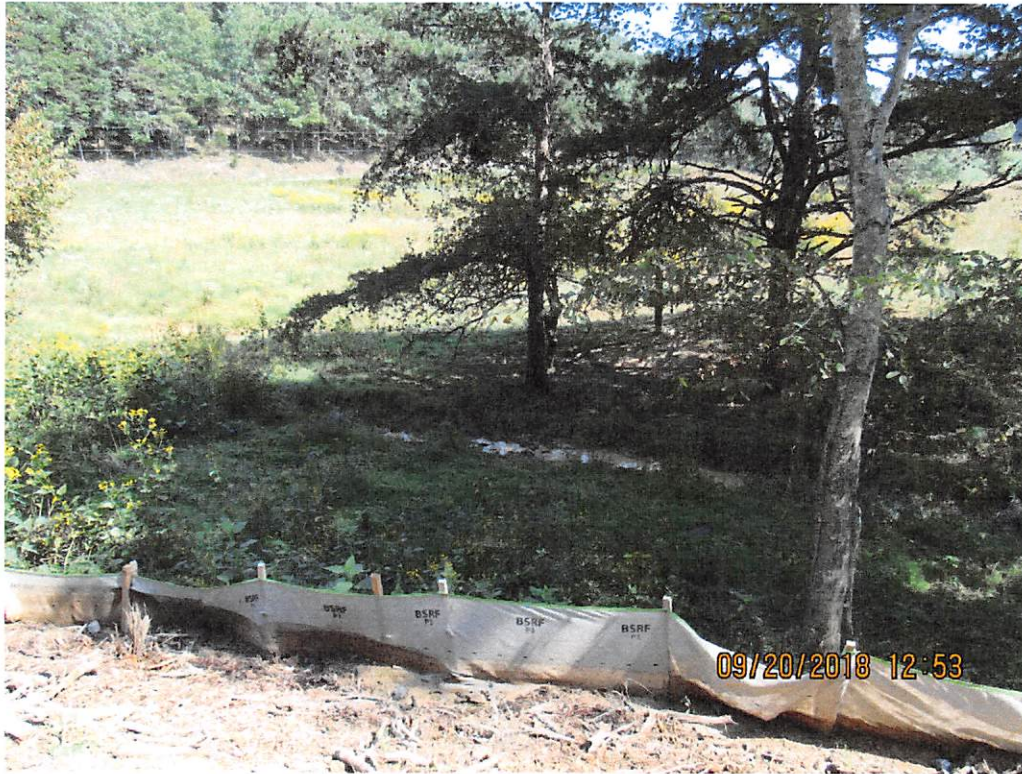
Photo 2: Silt fence needs replaced along access road 231.01 off Painters Run Road near station 10270+49.

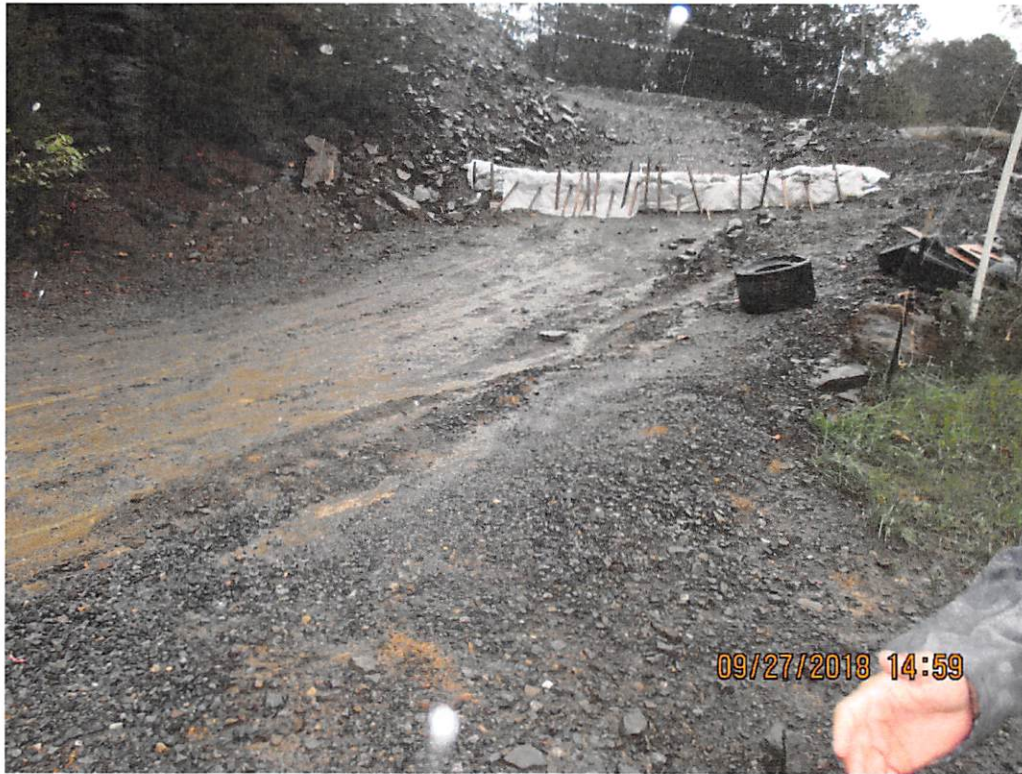
Photo 5: 2 of 3 improperly installed filter fabric bags still in use on north eastern side of site.

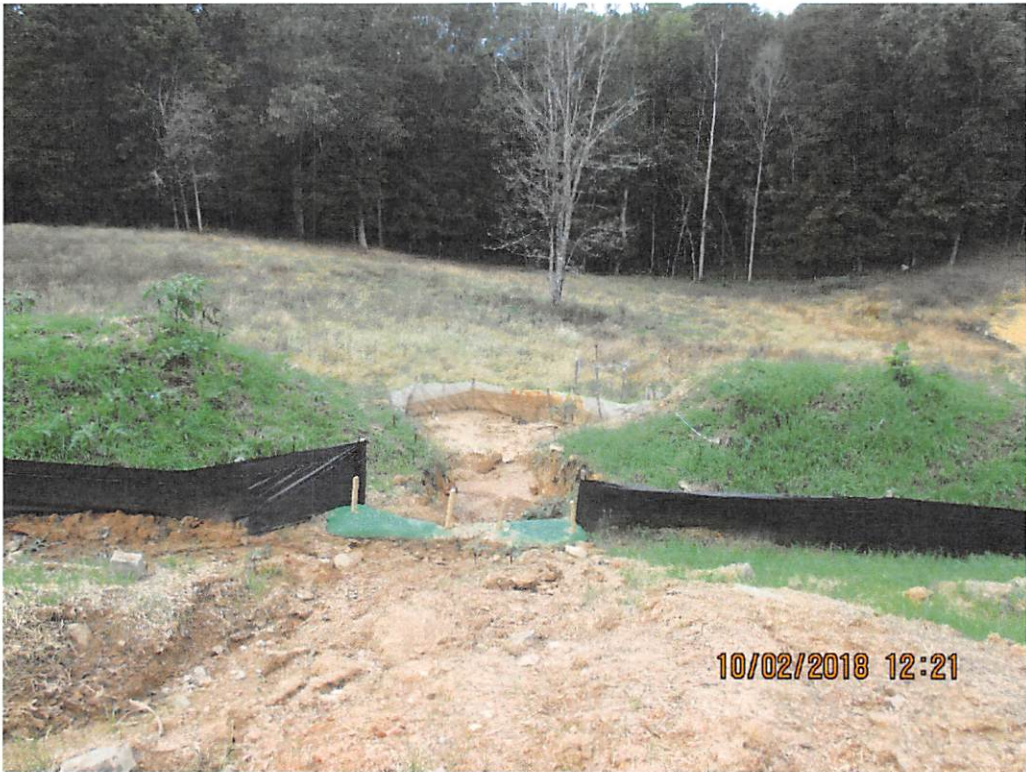
ROW near station #9687 where multiple BMP's are failing.

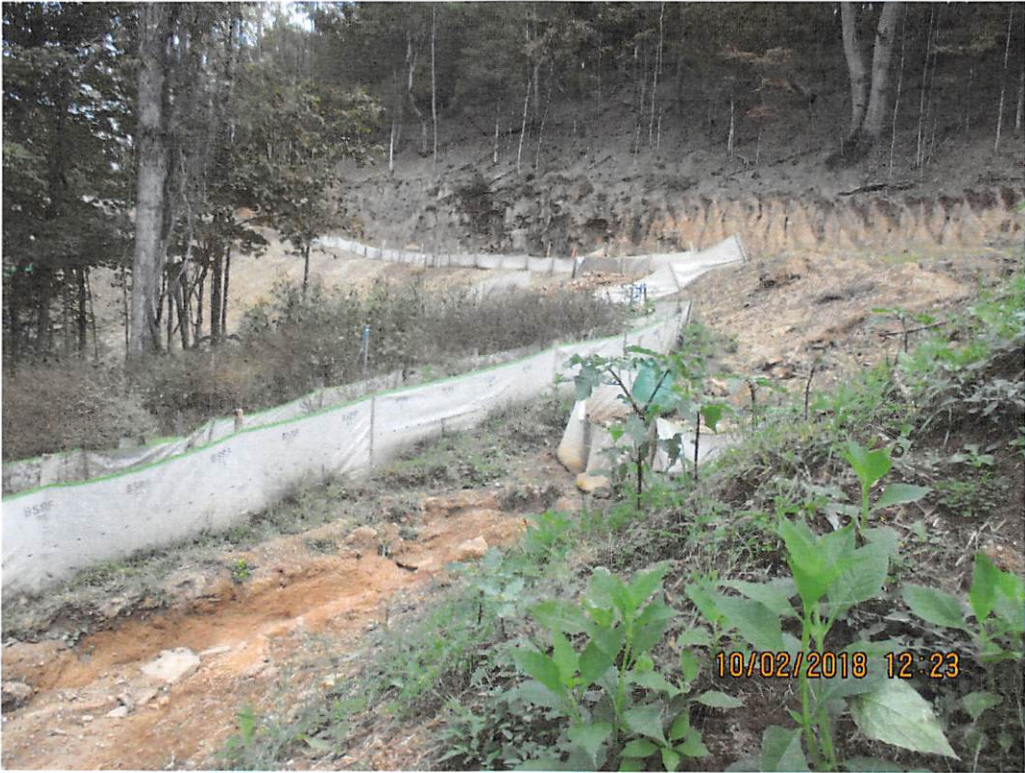
Gully erosion occurring near Station #9687 and flowing towards Pond (P-D2). BMP pictured was failing and off-site sediment deposits were present past the LOD.

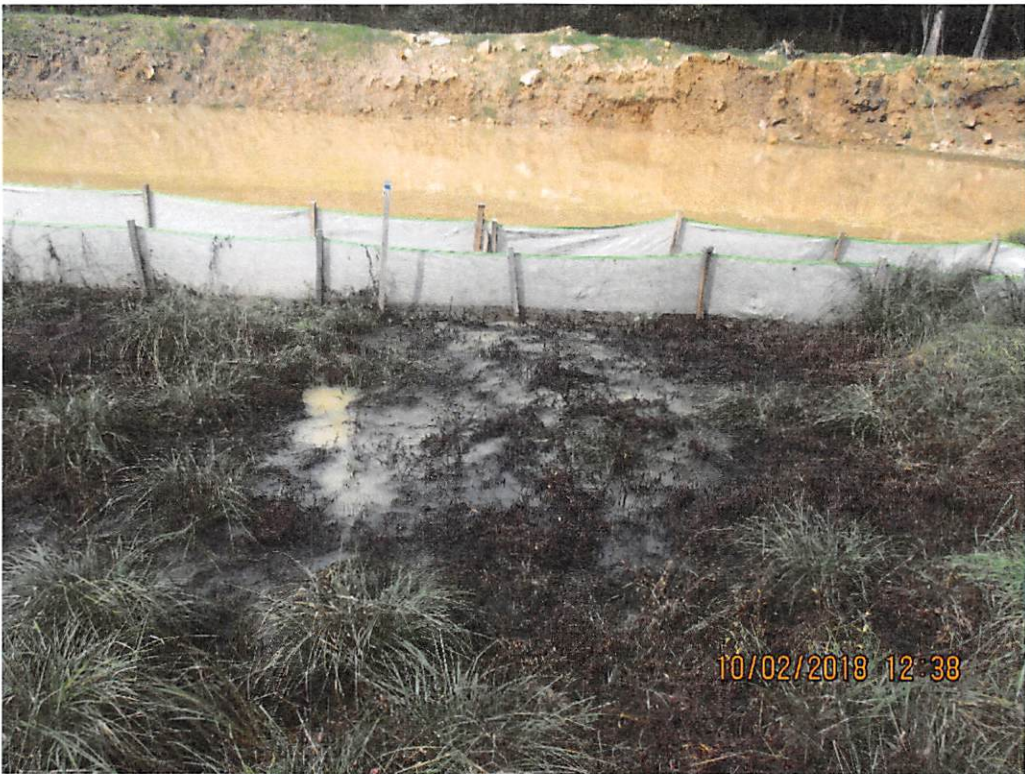
Edge of Pond (P-D2) near station number 9680.
