**CONSENT ORDER  
ISSUED UNDER THE  
WATER POLLUTION CONTROL ACT  
WEST VIRGINIA CODE, CHAPTER 22, ARTICLE 11**

TO: Mountain Valley Pipeline, LLC

DATE: April 19, 2019

ORDER NO.: 8951

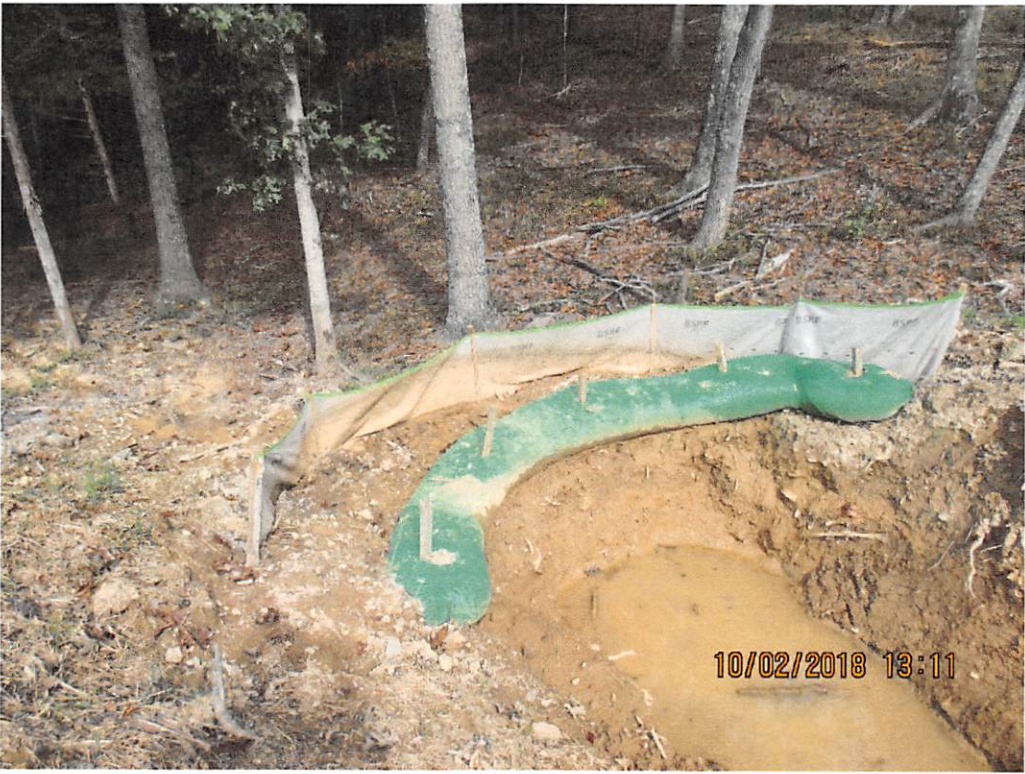
Sediment laden water infiltrating pond P-D2.

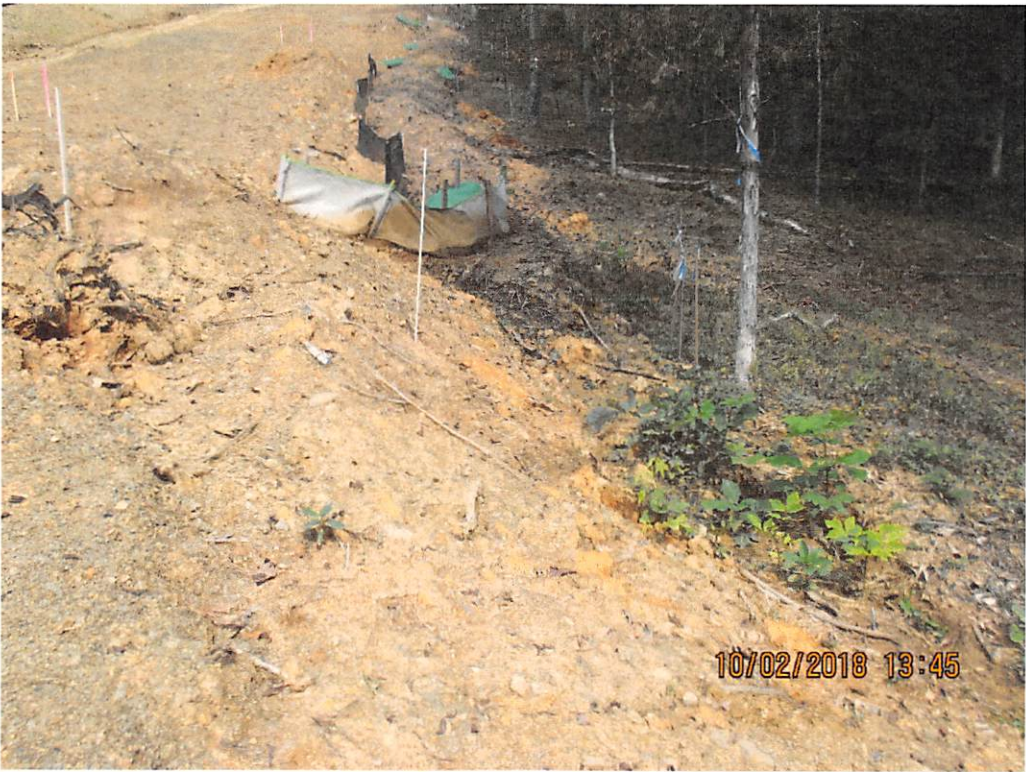
Off-site sediment deposits at Station #9717+52.

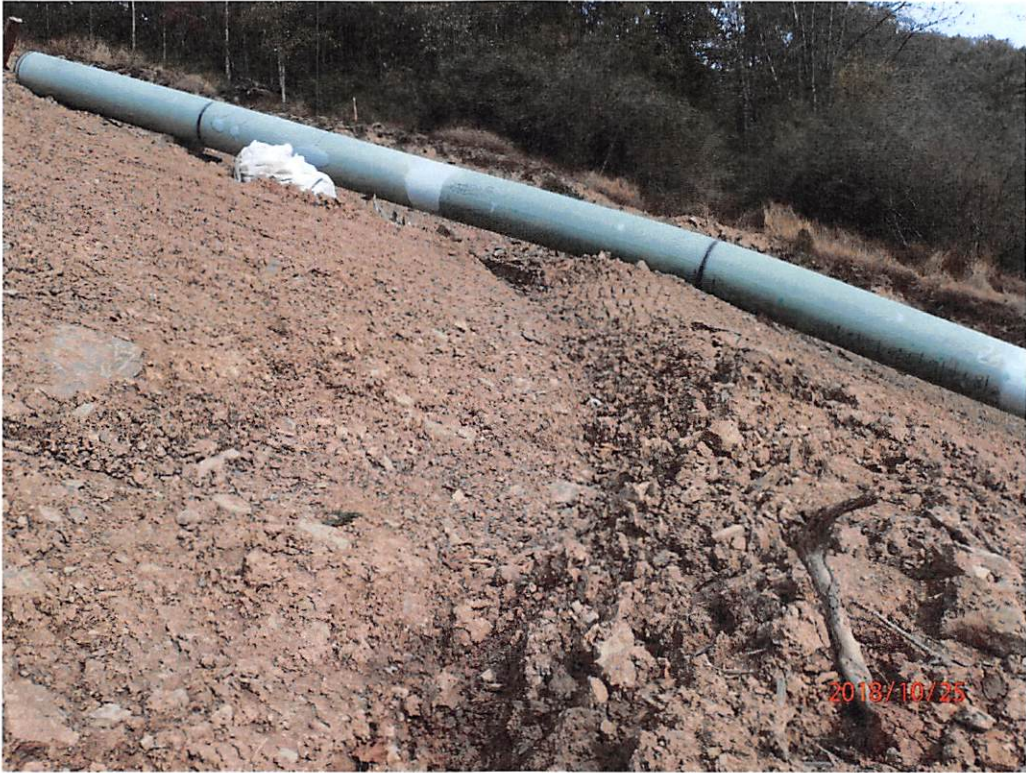
Overwhelmed sump near Sams Run.
