**CONSENT ORDER  
ISSUED UNDER THE  
WATER POLLUTION CONTROL ACT  
WEST VIRGINIA CODE, CHAPTER 22, ARTICLE 11**

TO: Mountain Valley Pipeline, LLC

DATE: April 19, 2019

ORDER NO.: 8951

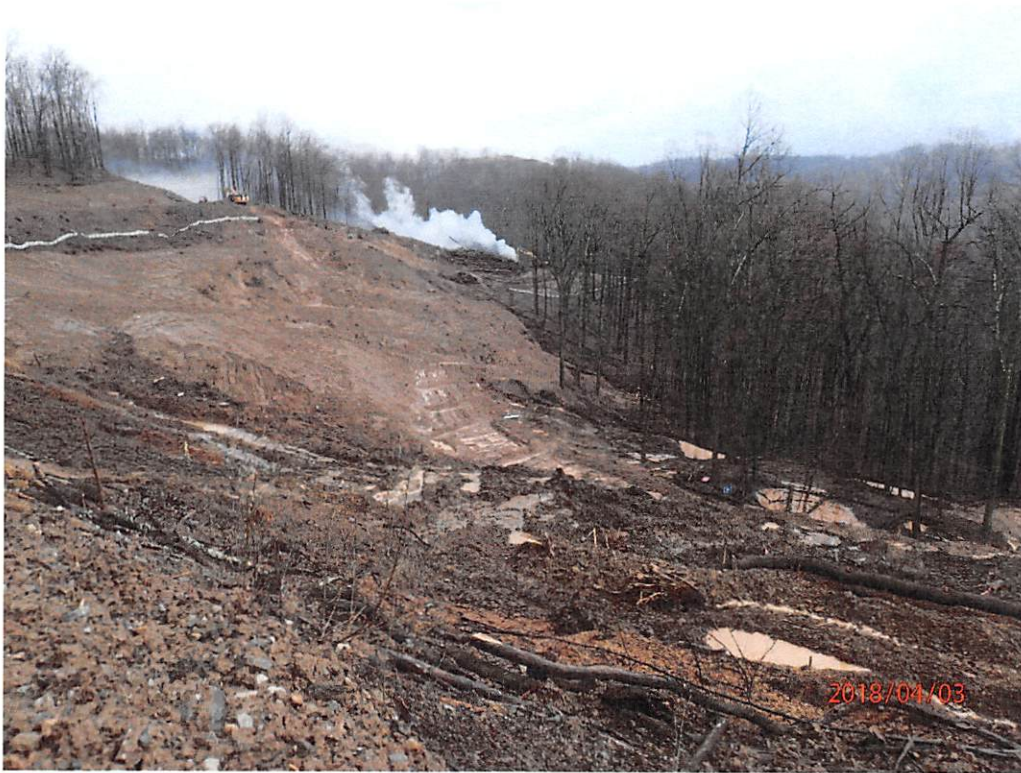
Disturbed area near the reported slip area.

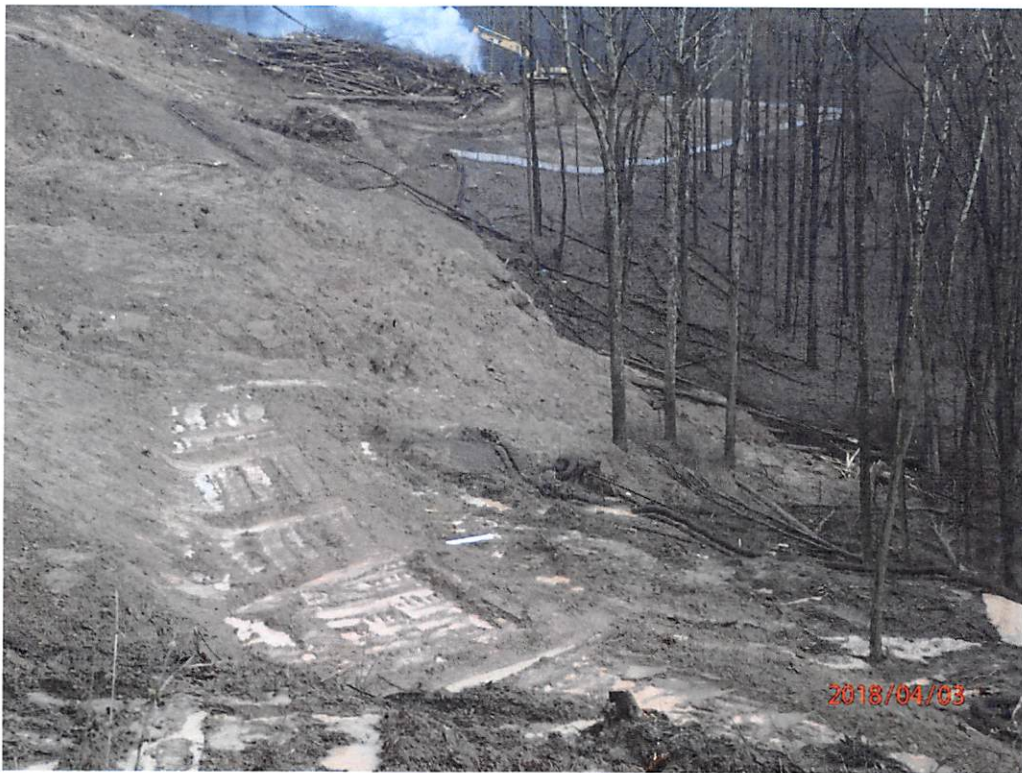
Reported slip area near Bradshaw Compressor Station.

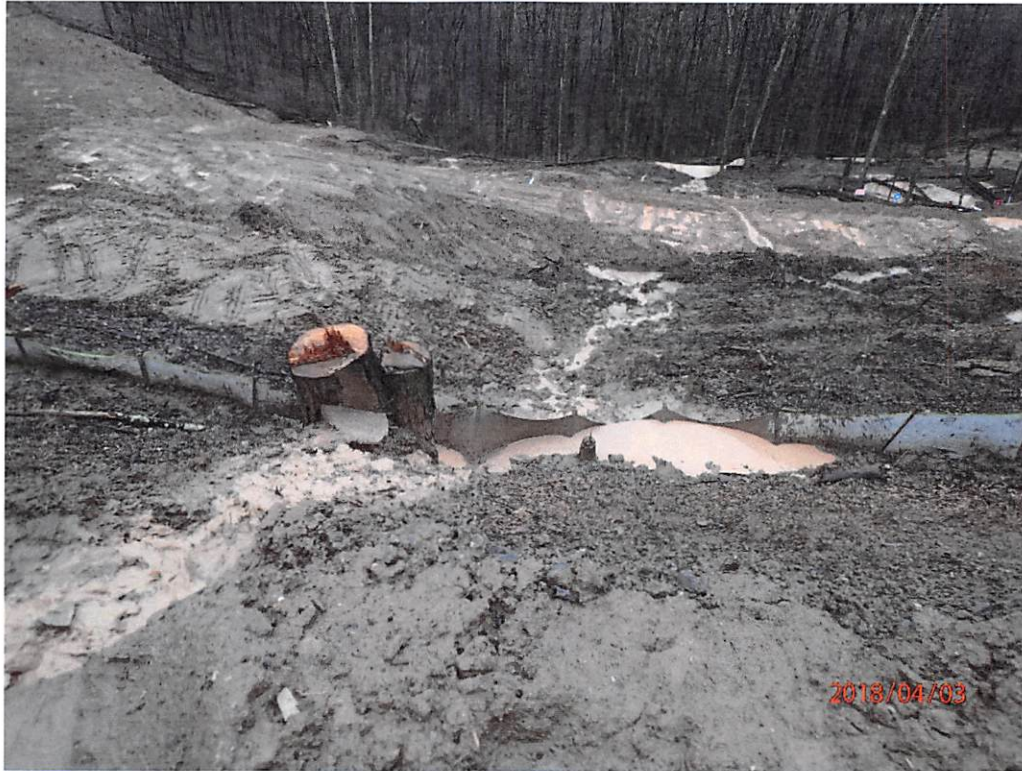
Concentrated flow eroding slope near slip.

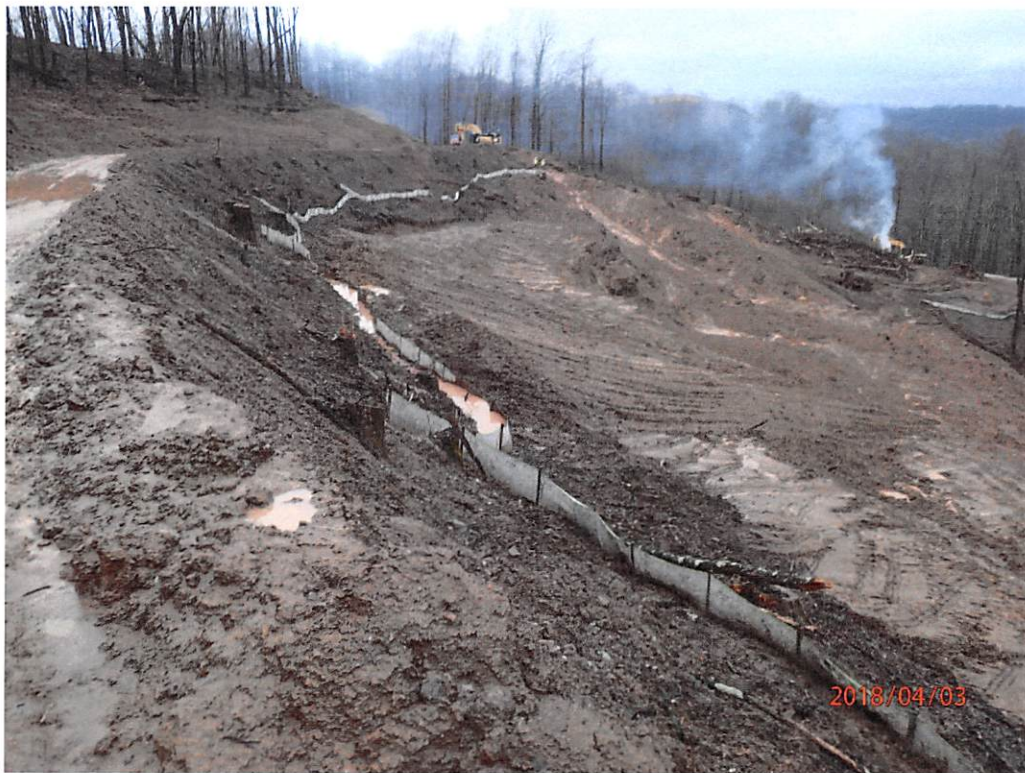
Hillside above slip near Bradshaw Compressor Station.

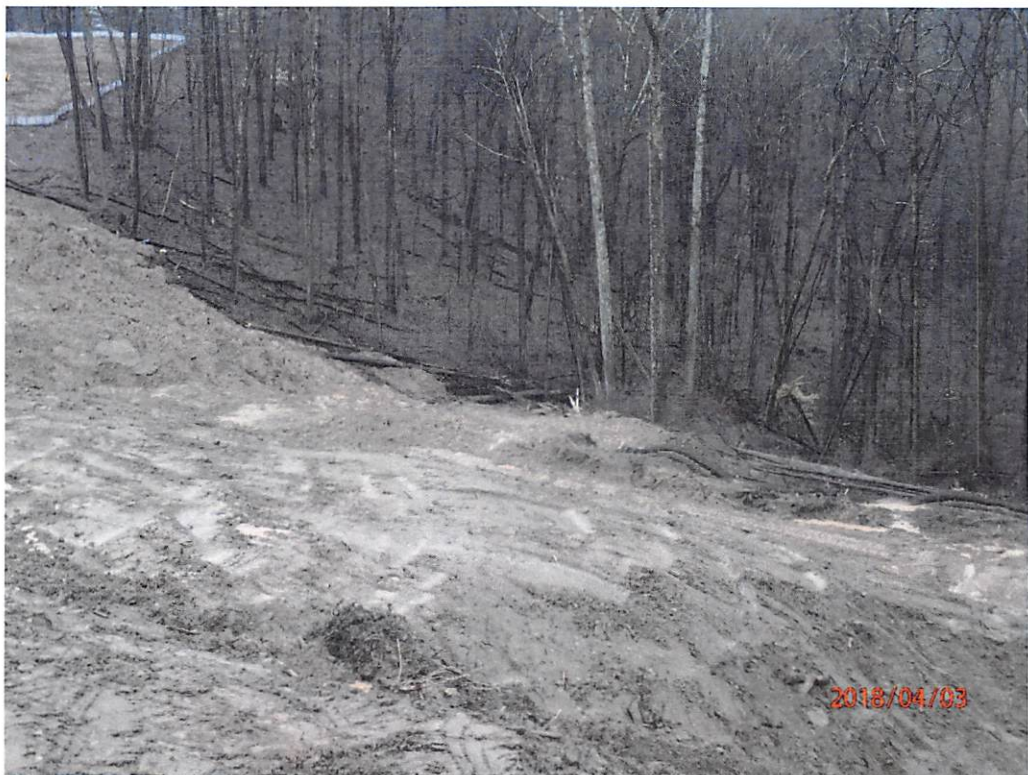
Slope above slip area.

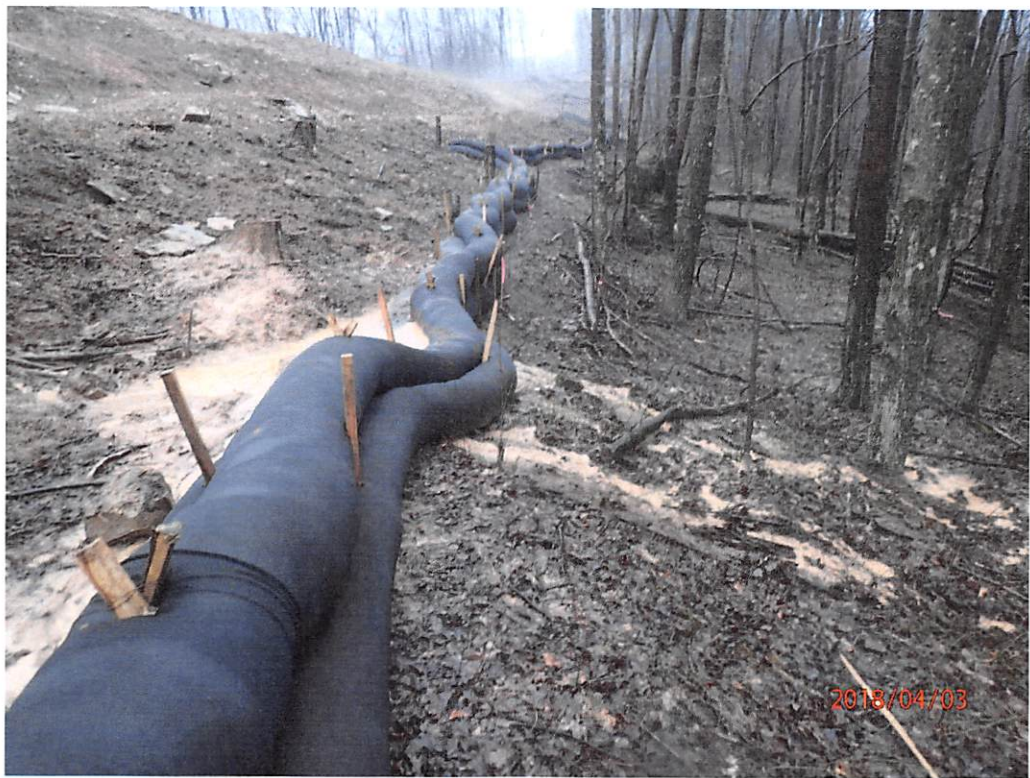
Second site of sediment laden water leaving site at Bradshaw Compressor Station.

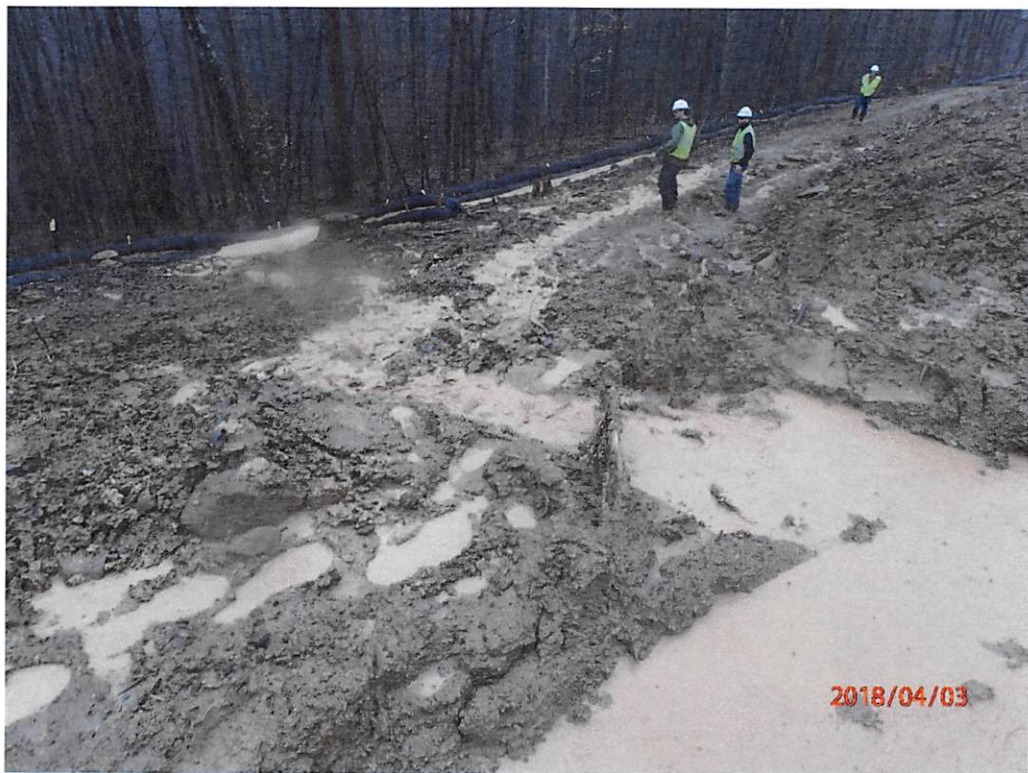
Third site of sediment laden water leaving site at Bradshaw Compressor Station.

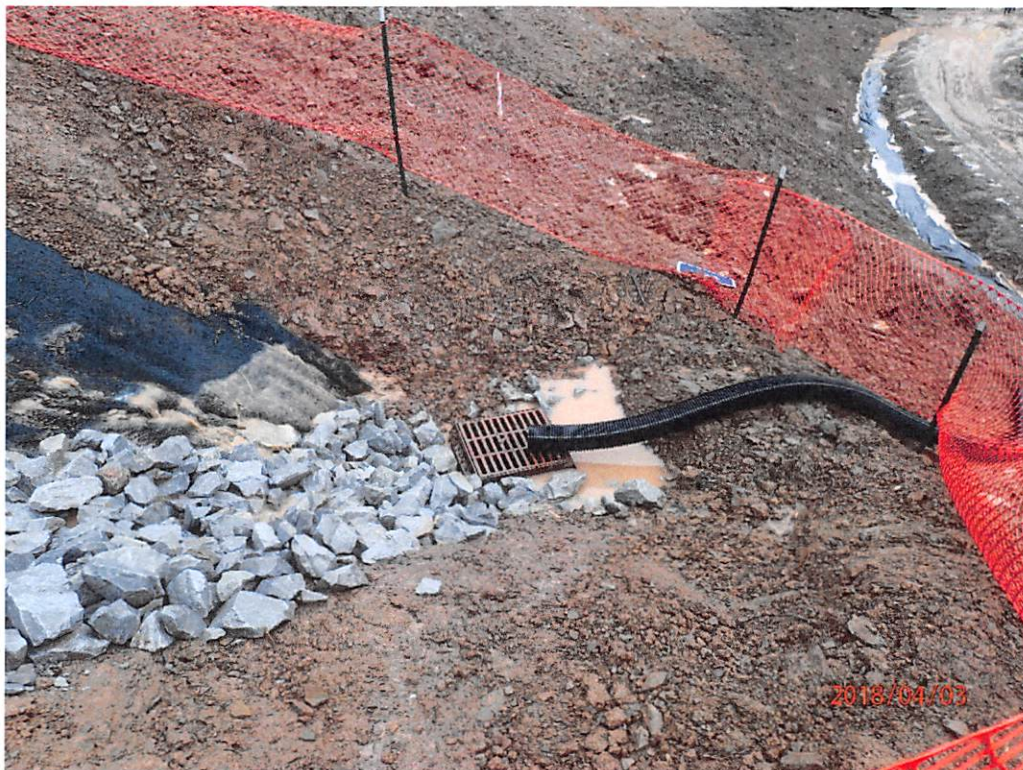
Unprotected drop inlet at Mobley Compressor Station.

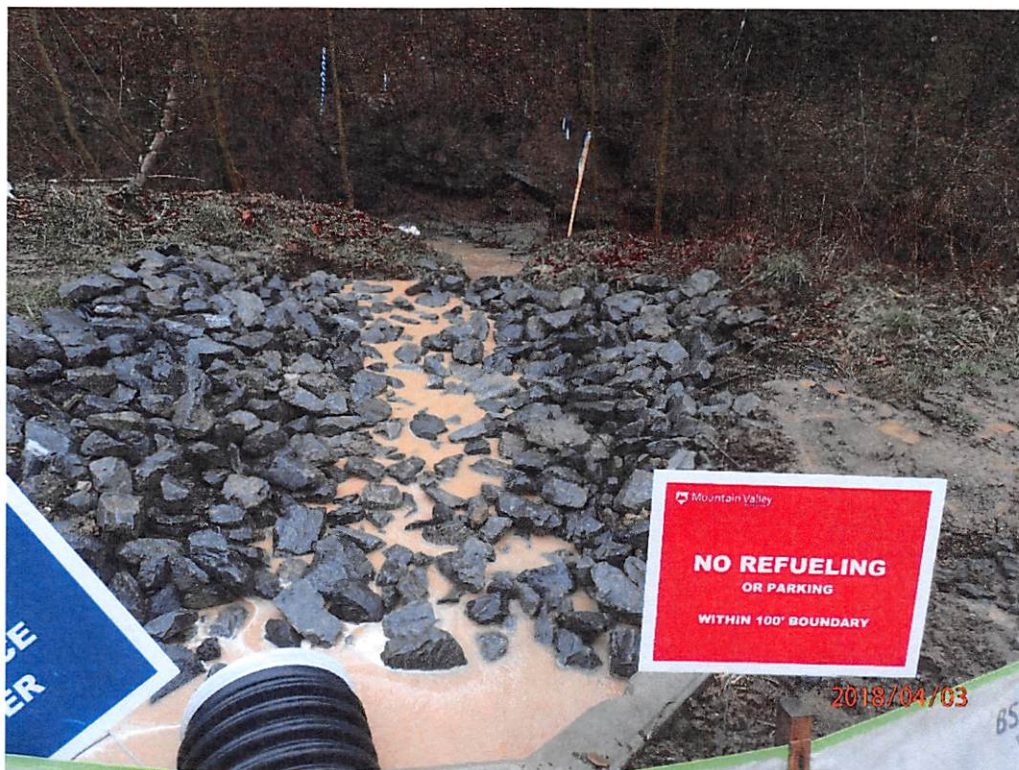
Sediment laden water leaving site into UT of Mobley Run.

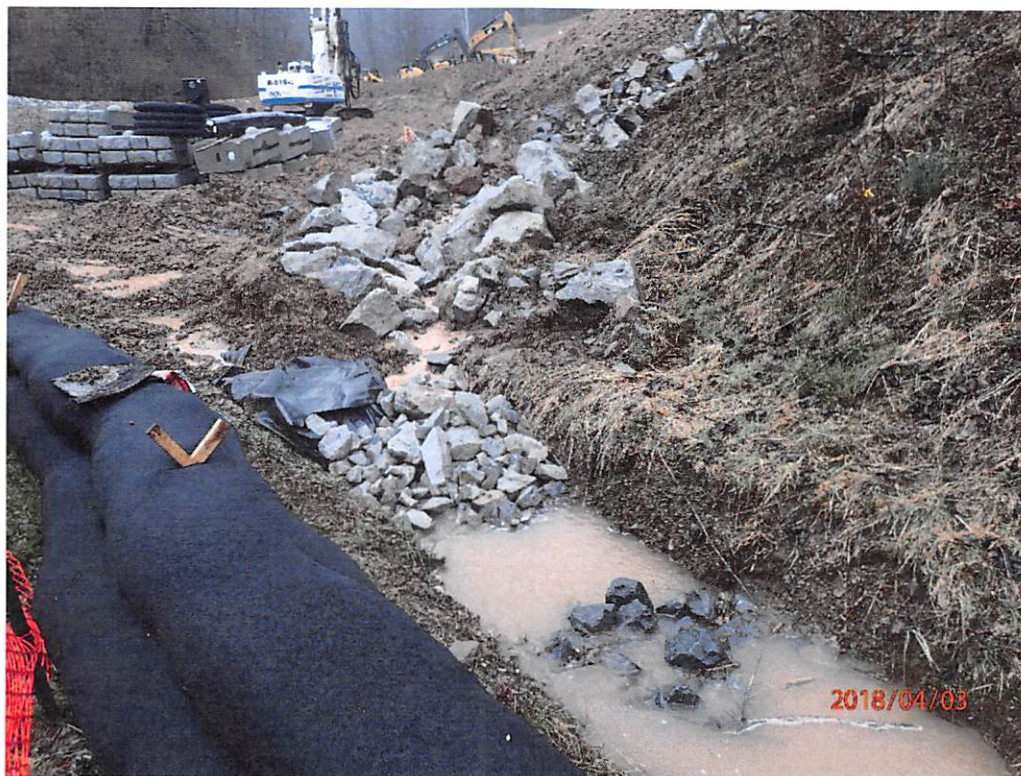
Sediment laden water leaving site through drop inlet.

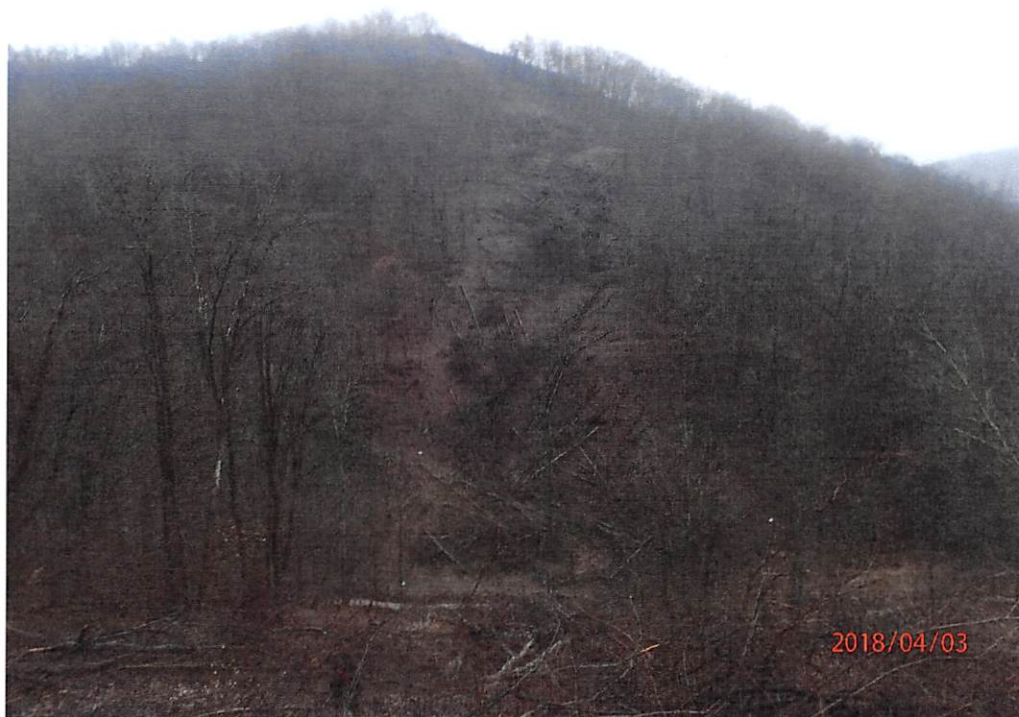
Line clearing off North Fork Road.

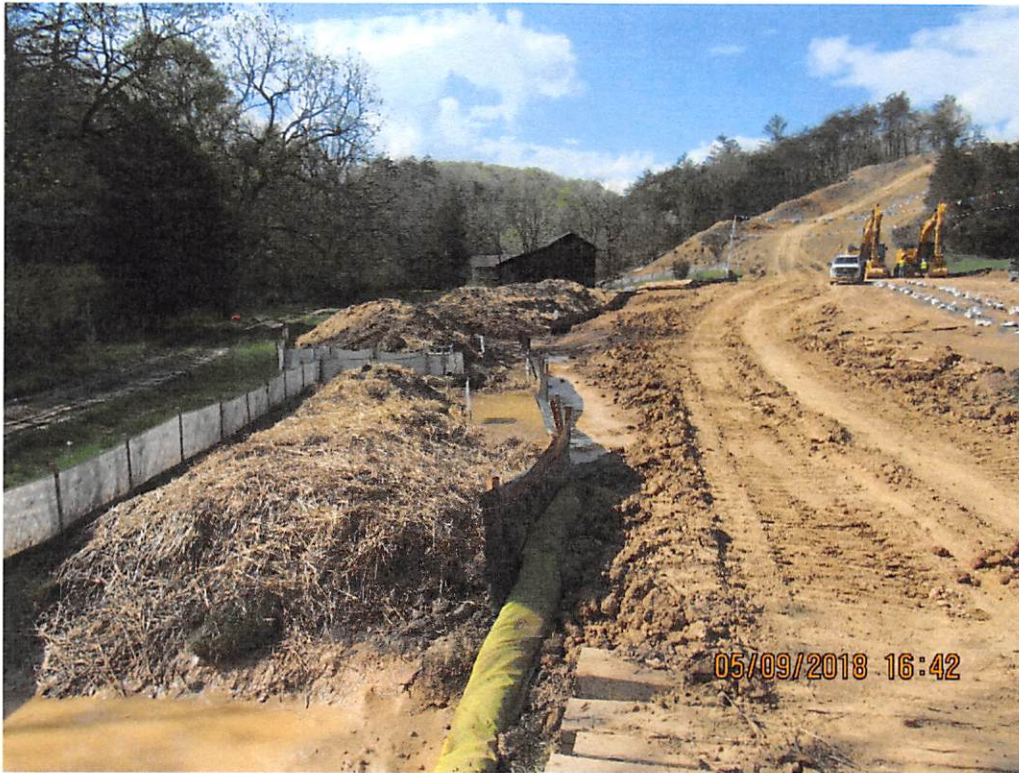
Photo 1: Delineation of topsoil stockpiles from subsoil with black silt fence and path to sump prior to stream.

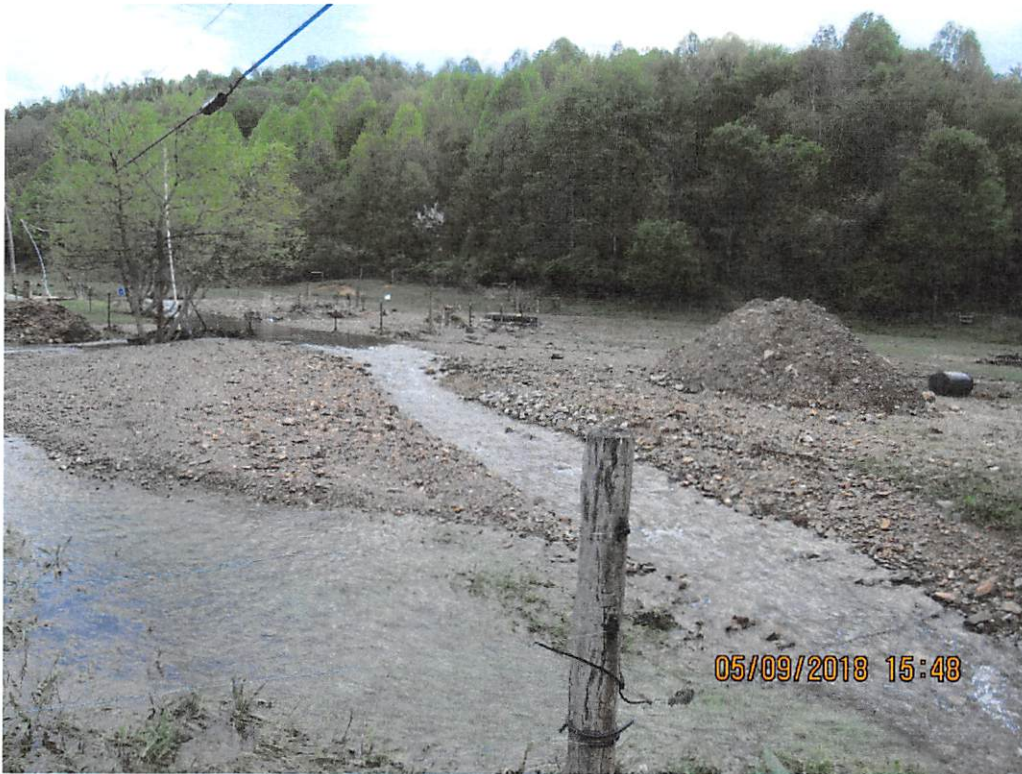
Photo 3: station 10146+32, sheet 9.35 - stream has been partially returned to channel. Rock/soil pile resulted from landowner removing debris to restore to channel.

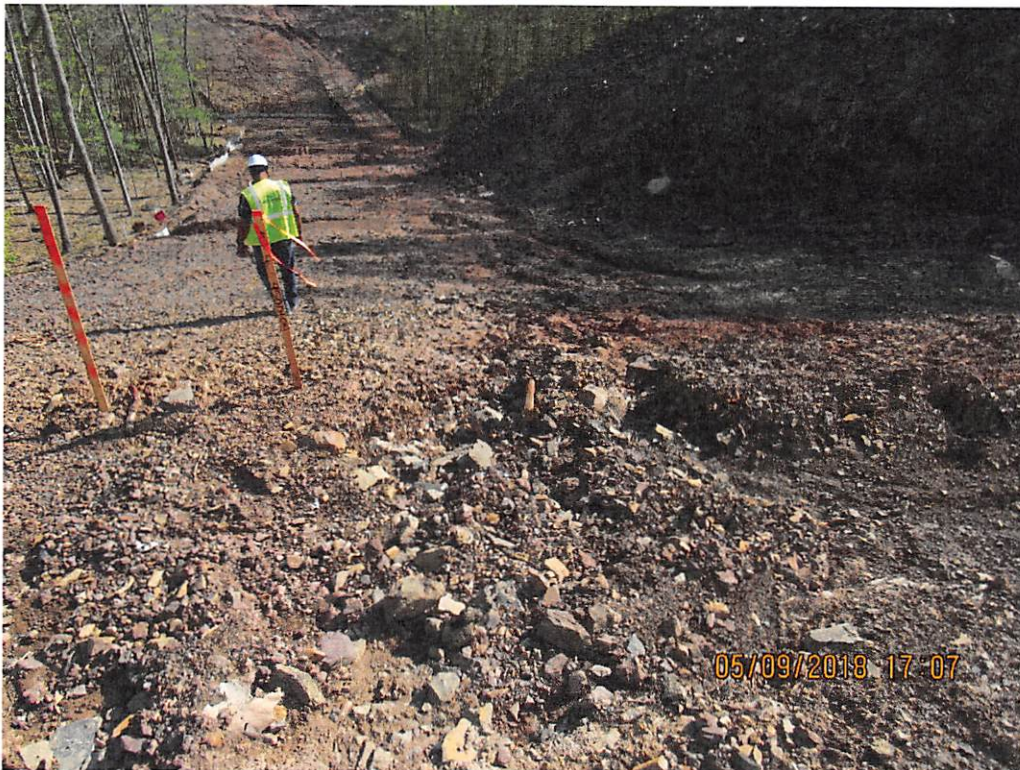
Photo 4: Downslope view of site of sediment laden water leaving site- erosion gullies observed on slope. (view south)

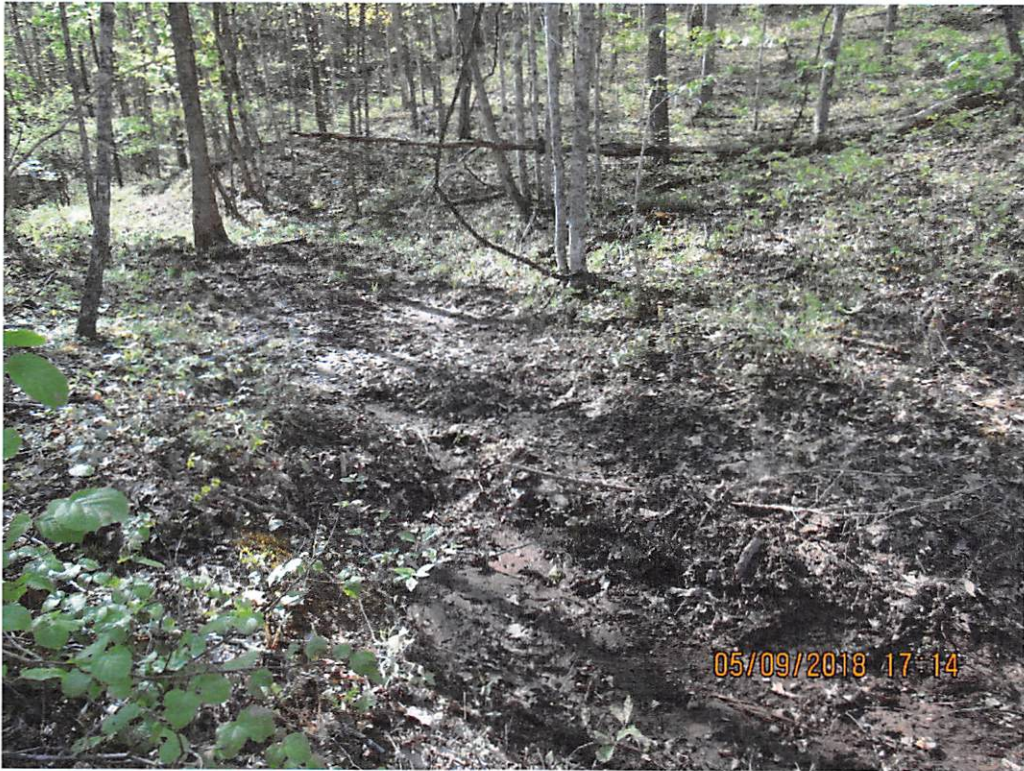
Photo 8: Downstream view of sediment deposits in stream S-IJ65 creating conditions not allowable. (view west)

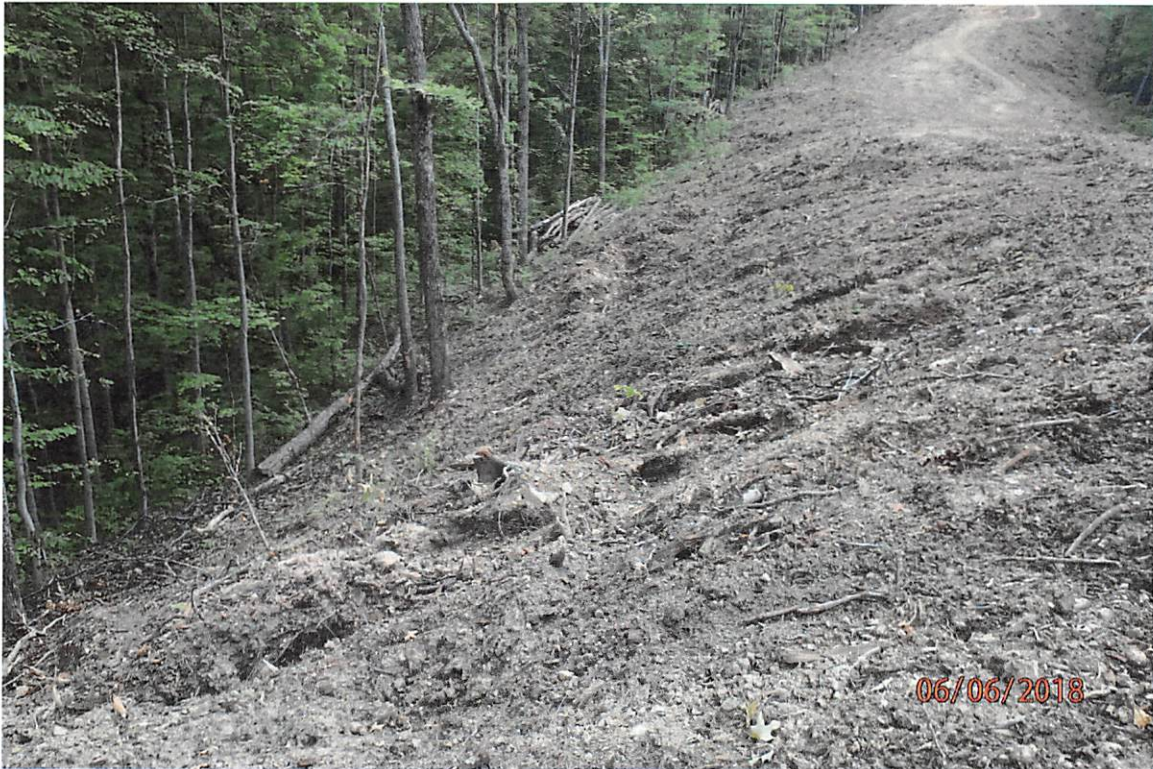
Areas of the project that have been cleared to mineral soil and BMPs are not in place as indicated in the SWPPP.

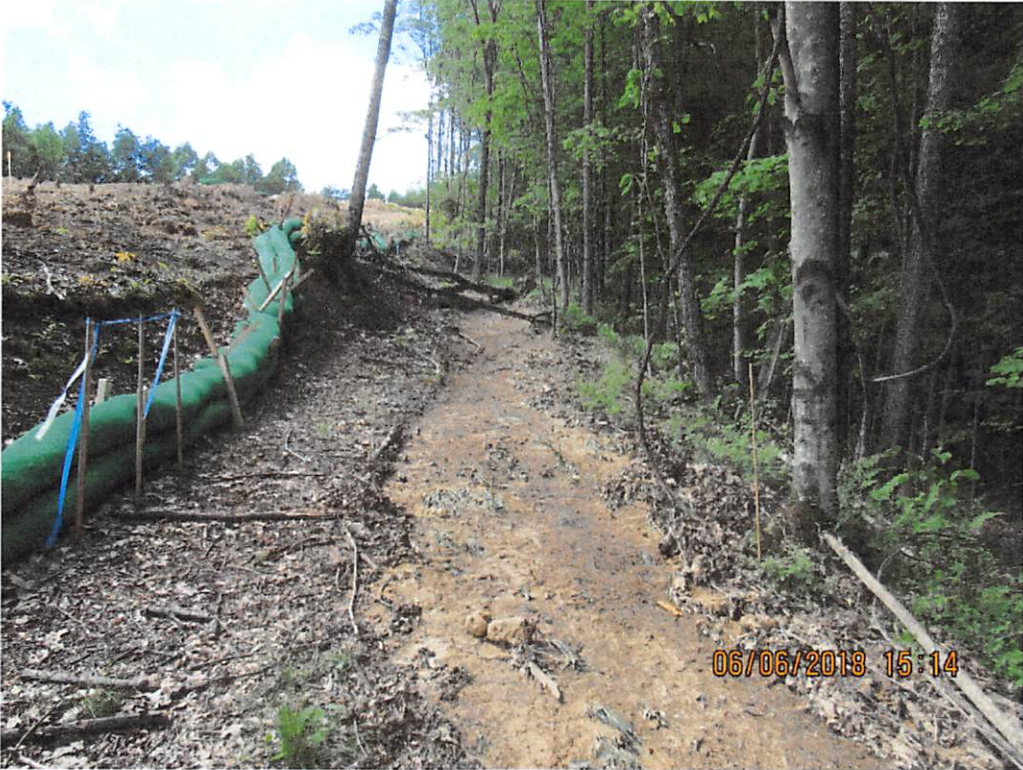
Photo 5: Scoured path from control failure at station 6812+58.

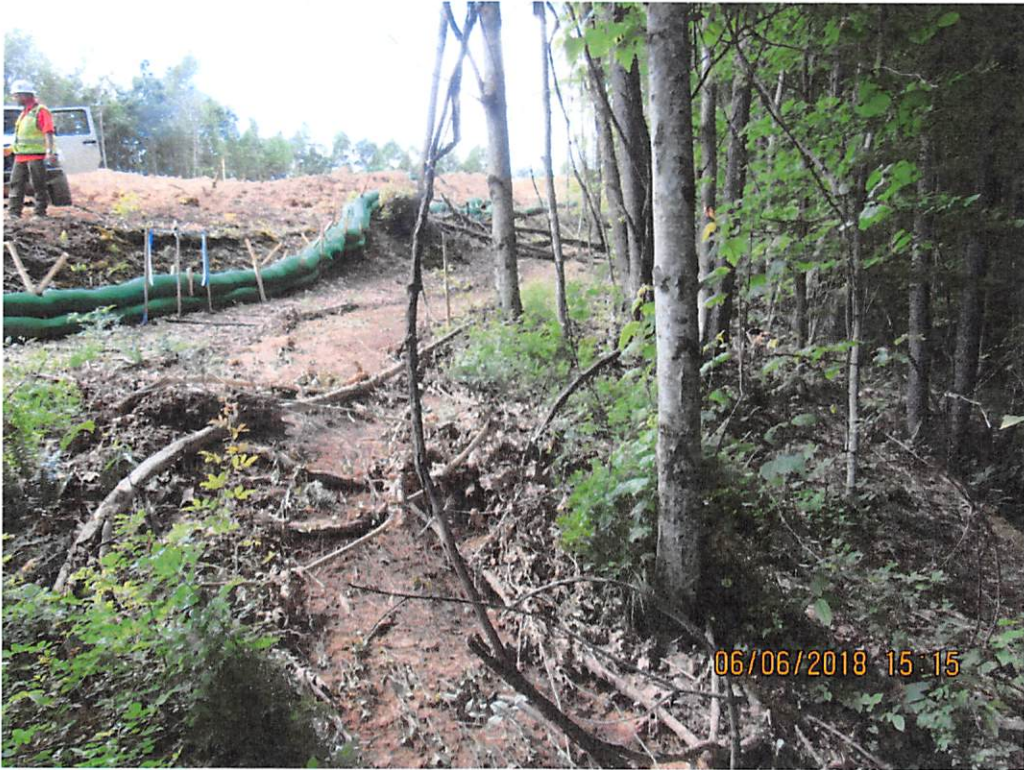
Photo 6: Continued scoured path from control failure at station 6812+58.

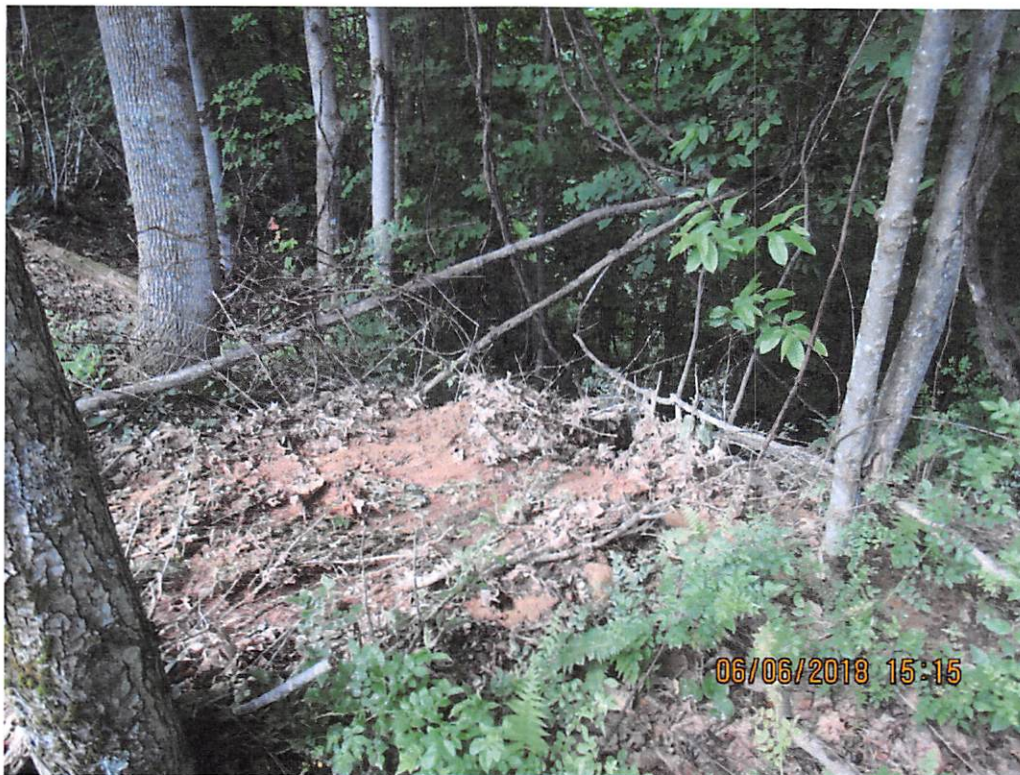
Photo 7: Water leaving the site from control failure at station 6812+58.

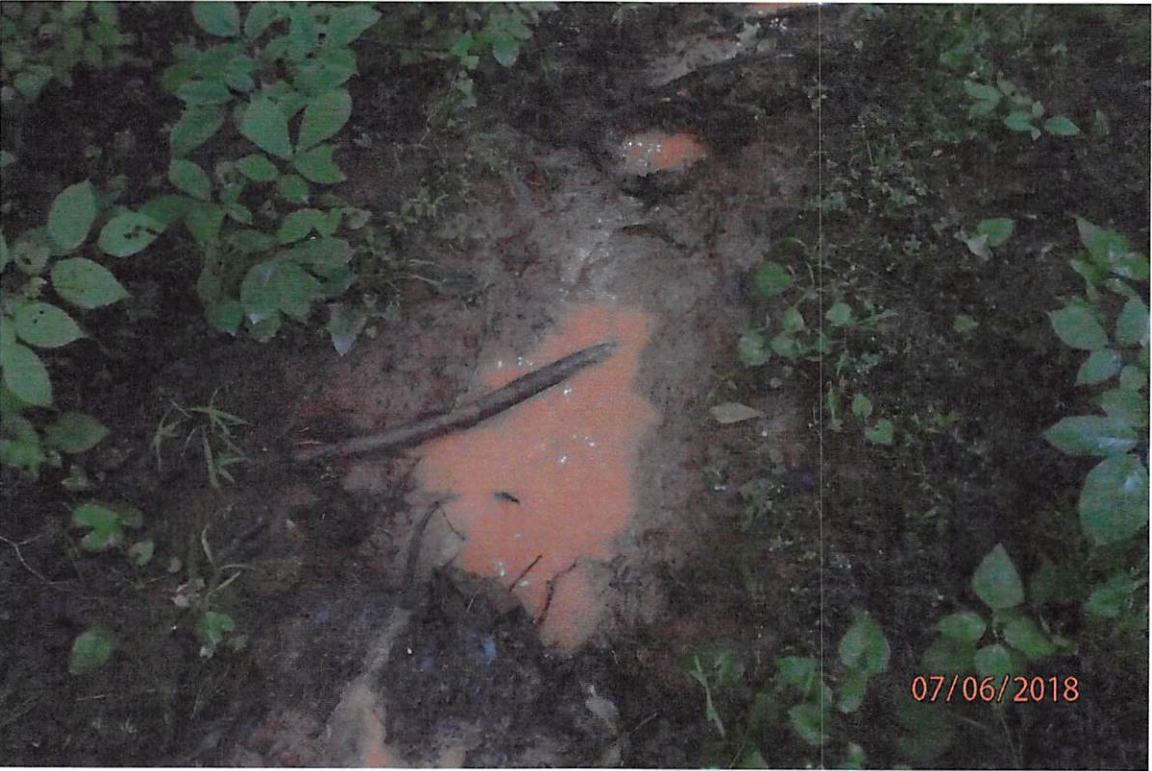
Sediment laden water in UNT Meathouse Fork (39° 11.891' X 80° 33.209') that originates from site.

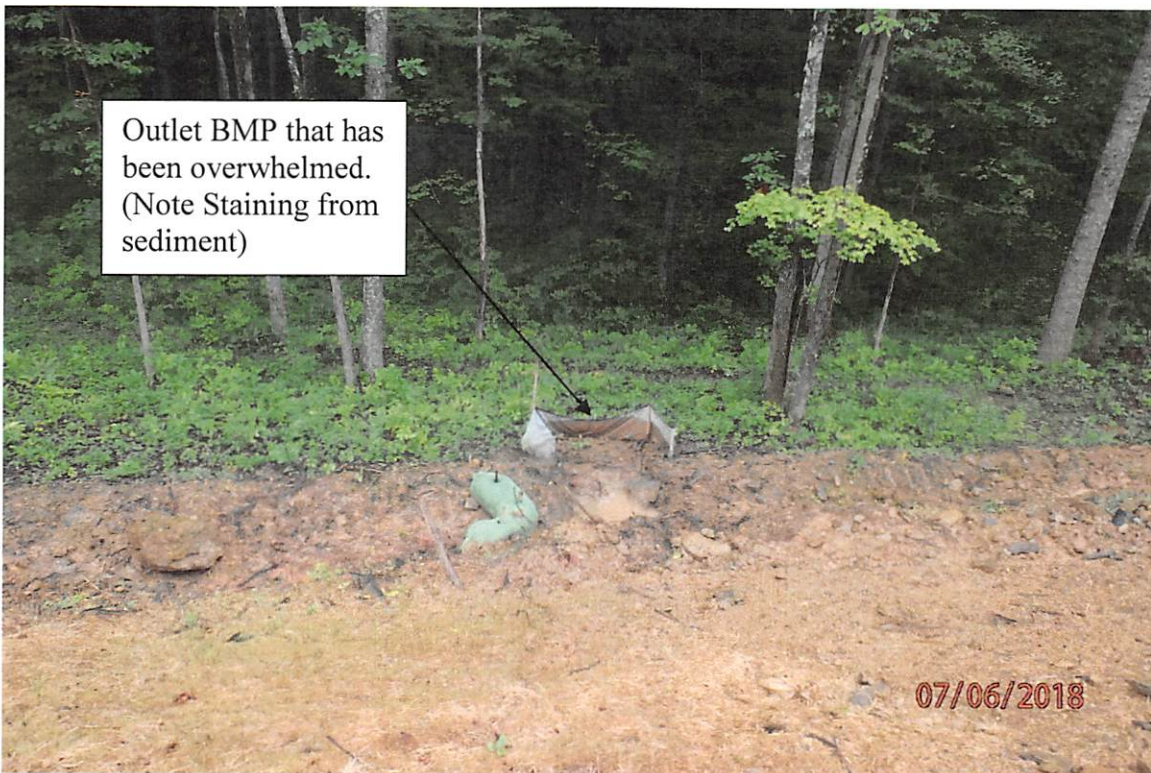
Installed temporary tight of way diversion and outlet that does not have adequate outlets adjacent to 1876+00. Evidence of the terminus BMP being overwhelmed in lower picture.

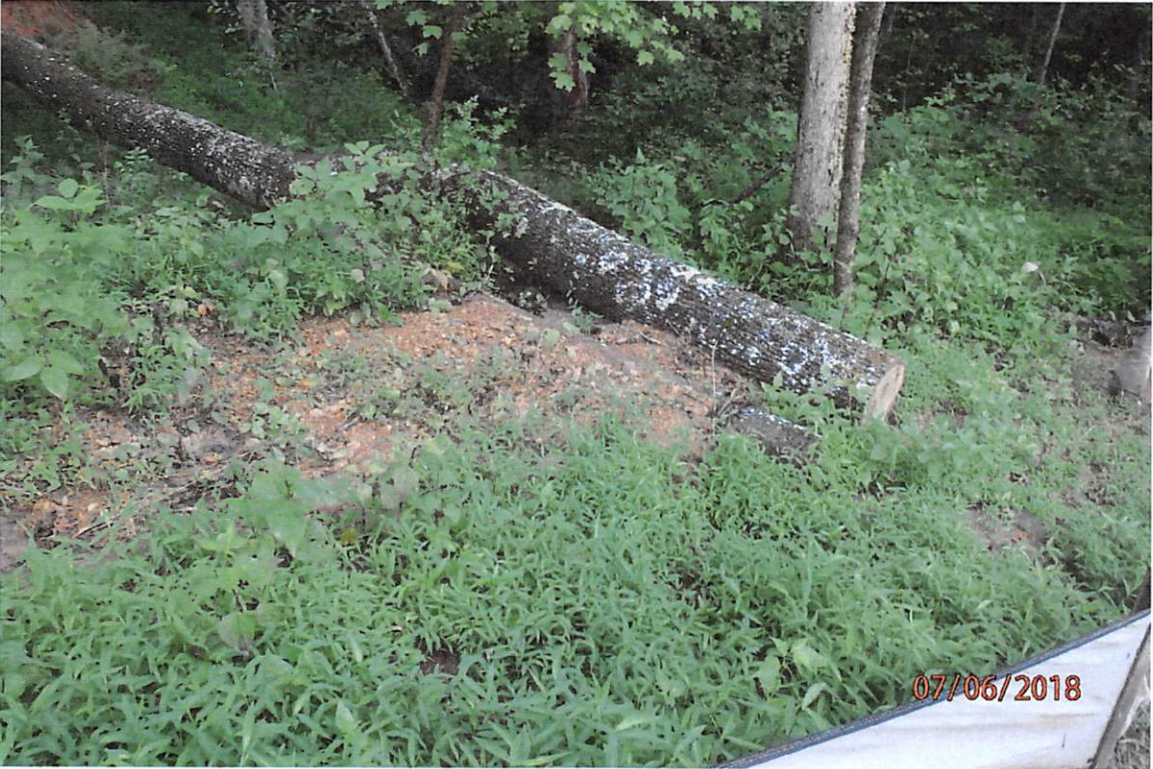
Water bar that has been installed at a steep angle with erosion and the associated offsite sediment deposits.

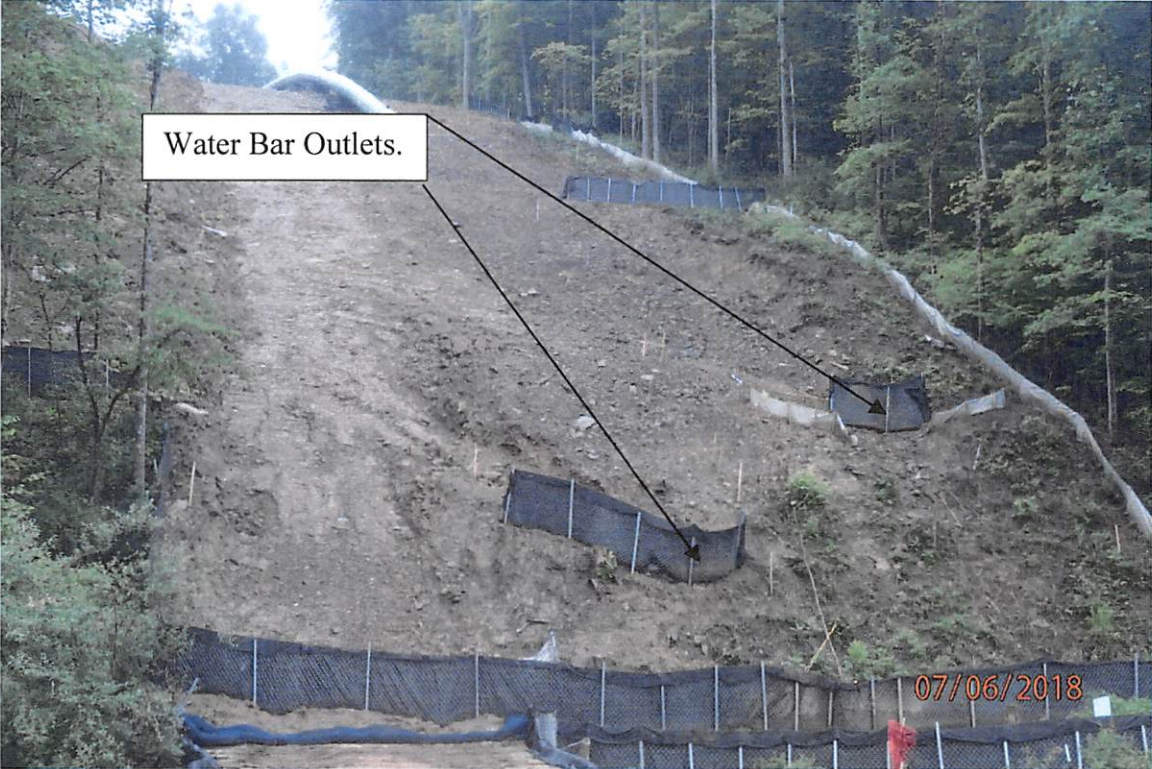
Water bars that are not installed properly and do not shed stormwater off of the LOD in small quantities as designed located adjacent to Laurel Run of Meathouse Fork crossing.

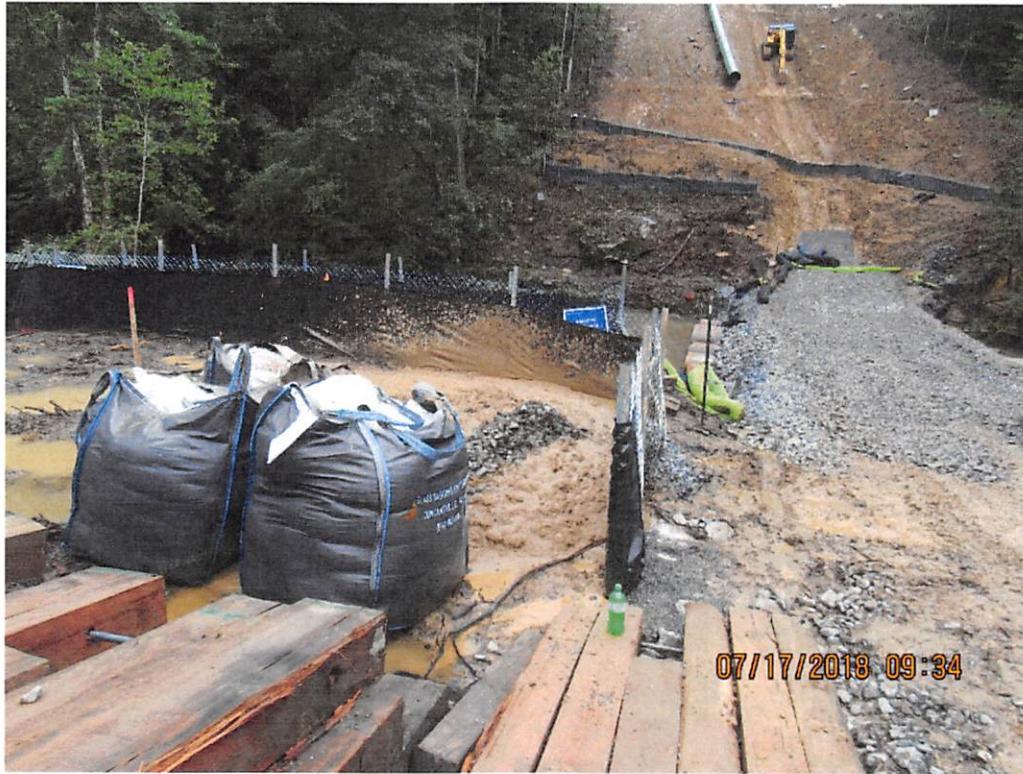
Photo 1: Sump at access road 129 needs maintenance.

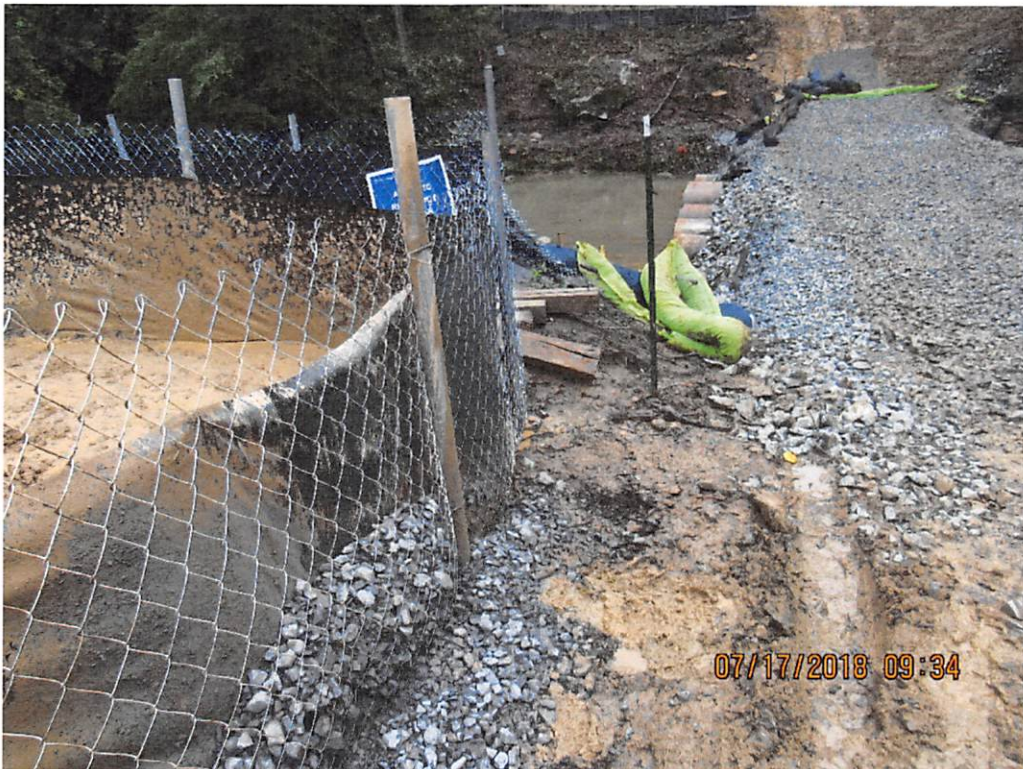
Photo 2: Proximity of outlet of sump and amount of accumulated sediment creates an area of concern.

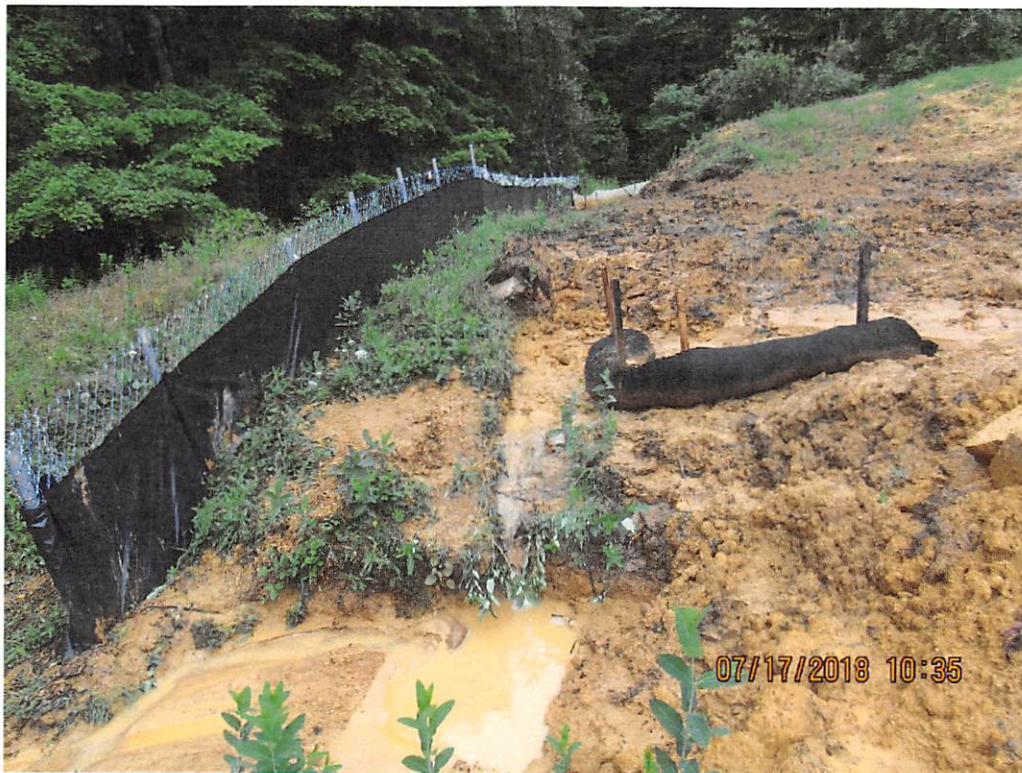
Photo 4: Station 5518+00 where water went around and undercut compost filter sock allowing sediment laden water to leave the site.

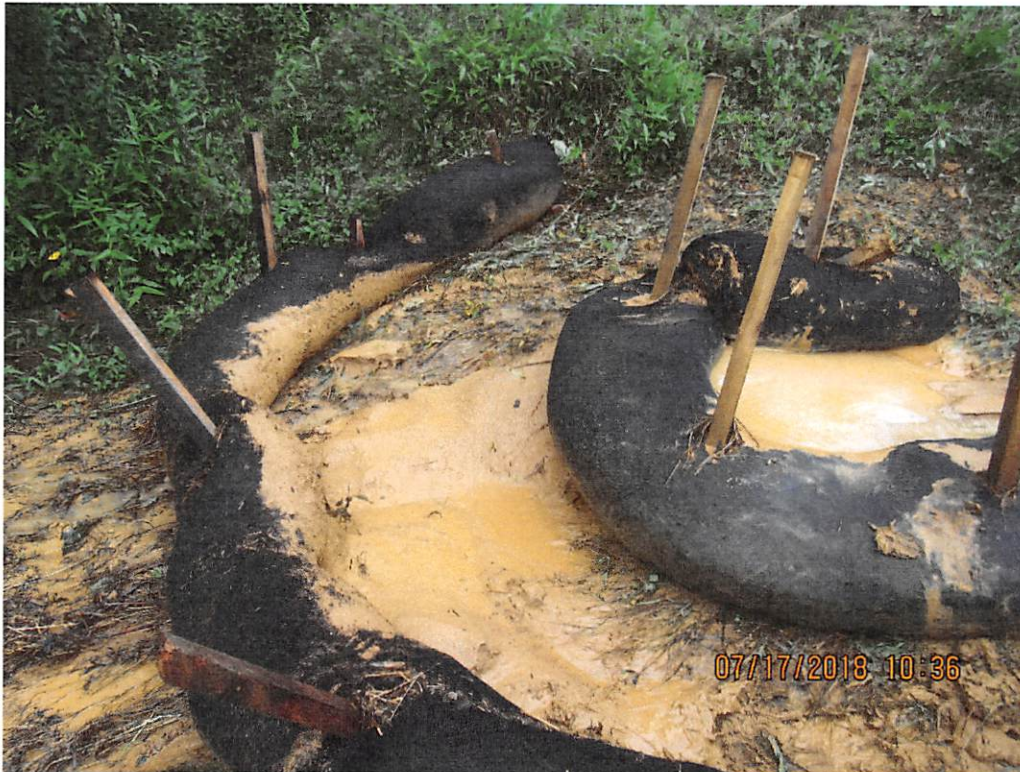
Photo 5: Next set of compost filter sock in sequence which was overtopped allowing sediment laden water to leave site.

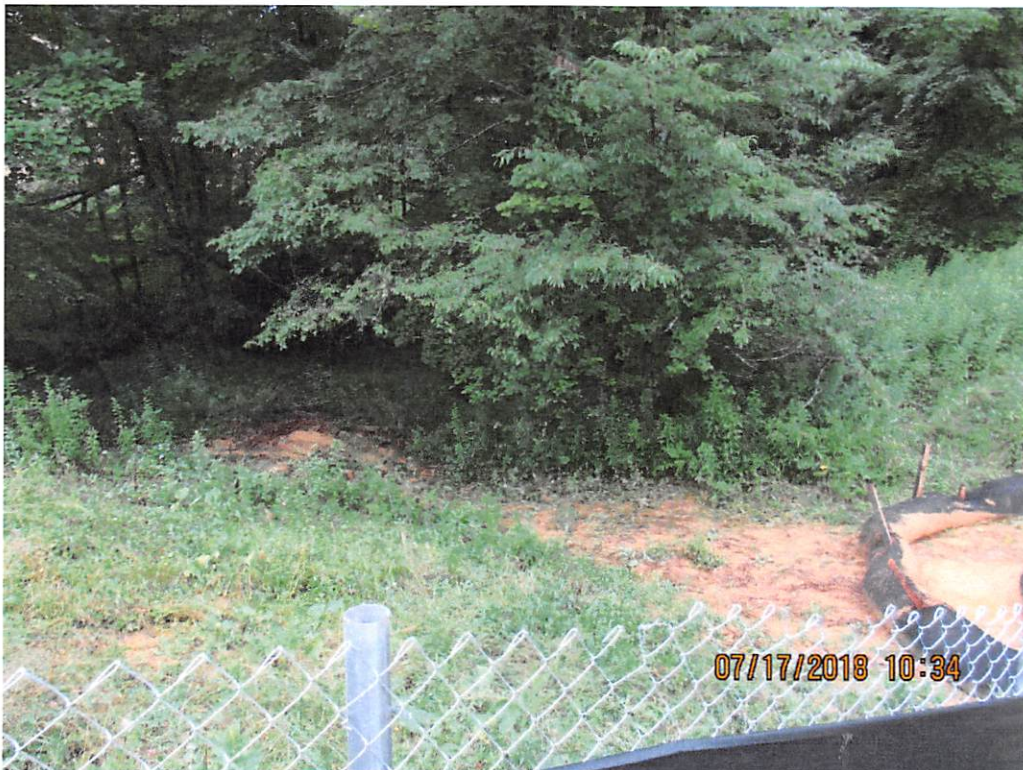
Photo 6: Last compost filter sock in sequence and path sediment laden water created leading to stream.
