**CONSENT ORDER  
ISSUED UNDER THE  
WATER POLLUTION CONTROL ACT  
WEST VIRGINIA CODE, CHAPTER 22, ARTICLE 11**

TO: Mountain Valley Pipeline, LLC

DATE: April 19, 2019

ORDER NO.: 8951

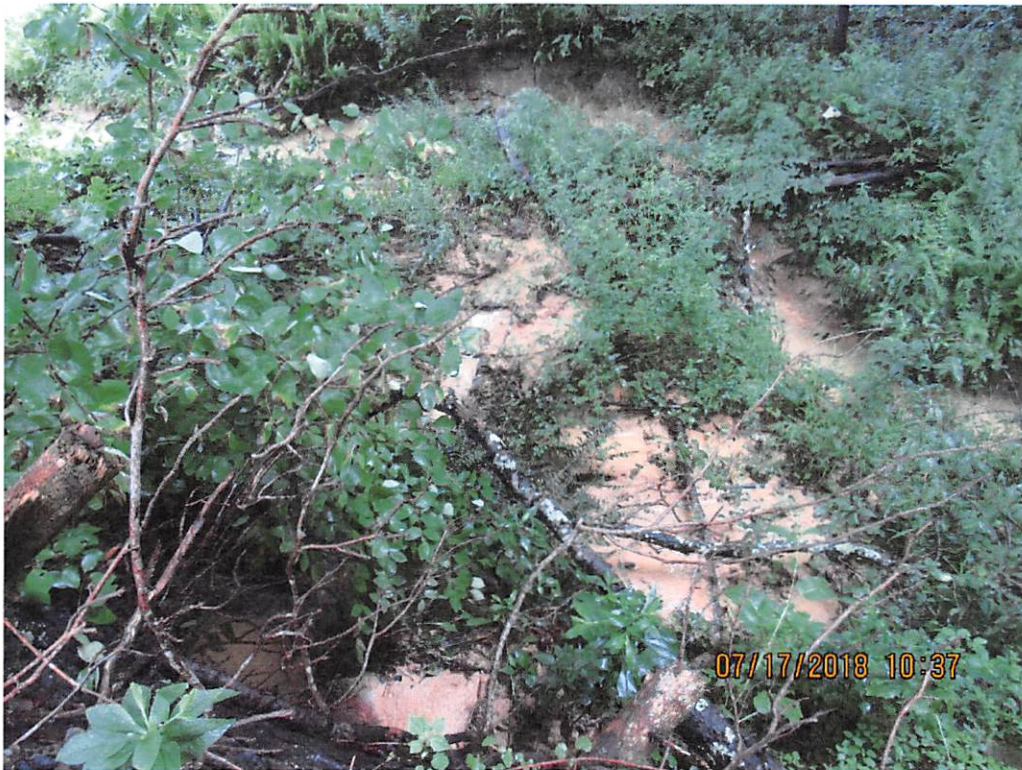
Photo 8: Sediment deposits below temporary tree dam.

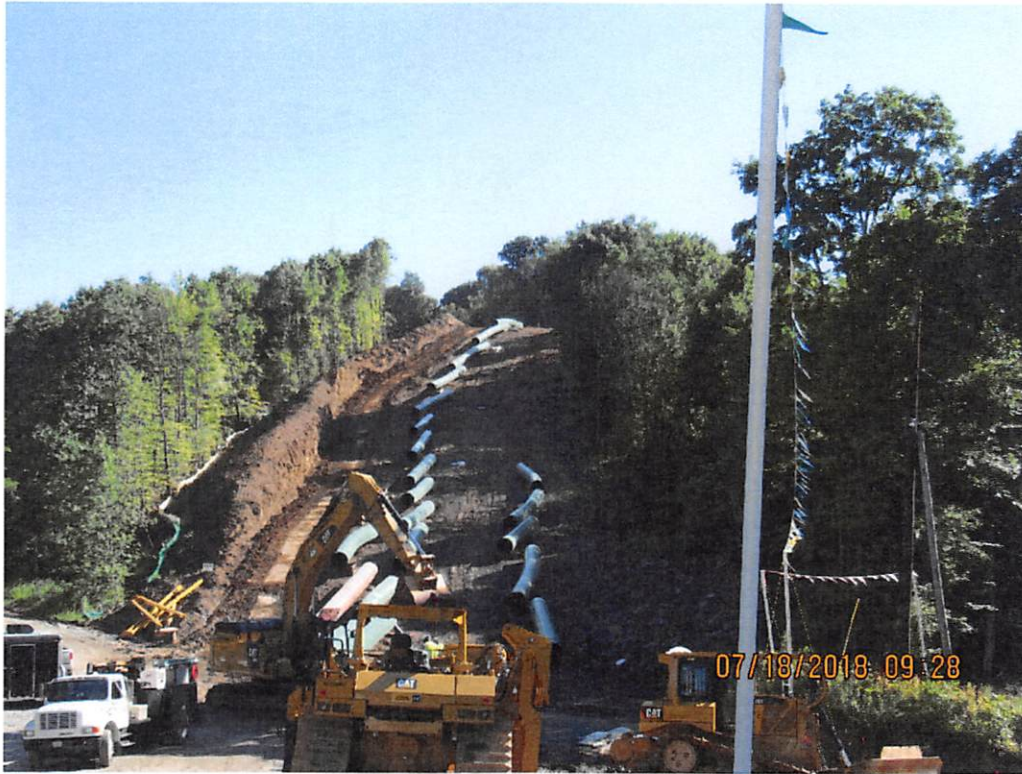
Photo 1: Station 6857+28 at access road 164 without temporary stabilization on large spoil pile. Photo is representative of project.

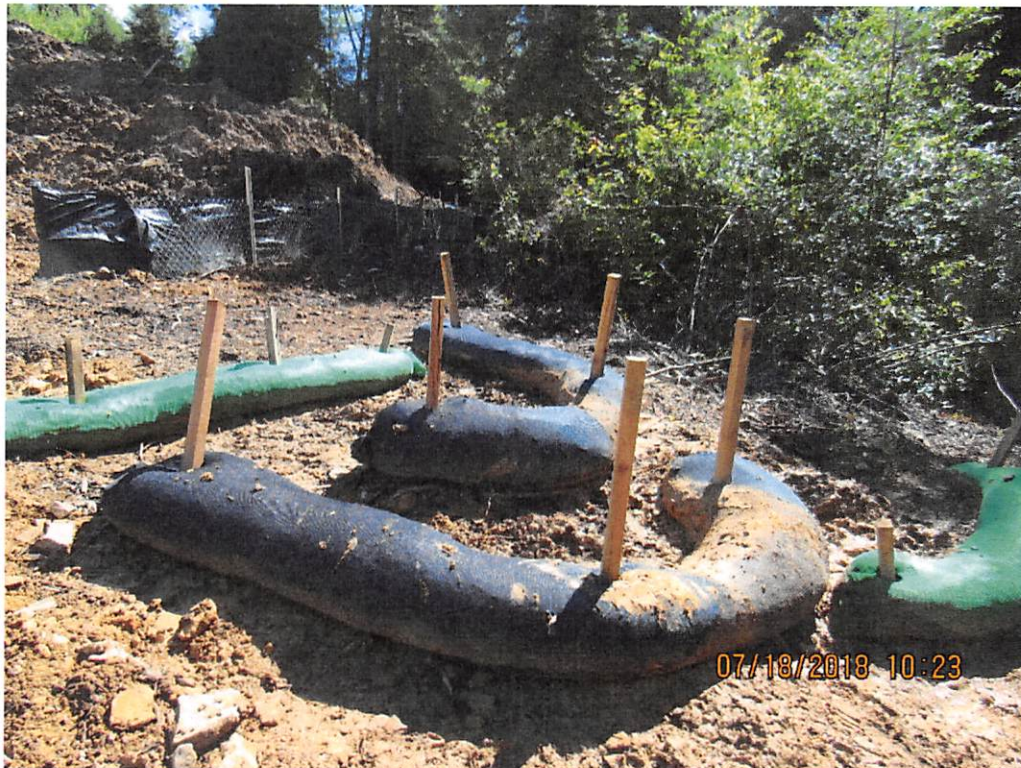
Photo 2: Controls at end of water bar were over topped at station 6898+59.

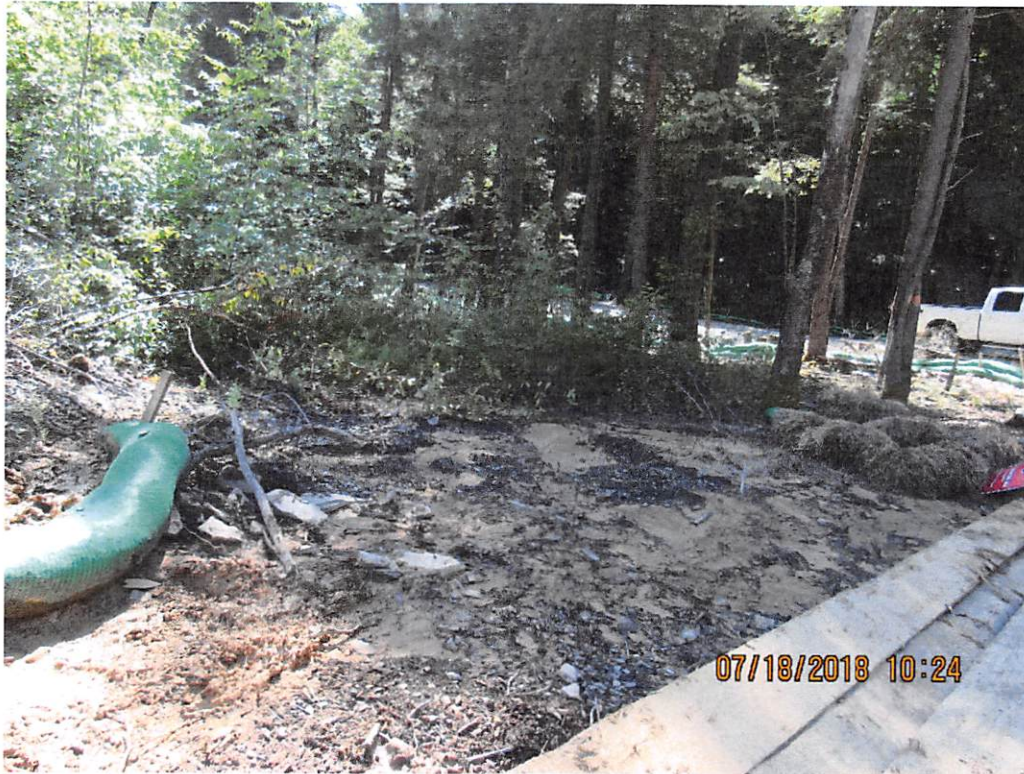
Photo 3: Down gradient of over topped water bar control at station 6898+59.

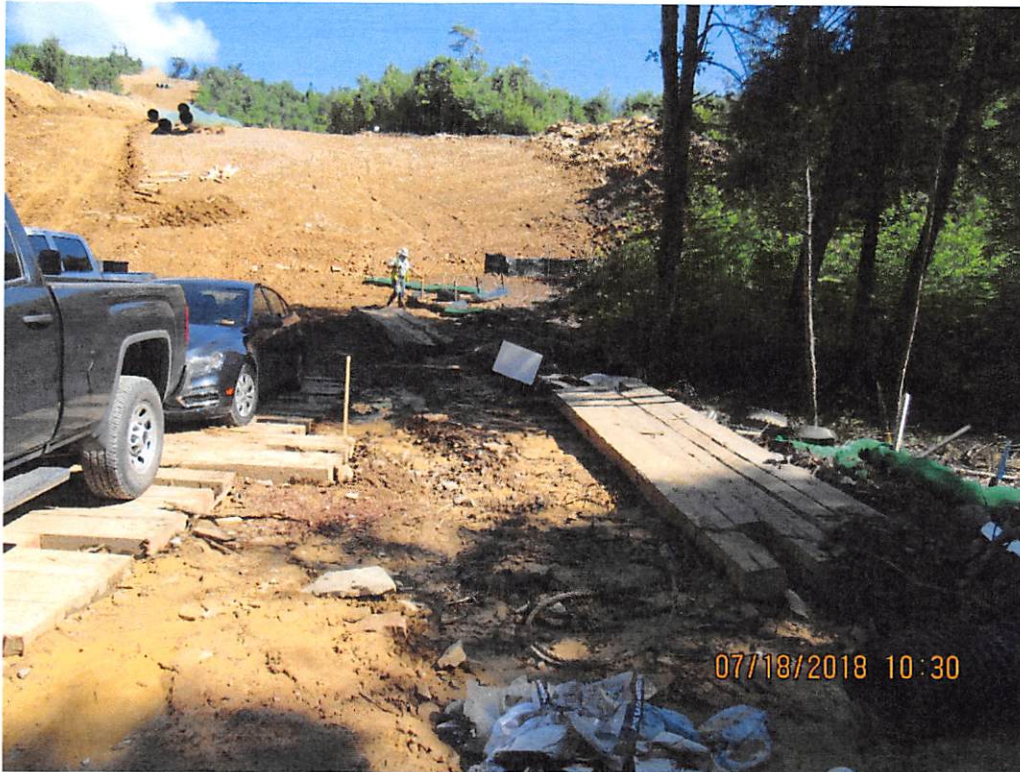
Photo 5: Upslope view of station 6898+59.

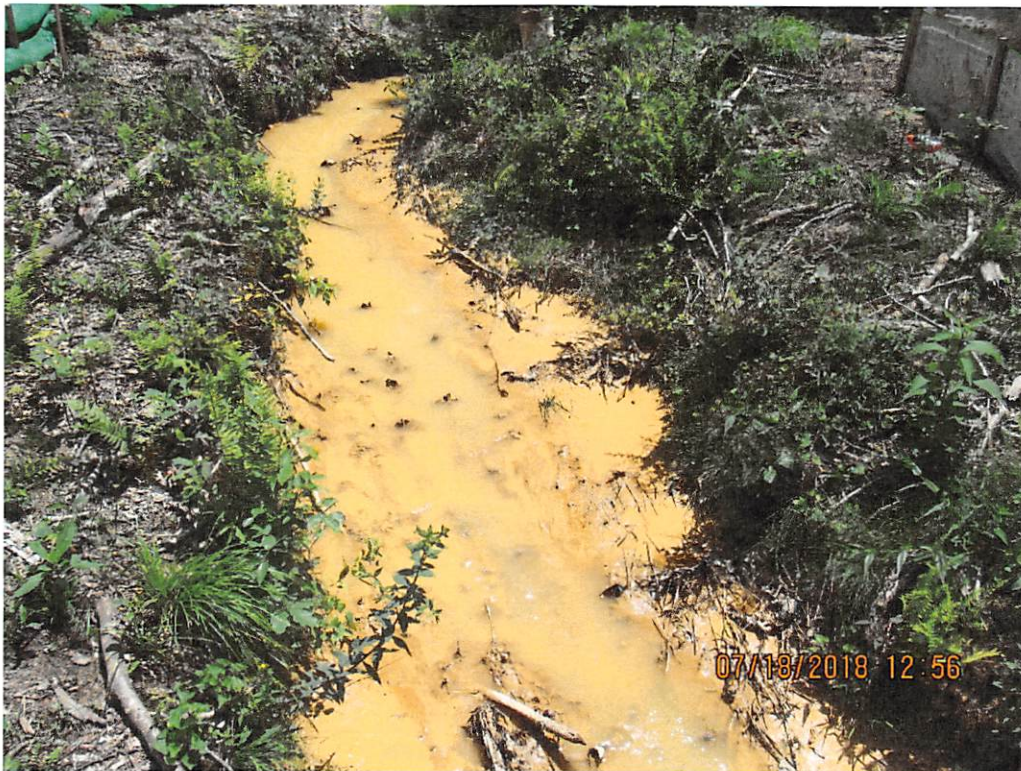
Photo 6: Sediment deposits in UNT of Harmony Creek at bridge near station 6781+87

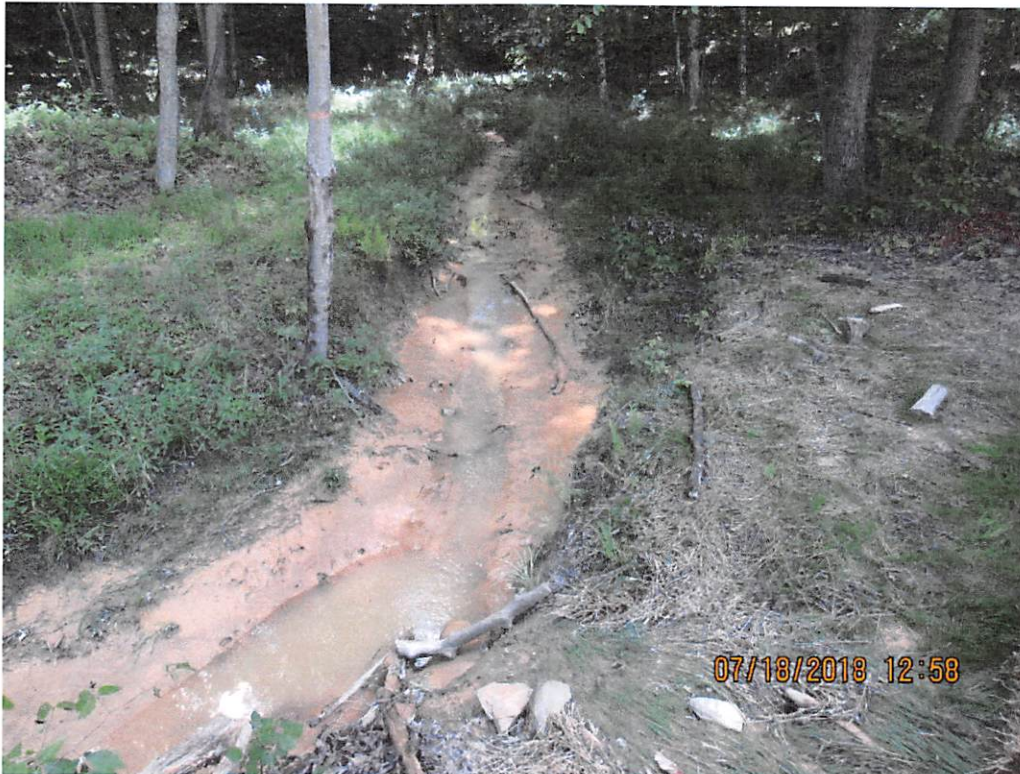
Photo 7: Sediment deposits in UNT of Harmony Creek- upstream of Photo 6. Terminus of control failure in Photos 9 & 10 (vegetation indication under date/time stamp)

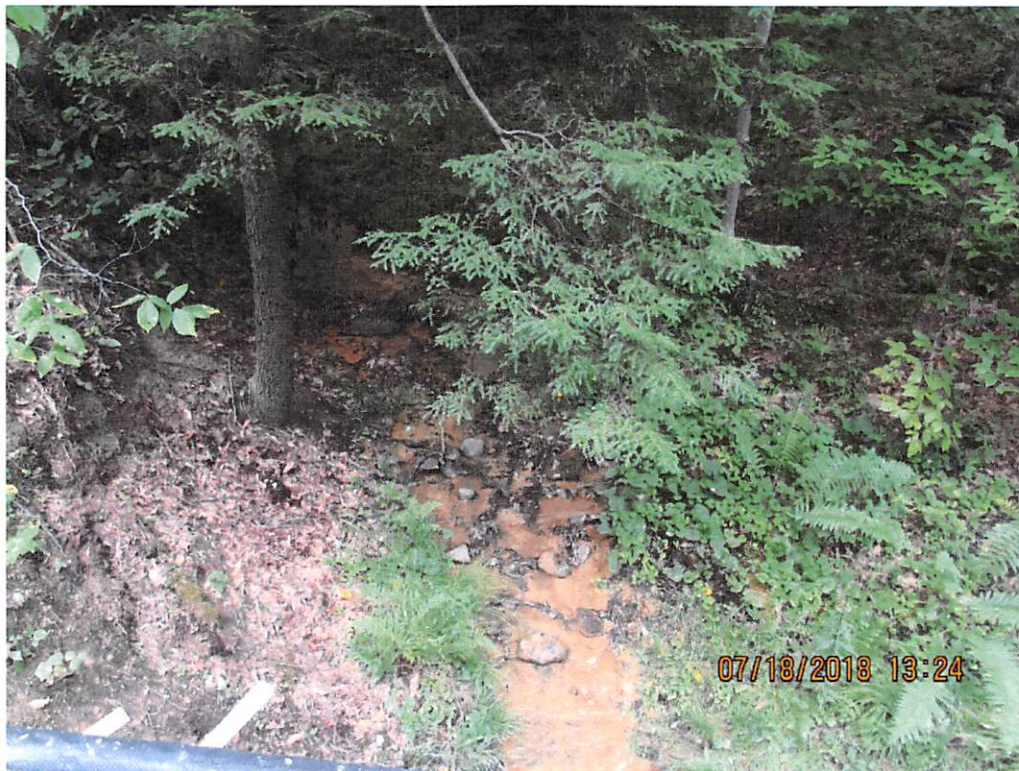
Photo 8: Sediment deposits in UNT of Harmony Creek below 1<sup>st</sup> water bar failure

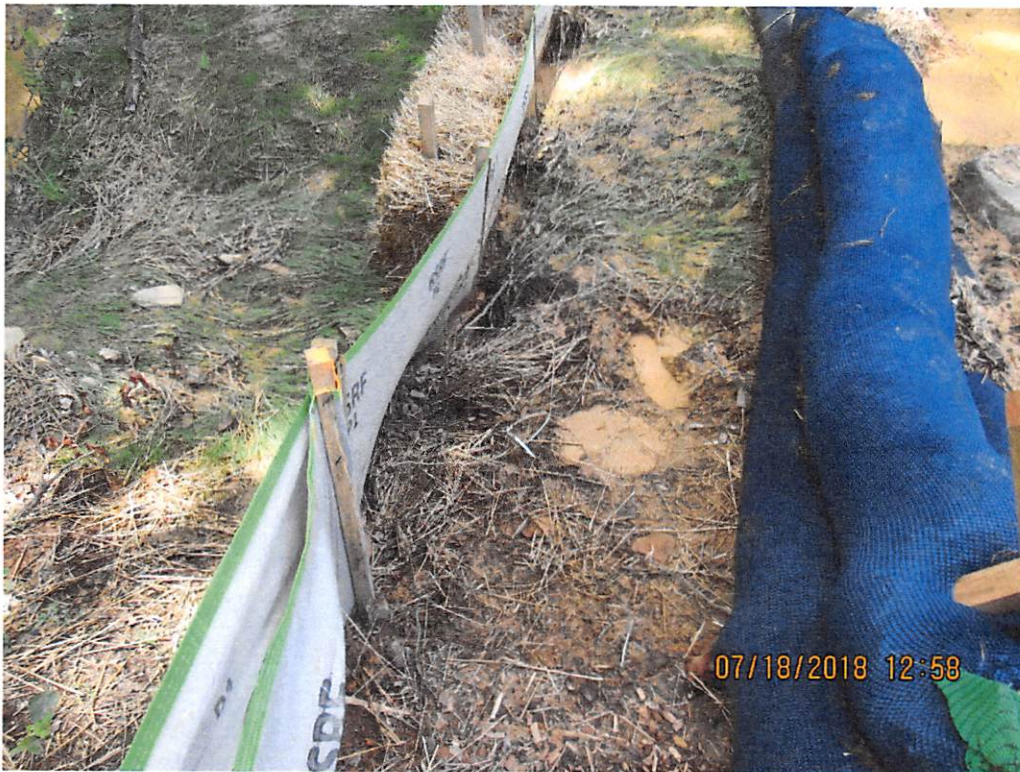
Photo 10: Last control in sequence allowing sediment laden water to leave site.

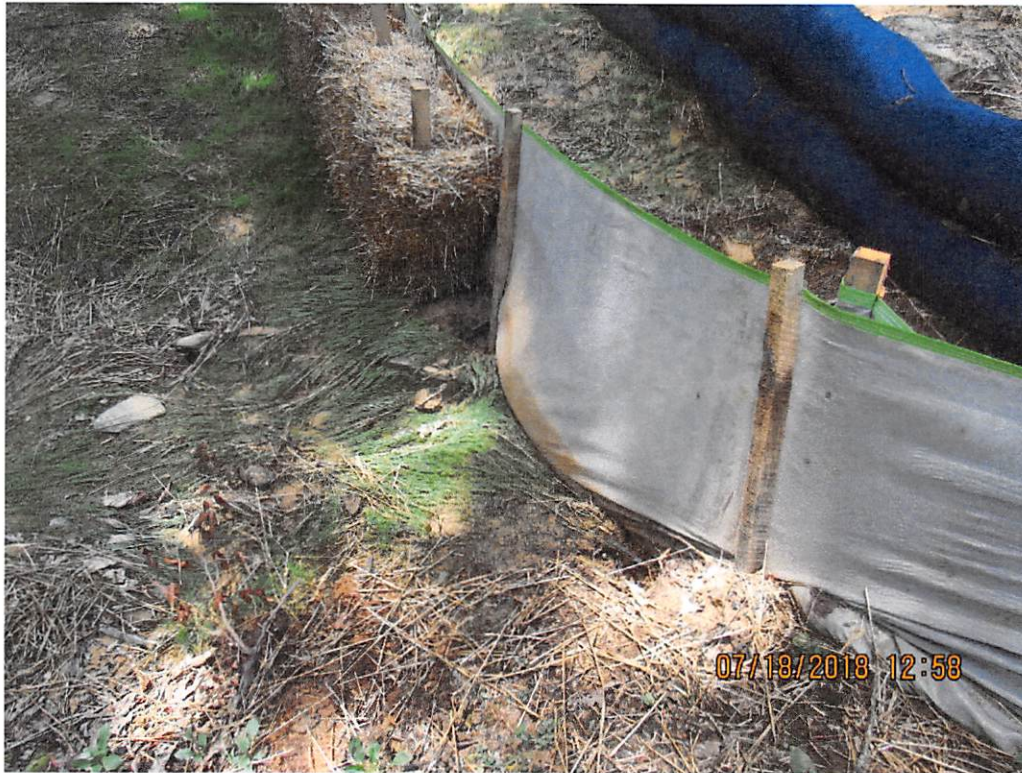
Photo 11: Down gradient of control failure from Photo 10. Photo #7 shows terminus of this control failure.

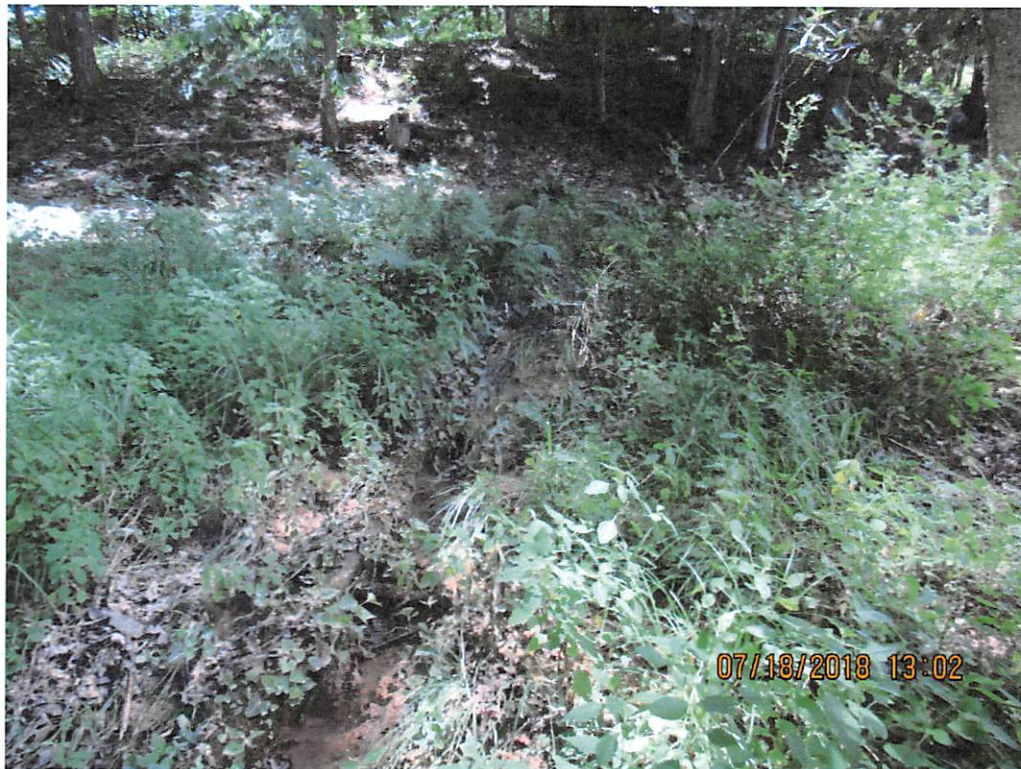
Photo 12: Terminus of sediment laden water leaving site from control failure near station 6785+50 (between MP 128.3 & 128.5)

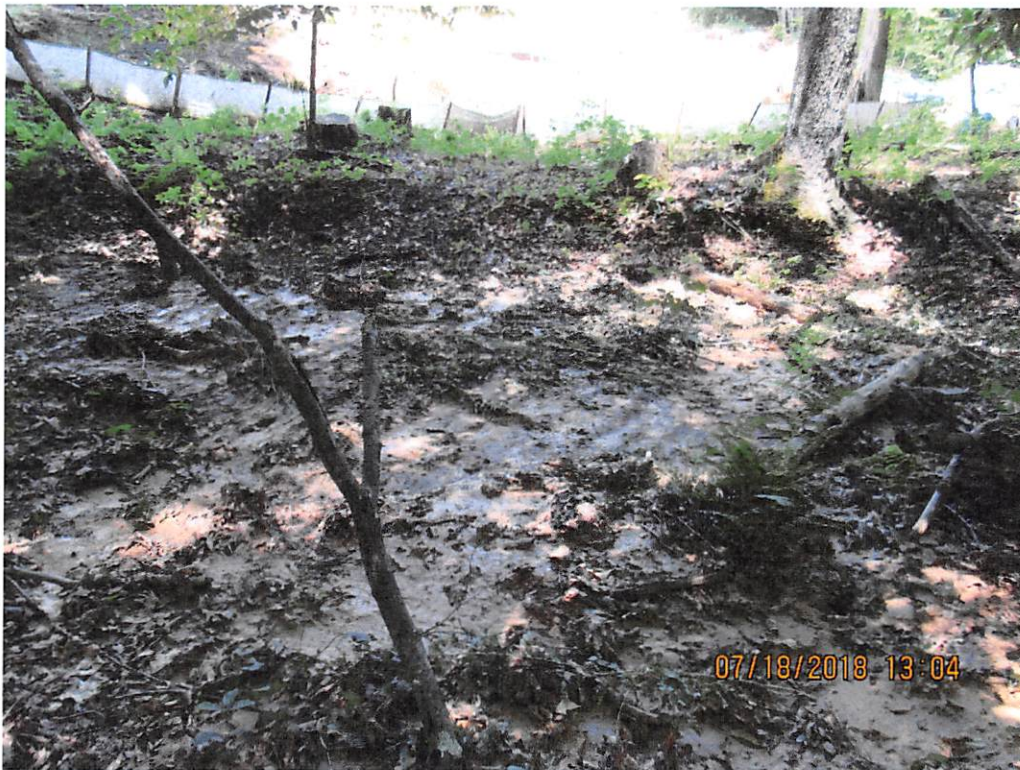
Photo 14: Sediment deposits off limits of disturbance from station 6785+50 control failure.

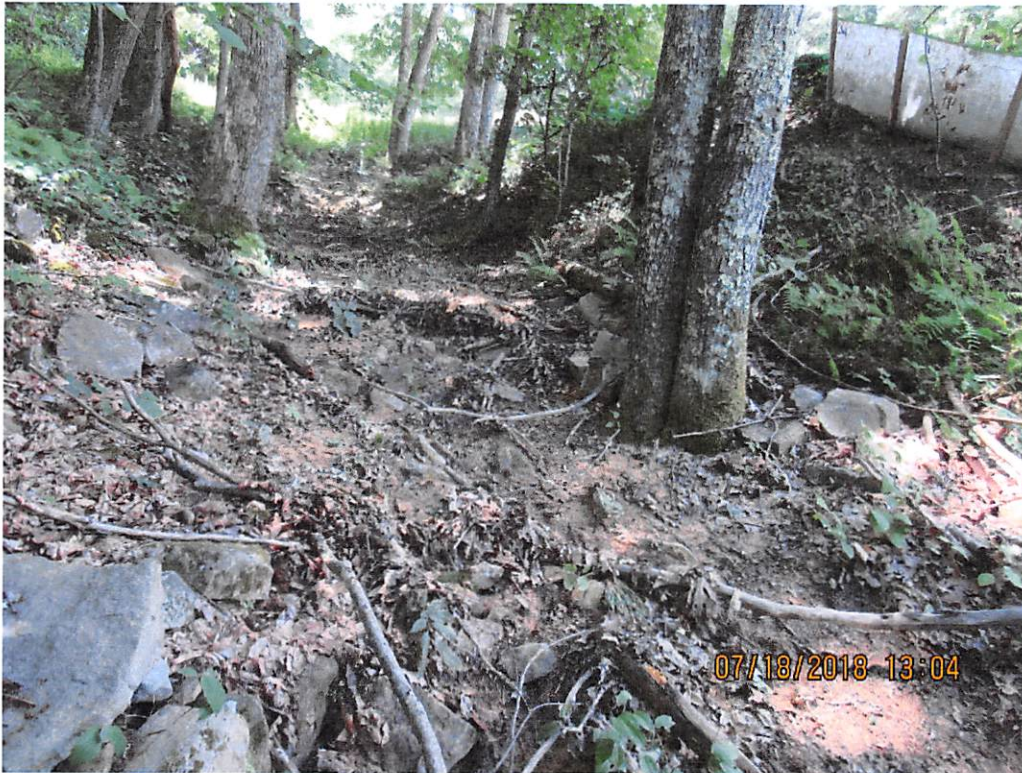
Photo 15: Scour through woods off limits of disturbance upgradient of sediment deposits in Photo 14.

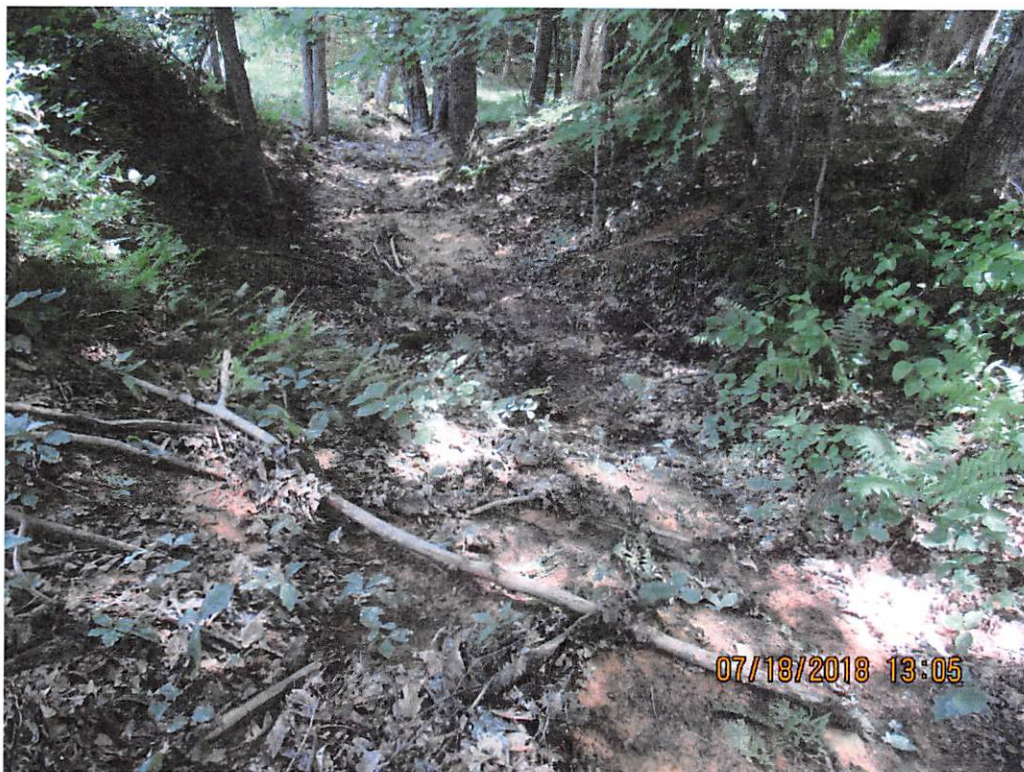
Photo 16: Down gradient view of scour from control failure at 6785+50.

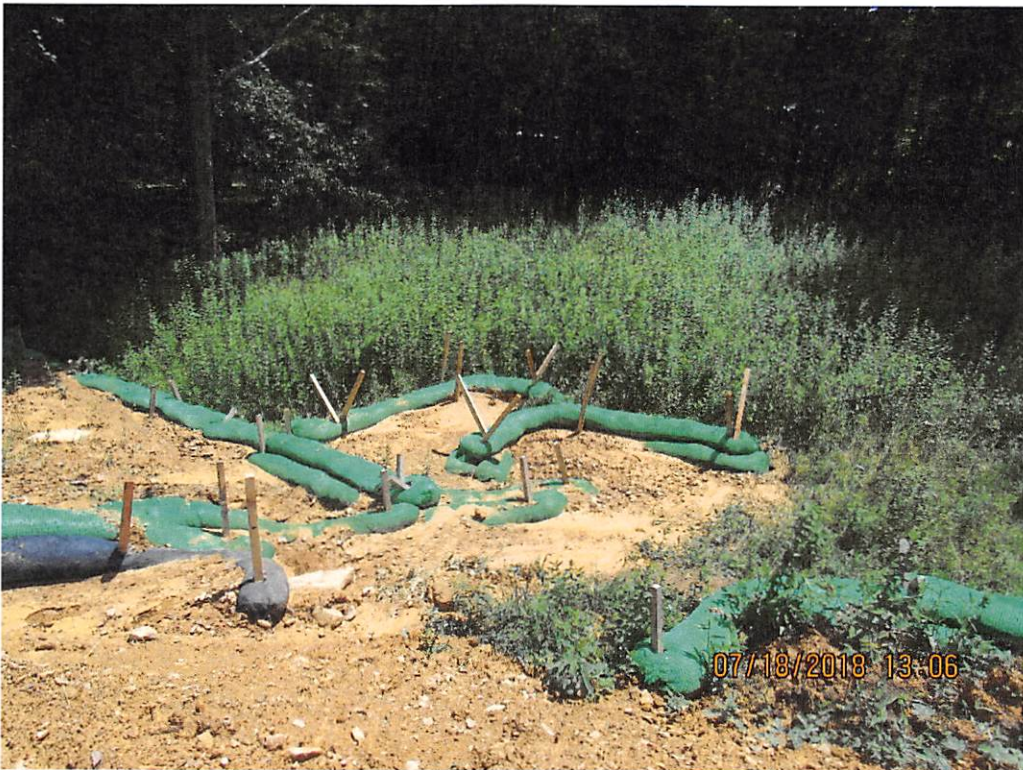
Photo 18: Installed controls at end of water bar proved inadequate and failed allowing sediment laden water to leave site.

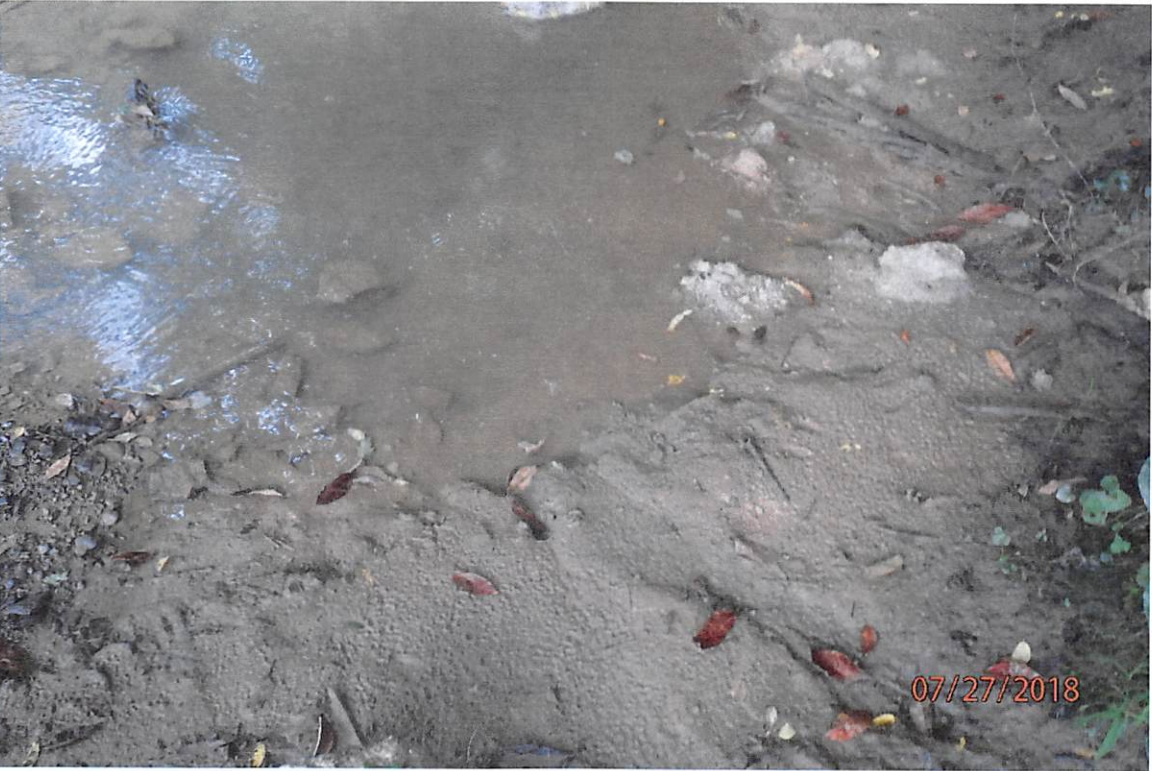
Offsite sediment deposits in Grass Run (S-A11a) that originate from site.

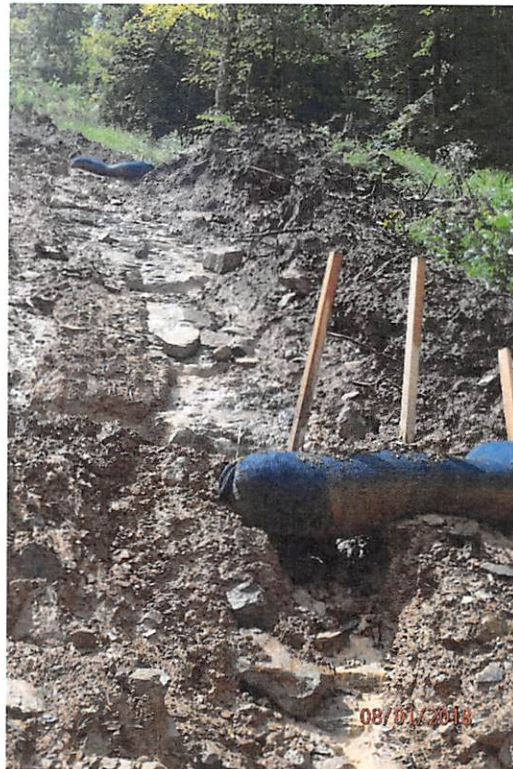
Improperly installed water bars that have caused fill slope erosion in the Big Elk Creek watershed.

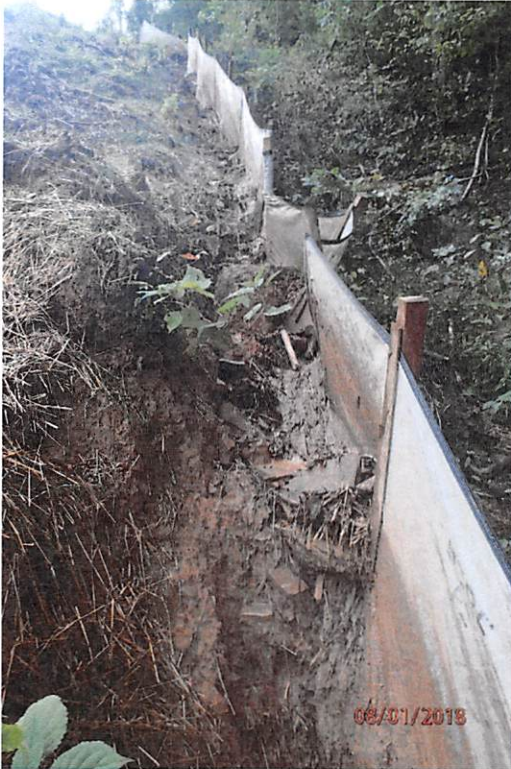
Concentrated flow being channeled along perimeter control trench due to improperly installed water bars in the Goose Run watershed.

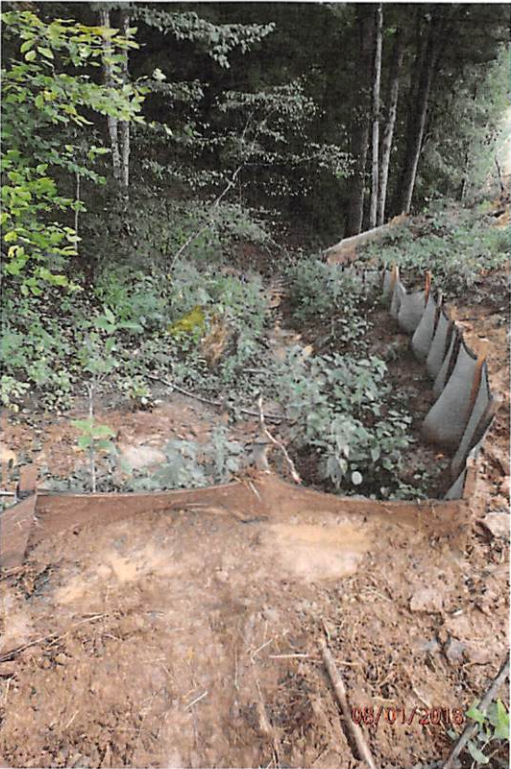
Perimeter control that has been overwhelmed due to concentrated flow from improperly installed water bars in the Goose Run watershed.

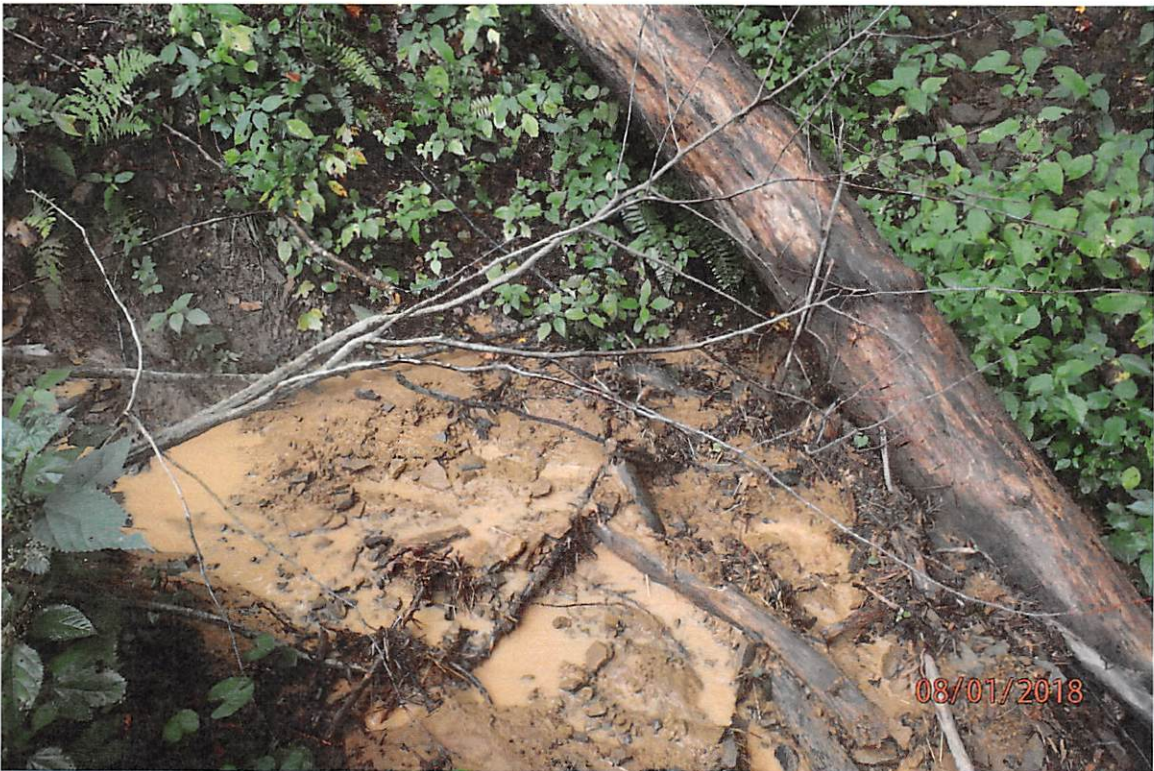
CNA offsite sediment deposits and visible plume in UNT Goose Run (39° 26.100' X 80° 28.4922')  
originating from site.

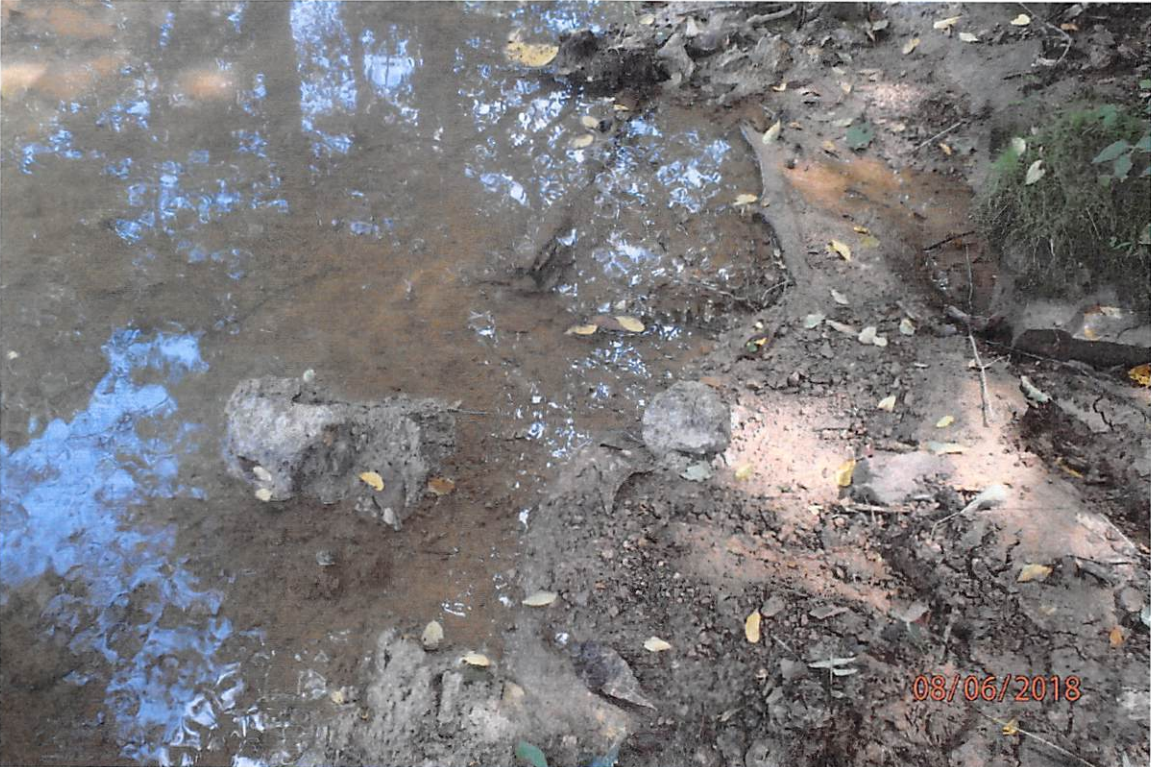
Offsite CNA deposits in Grass Run (39° 20.1127' X 80° 31.3233') that originate from site.

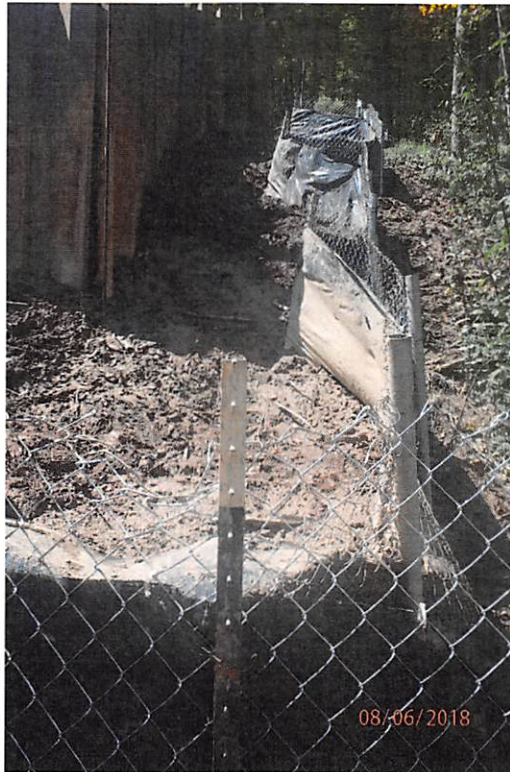
Sheet flow BMP adjacent to Rockcamp Run that is being utilized to treat concentrated flow from previously pictured unstable diversion that collects stormwater from water bars.

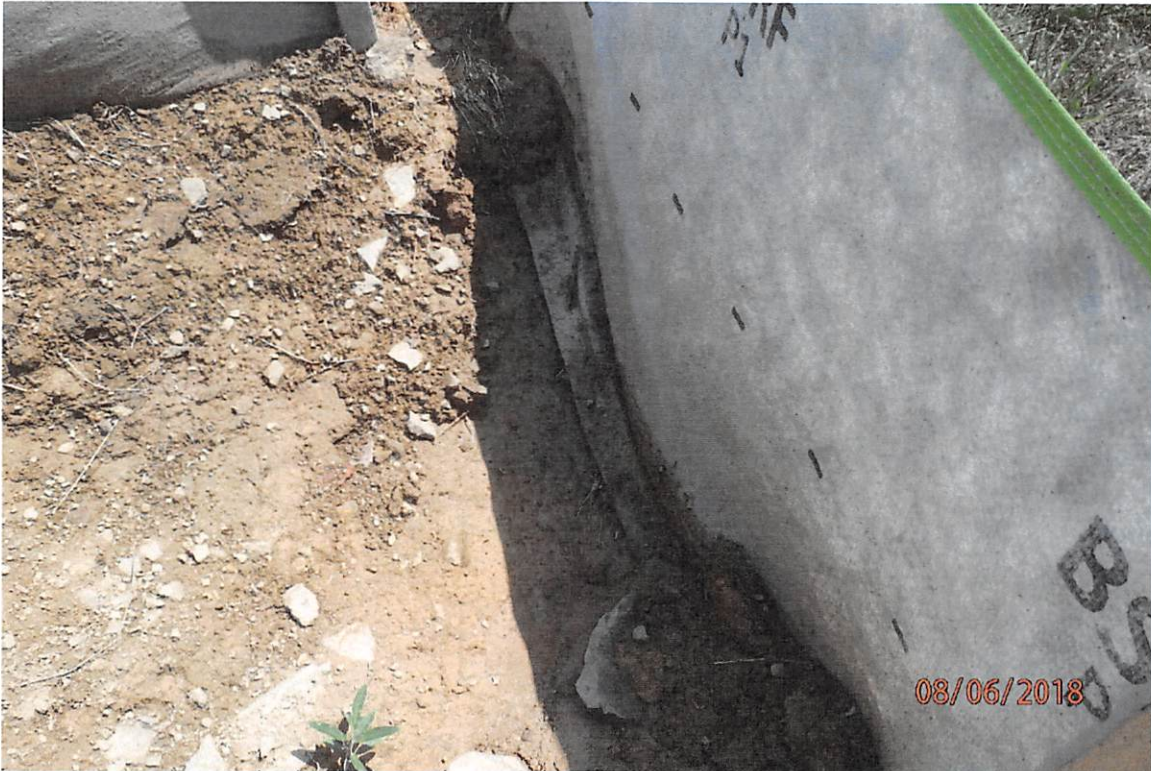
BMP in Seal Run watershed in need of maintenance that led to offsite sediment deposits.

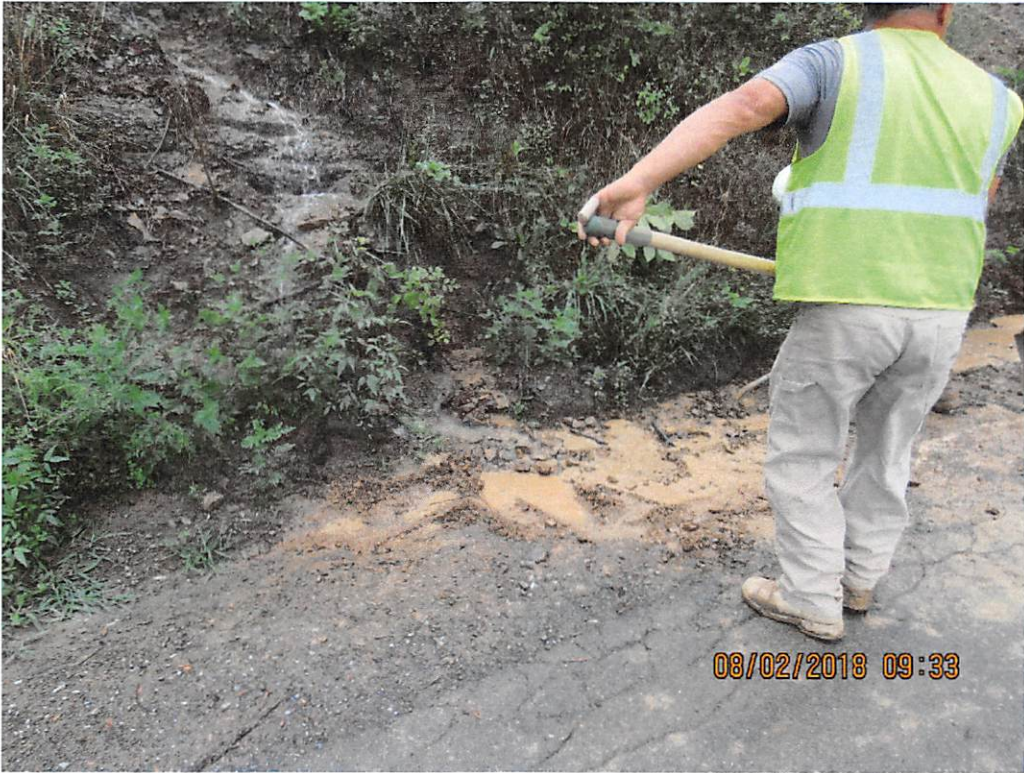
Water bar discharge mixing with sediment in road side ditch with crew performing maintenance.

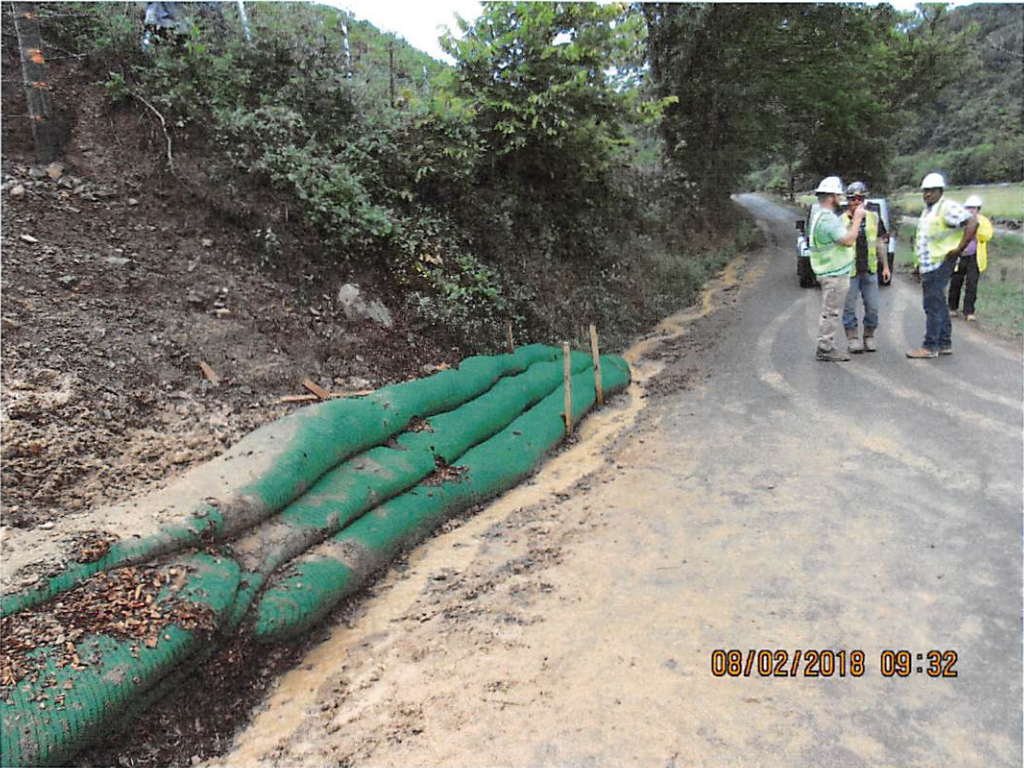
In process of stabilizing slope. Mud on road from crews performing maintenance.

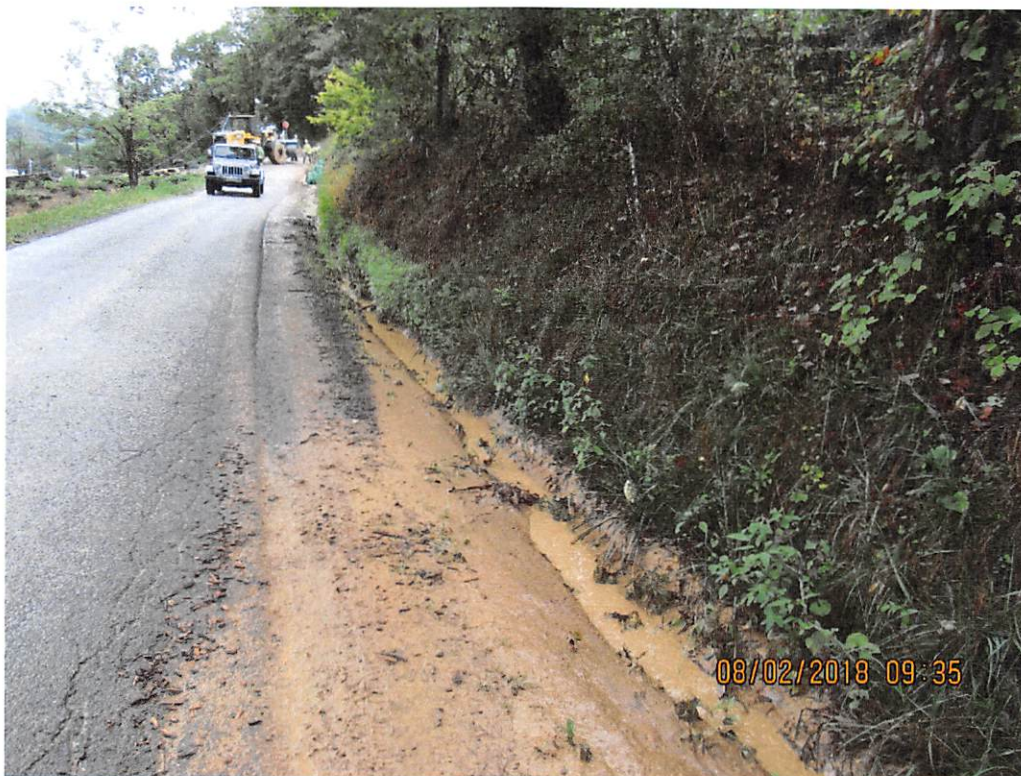
End of road side ditch prior to culvert diverting to laydown yard.

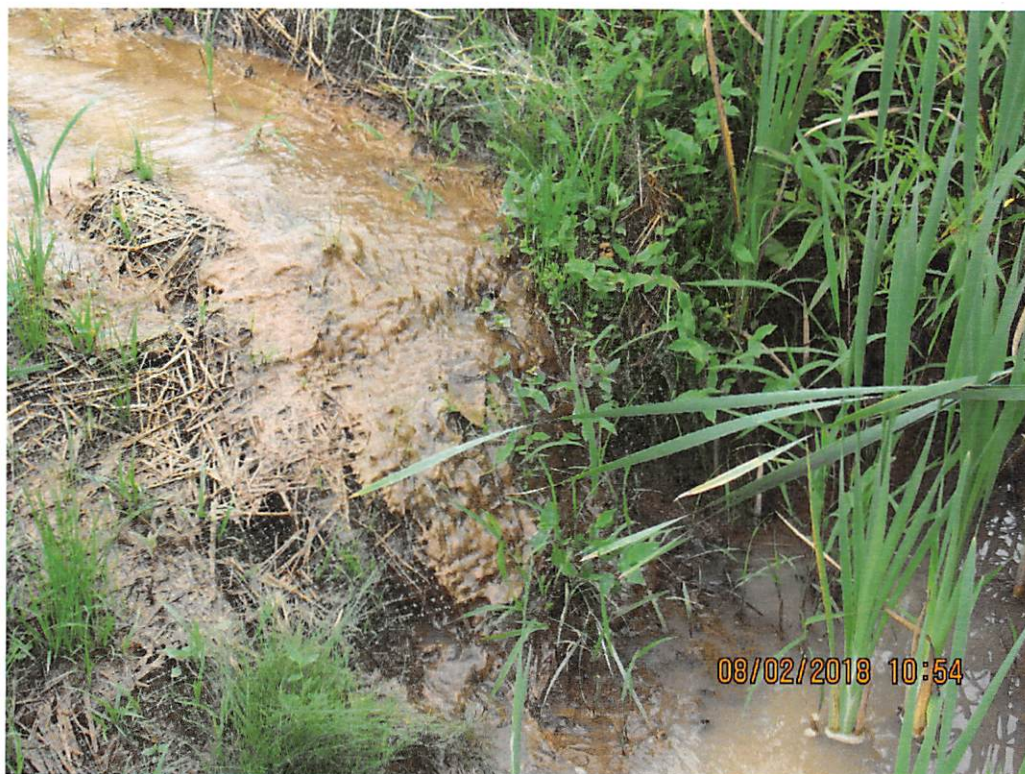
Sediment has been deposited on bank protection product, which is being picked back up prior to entering stream

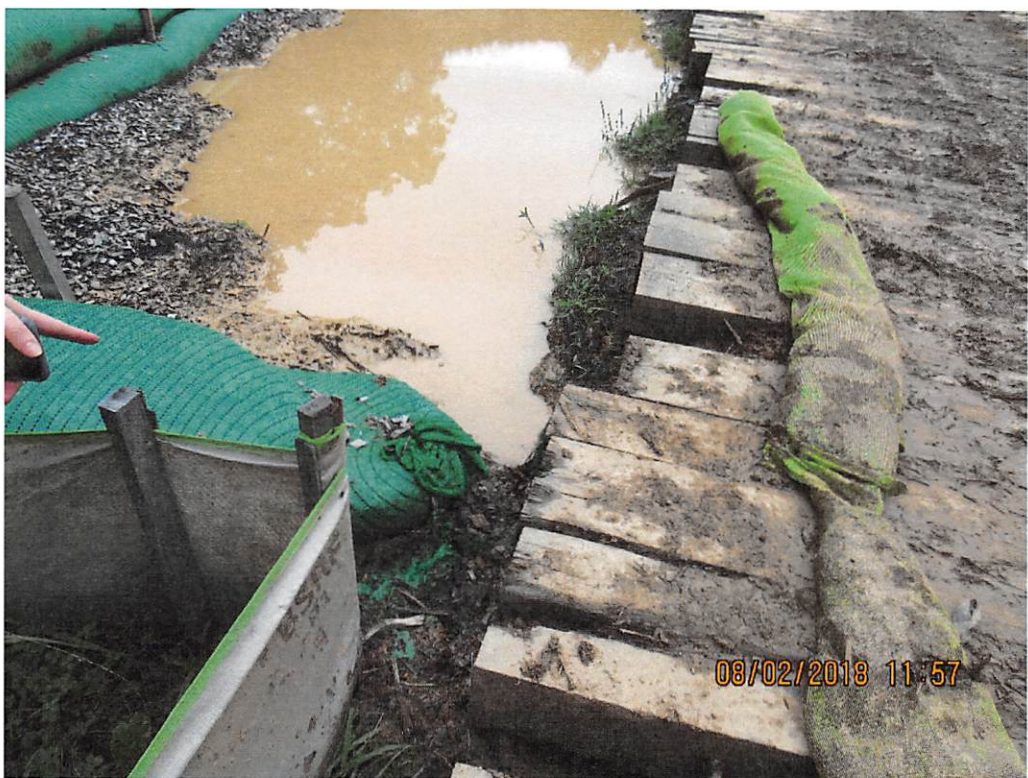
Source of sediment laden water in Slate Run.

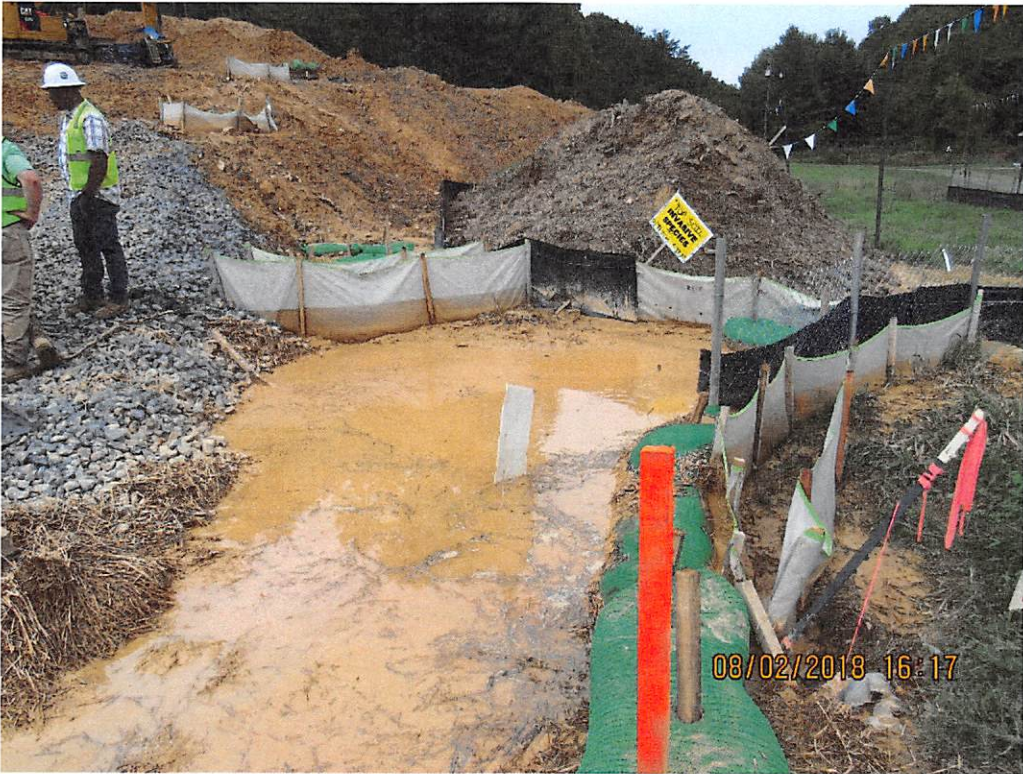
Station 10270+00, sump is full.

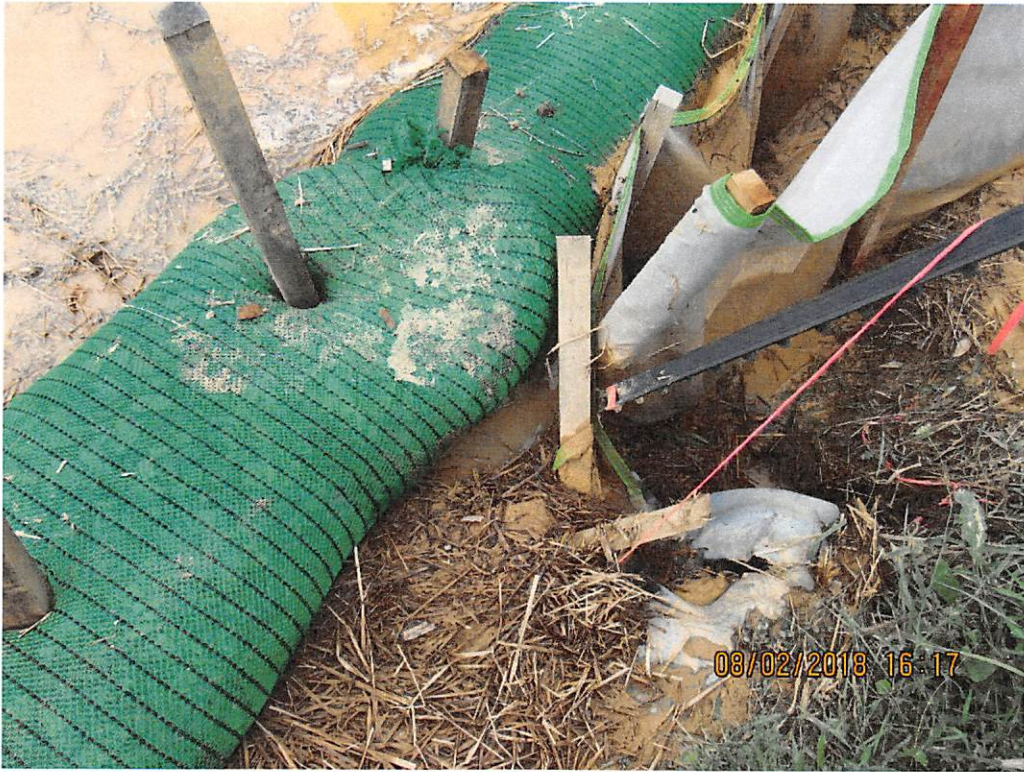
Sediment laden water entering culvert.
