**CONSENT ORDER  
ISSUED UNDER THE  
WATER POLLUTION CONTROL ACT  
WEST VIRGINIA CODE, CHAPTER 22, ARTICLE 11**

TO: Mountain Valley Pipeline, LLC

DATE: April 19, 2019

ORDER NO.: 8951

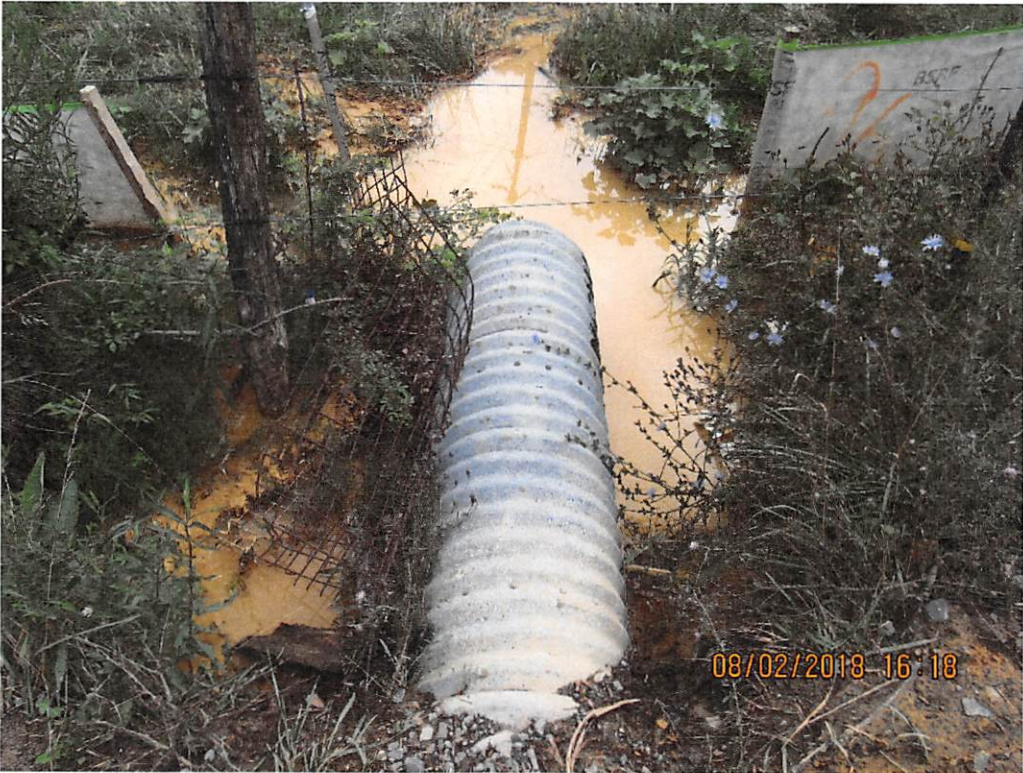
Culvert outlet into wetland area across road from full sump.

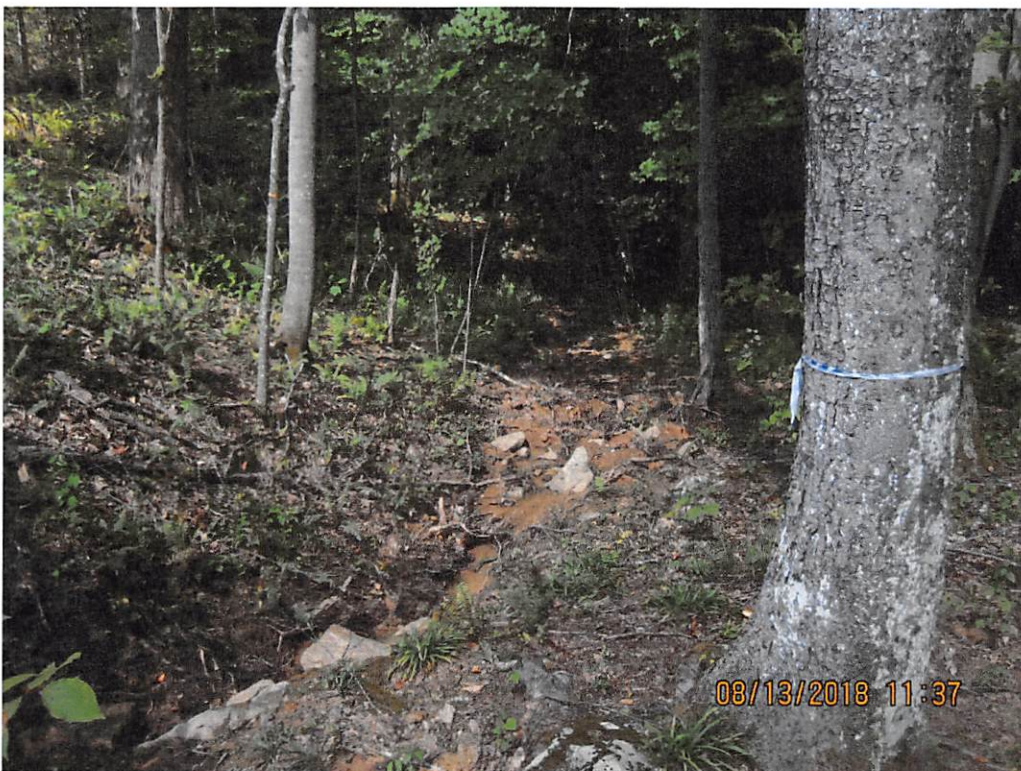
At St. 00+220 a series of perimeter controls used in a concentrated flow area had failed allowing sediment laden water to leave the site. Sediment deposits were noted in receiving stream A-104 creating Conditions Not Allowable in the Waters of the State.

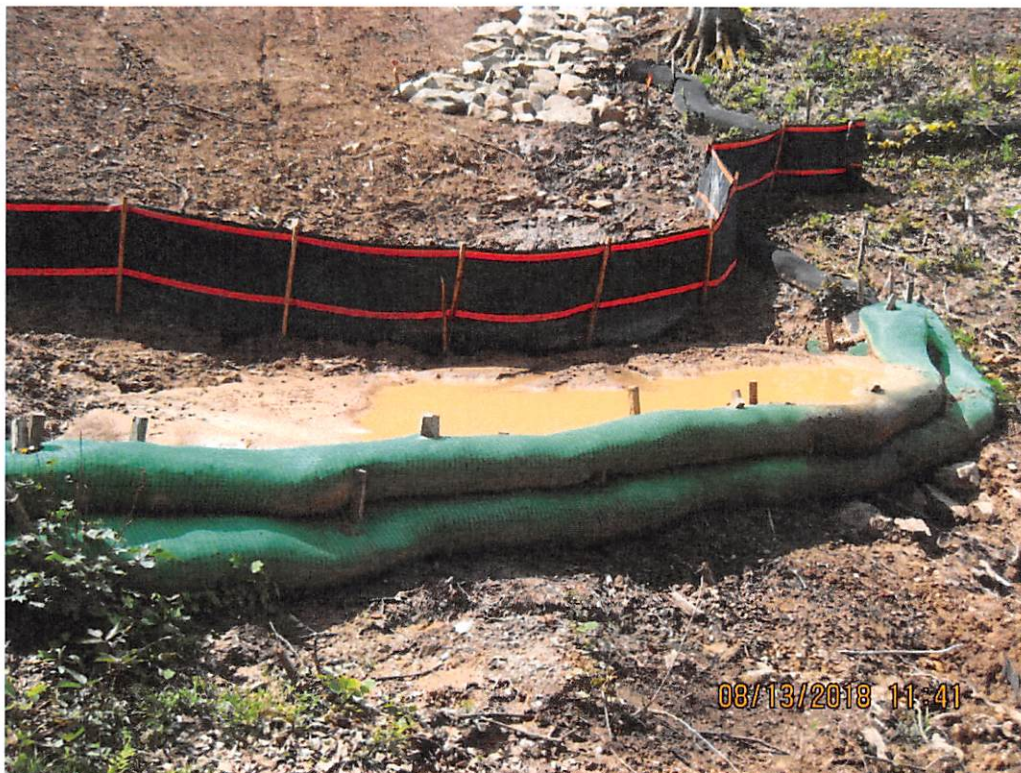
Maintenance needed north of the east wall.

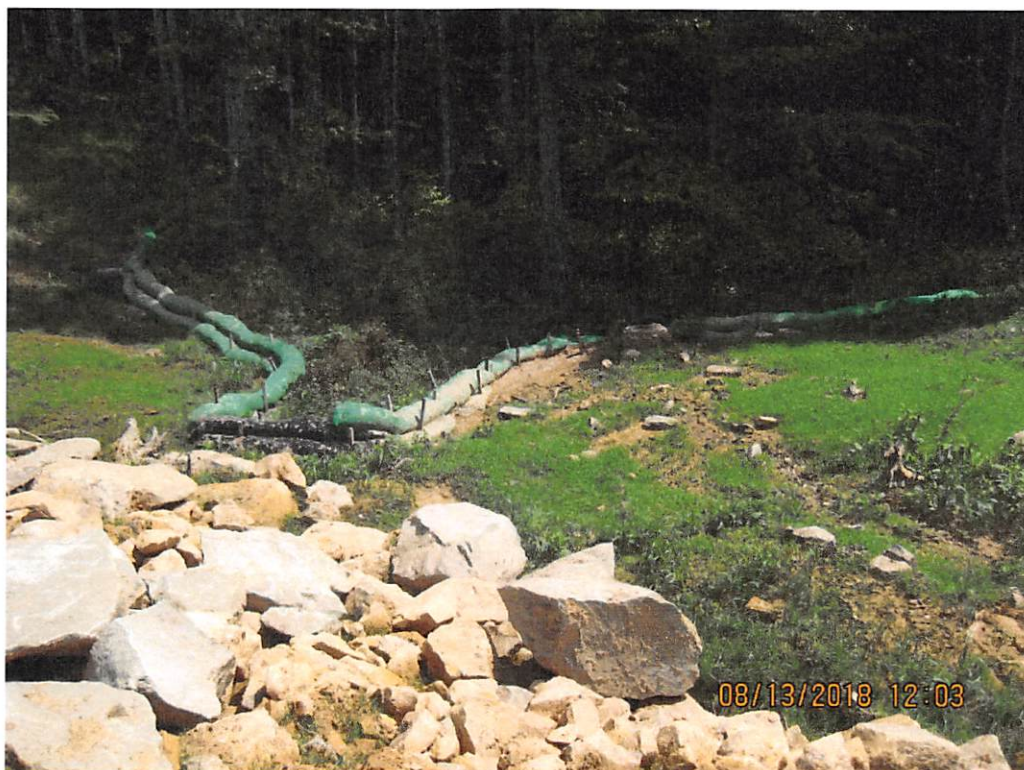
Maintenance needed for CFS below the east wall.

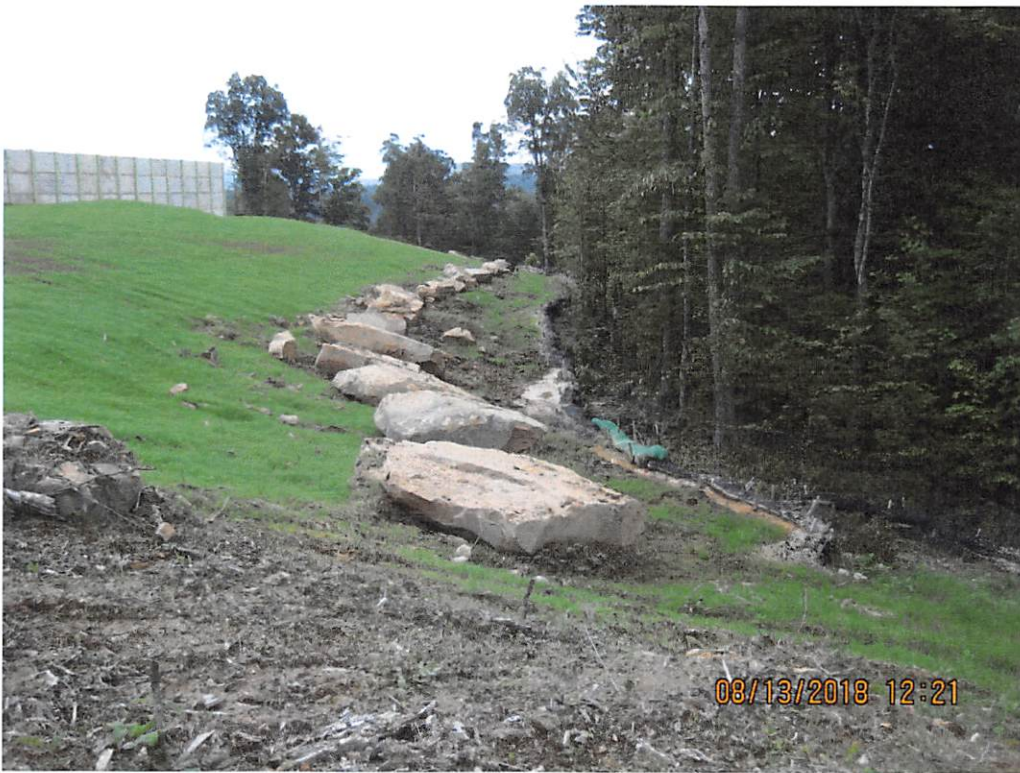
Maintenance needed for filter sock at Southwest wall.

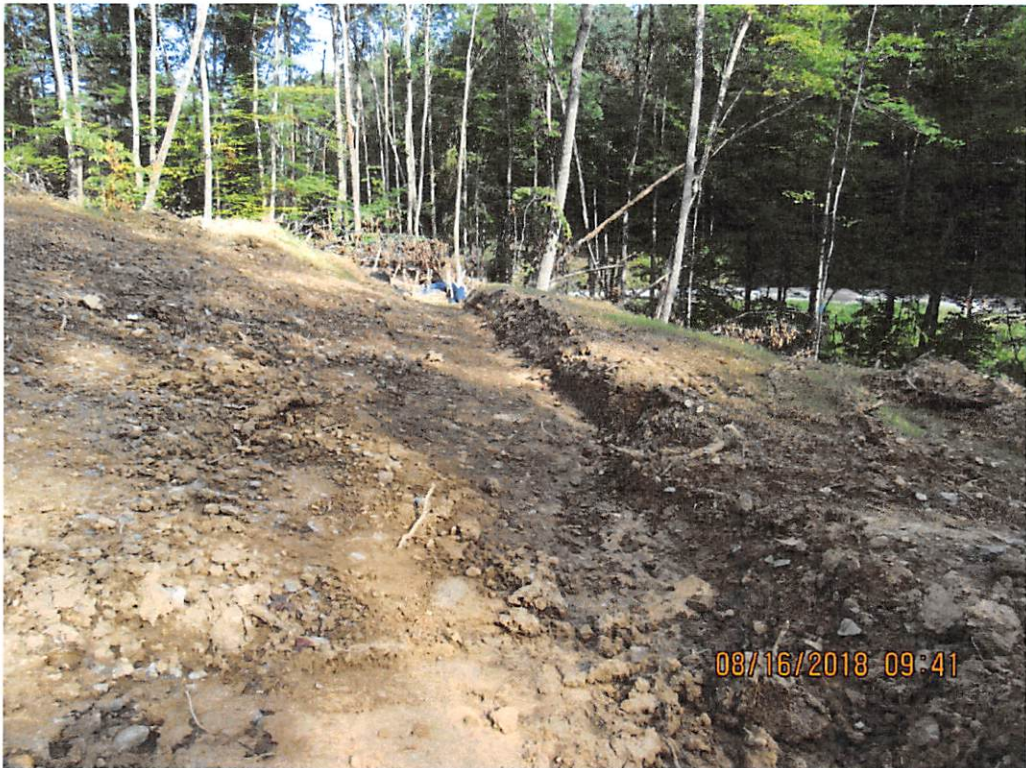
Photo 2: Western view of one of several incorrectly sloped water bars in Photo 1 off Bingham Road station 7450+00.

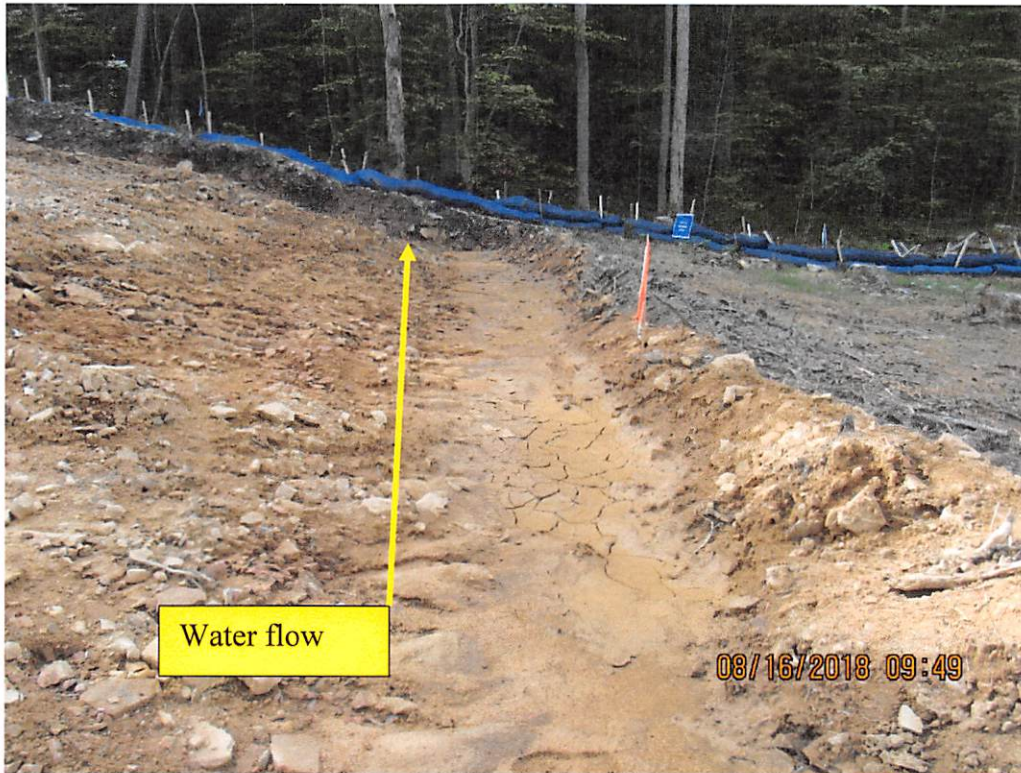
Photo 3: Incorrectly sloped water bar at Bingham Road station 7450+00- water is flowing away from outlet.

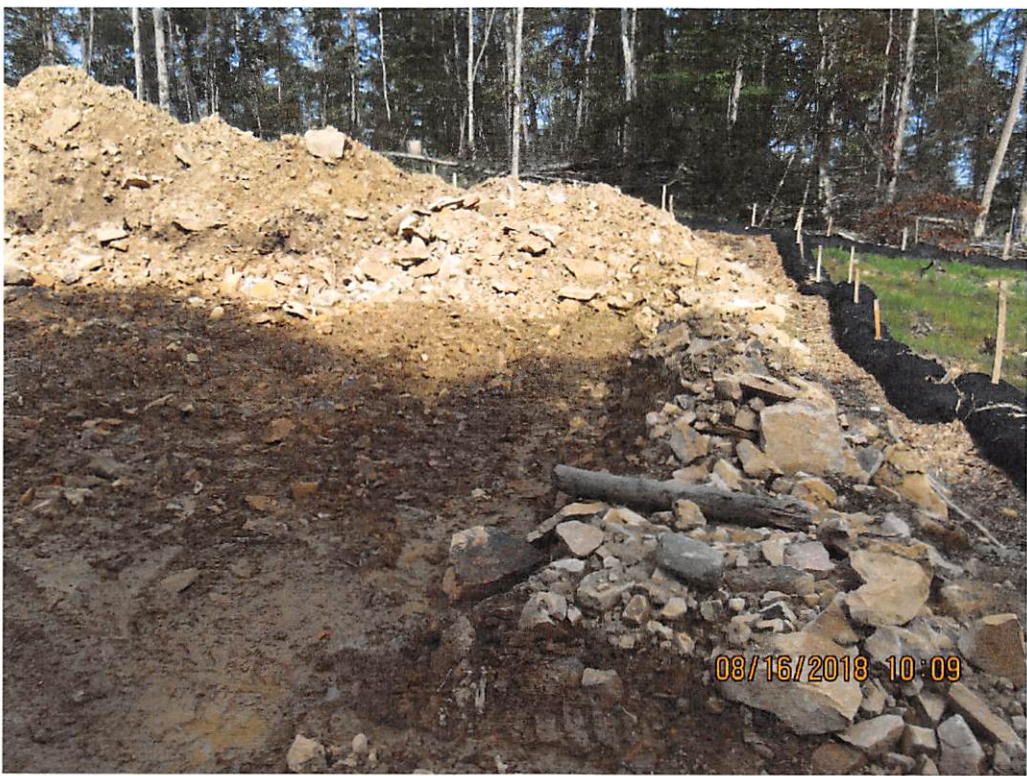
Photo 6: Western view of water bar without outlet near Bingham Road station 7450+00.

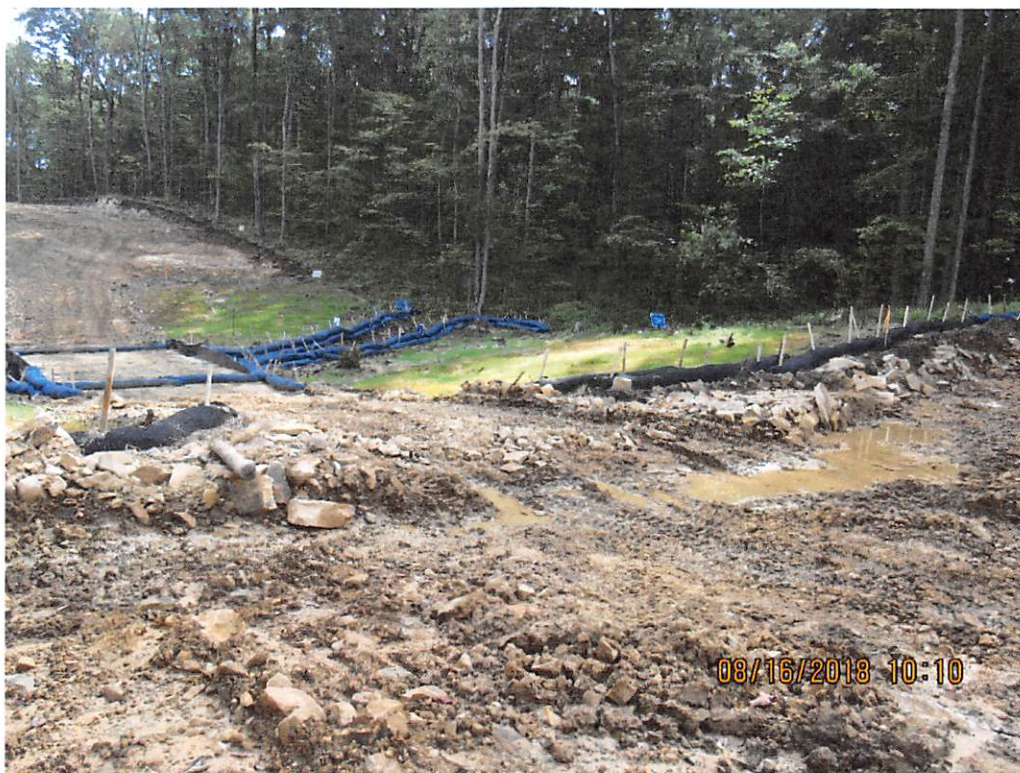
Photo 7: Middle section of water bar without outlet near Bingham Road station 7450+00.

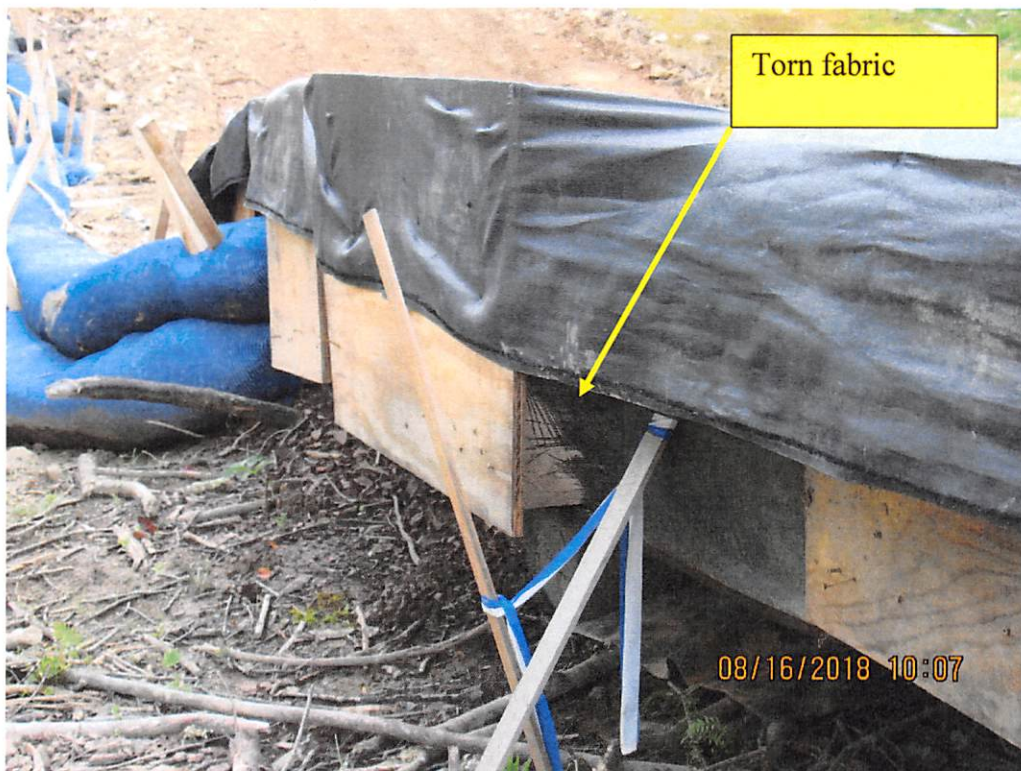
Photo 10: Exterior view of punctured fabric in Photo 9.

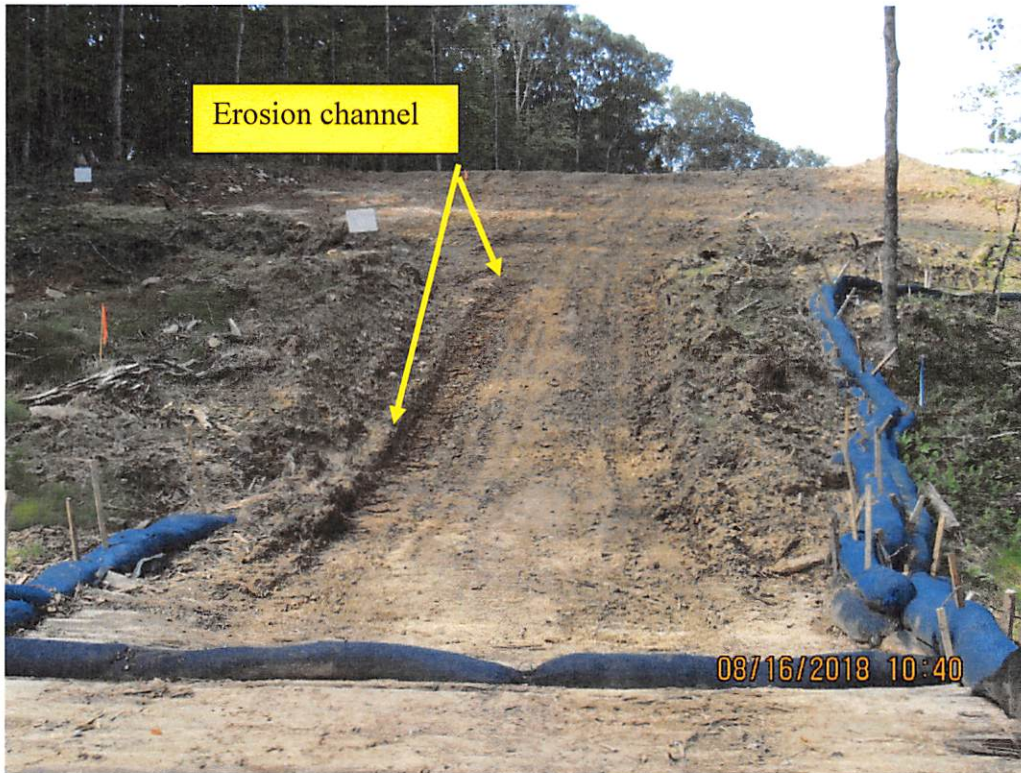
Photo11: Entrance off Bingham Road (station 7450+00) with inadequate slope breakers near stream.

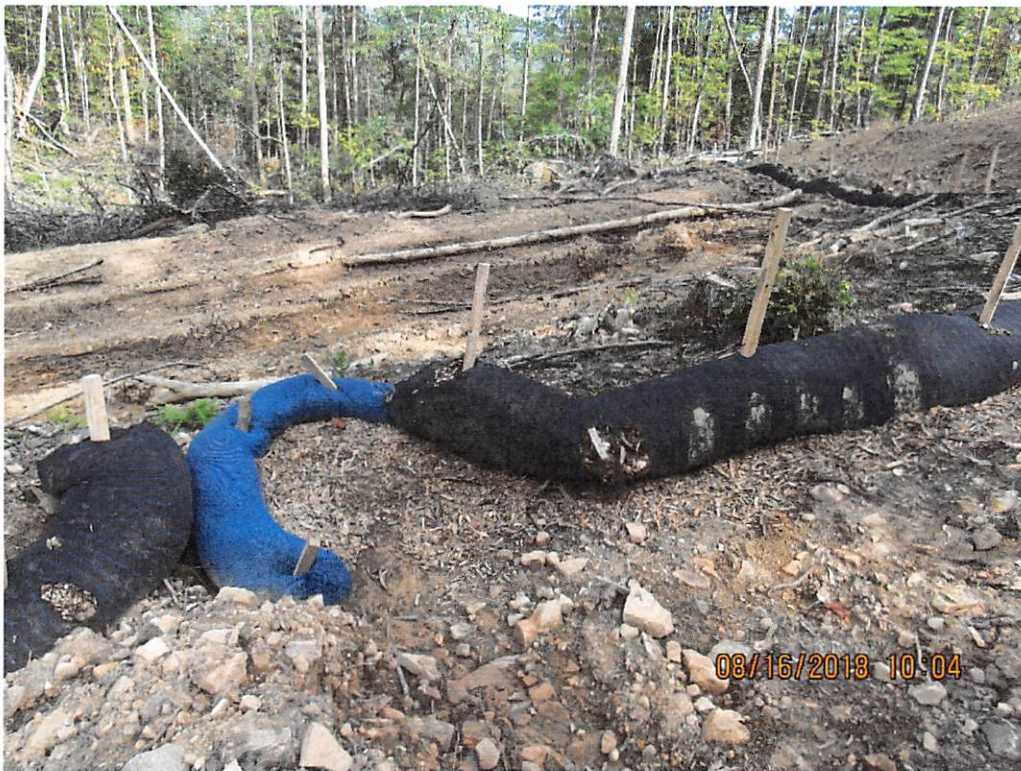
Photo 12: CFS needs maintenance near Bingham Road station 7450+00.

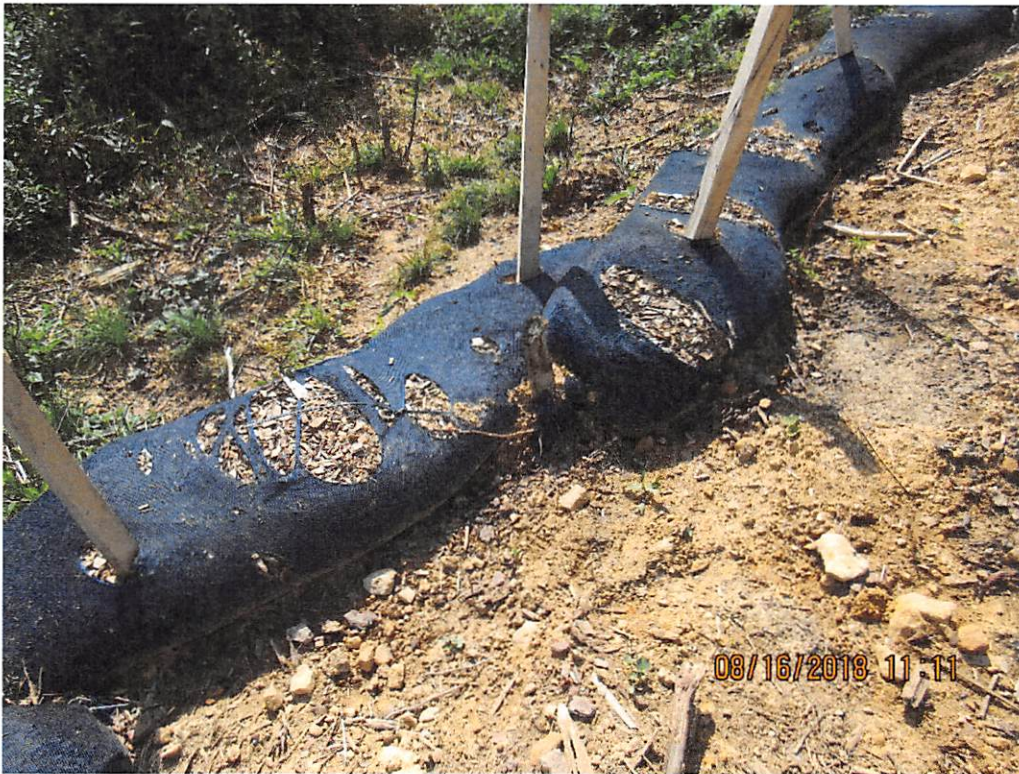
Photo 13: CFS needs maintenance near station 7232+00

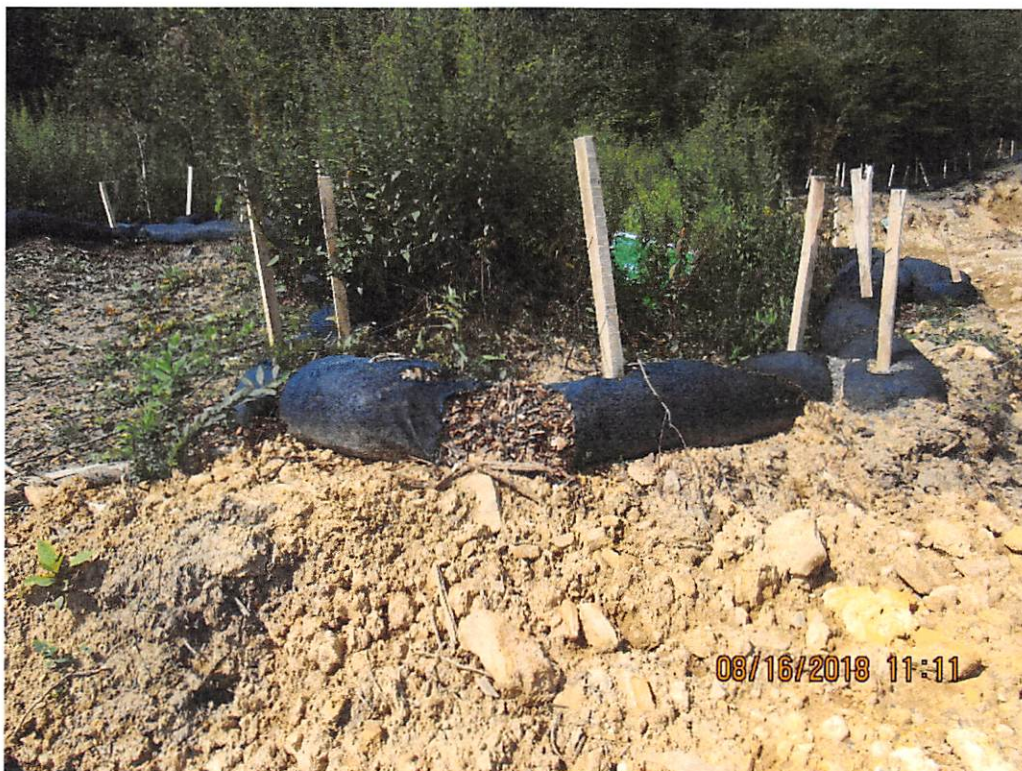
Photo 14: CFS needs maintenance near station 73232+00.

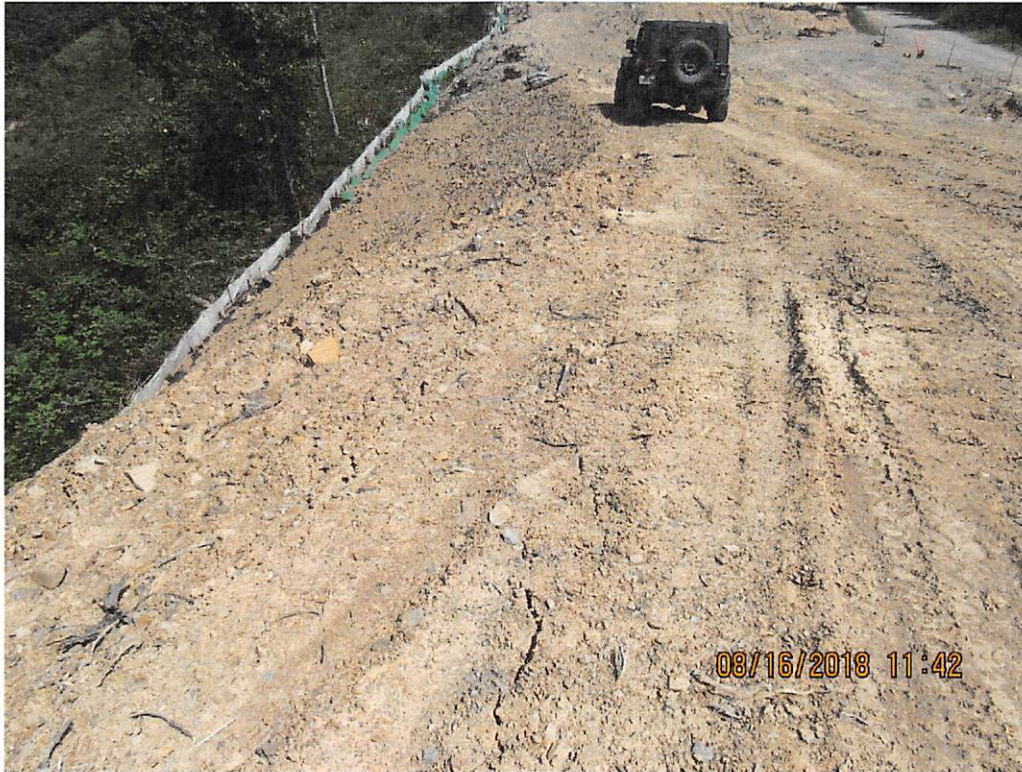
Photo 15: Northern view of Bamboo Road near Station 7158+00 without fill slope protection and temporary stabilization.

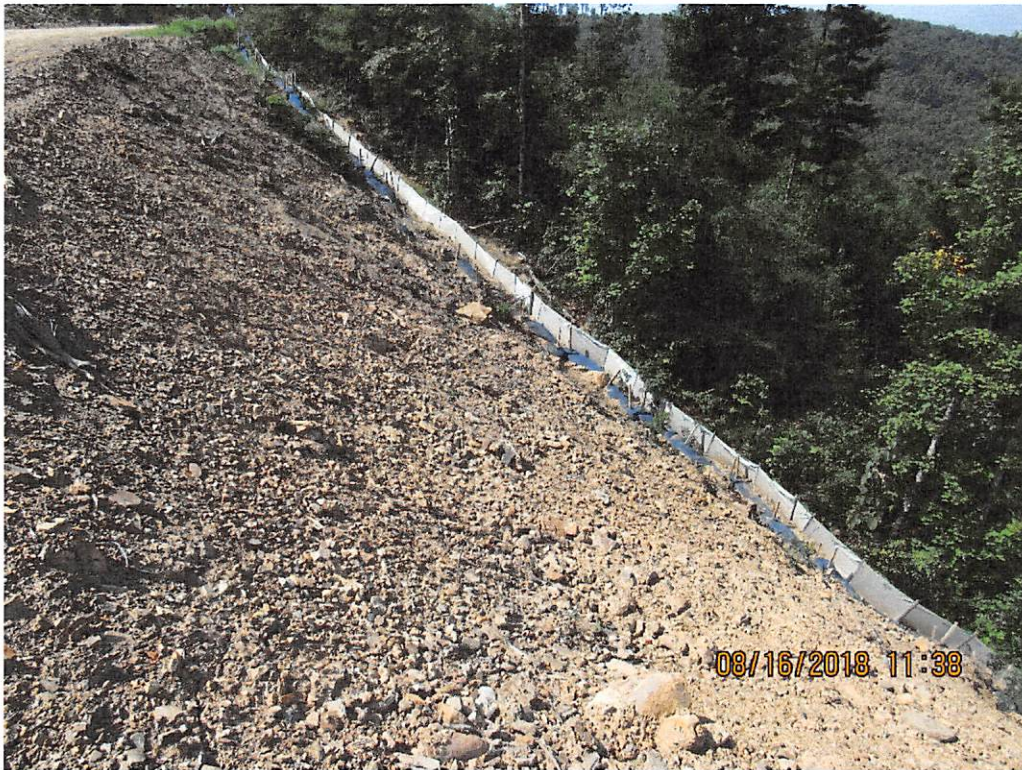
Photo 16: Southern view of Bamboo Road near Station 7158+00 without fill slope protection and temporary stabilization.

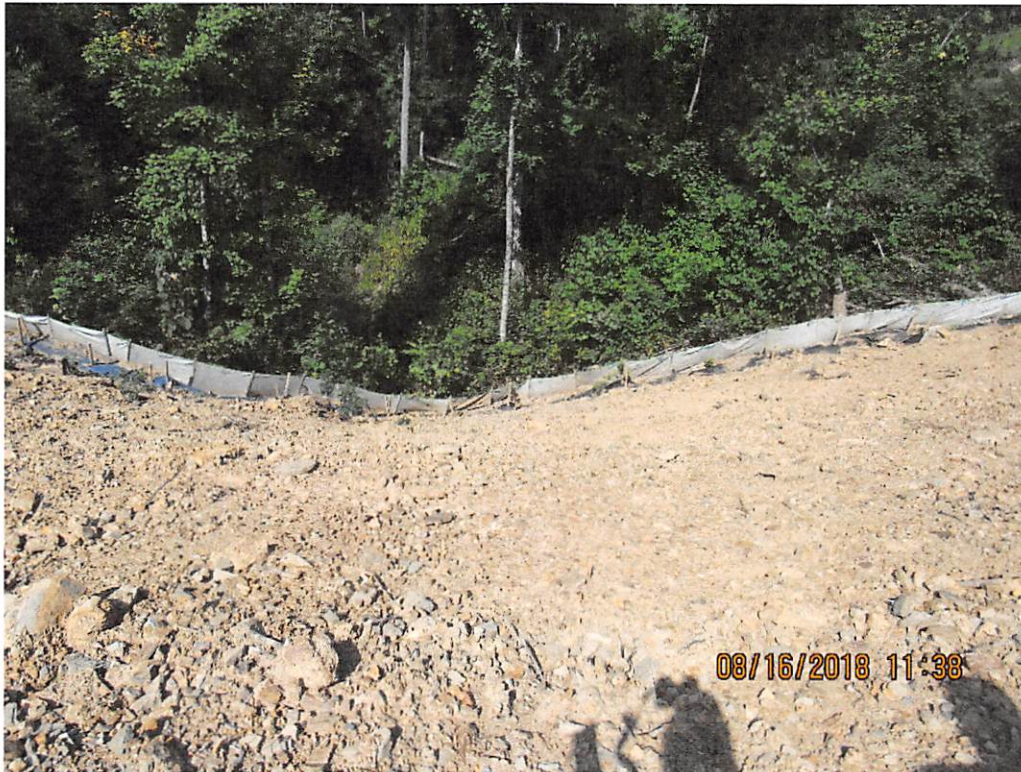
Photo 17: Inadequate controls for concentrated flow at base of fill slope near station 7158+00.

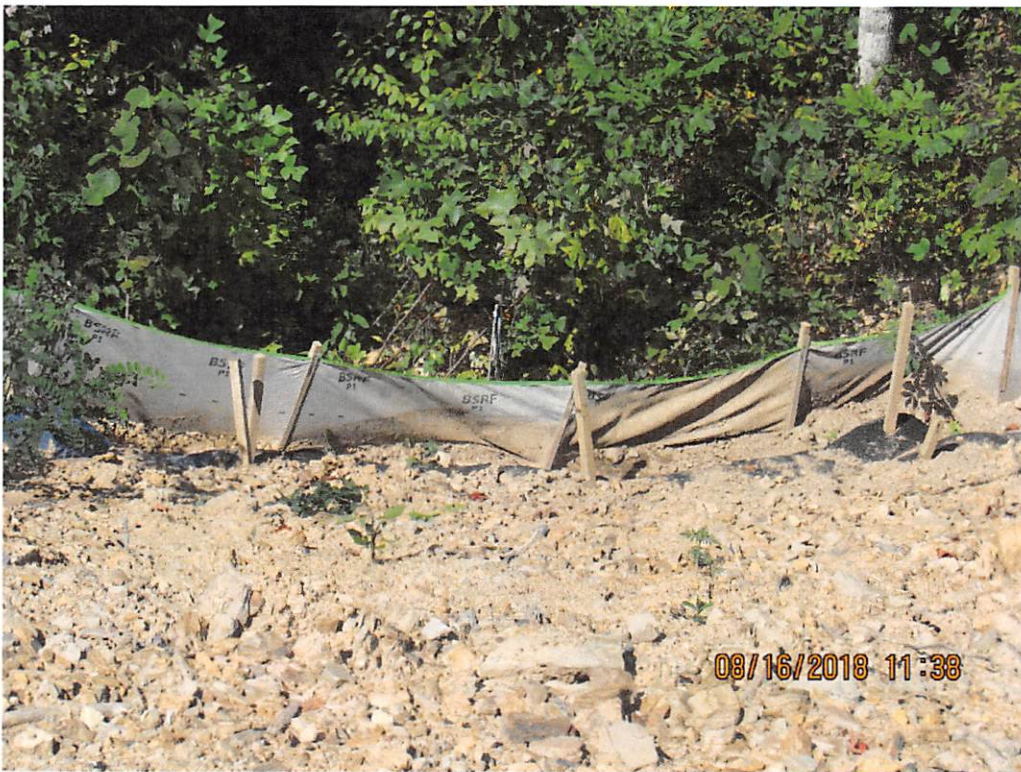
Photo 18: Close-up of inadequate controls for concentrated flow at base of fill slope near station 7158+00.

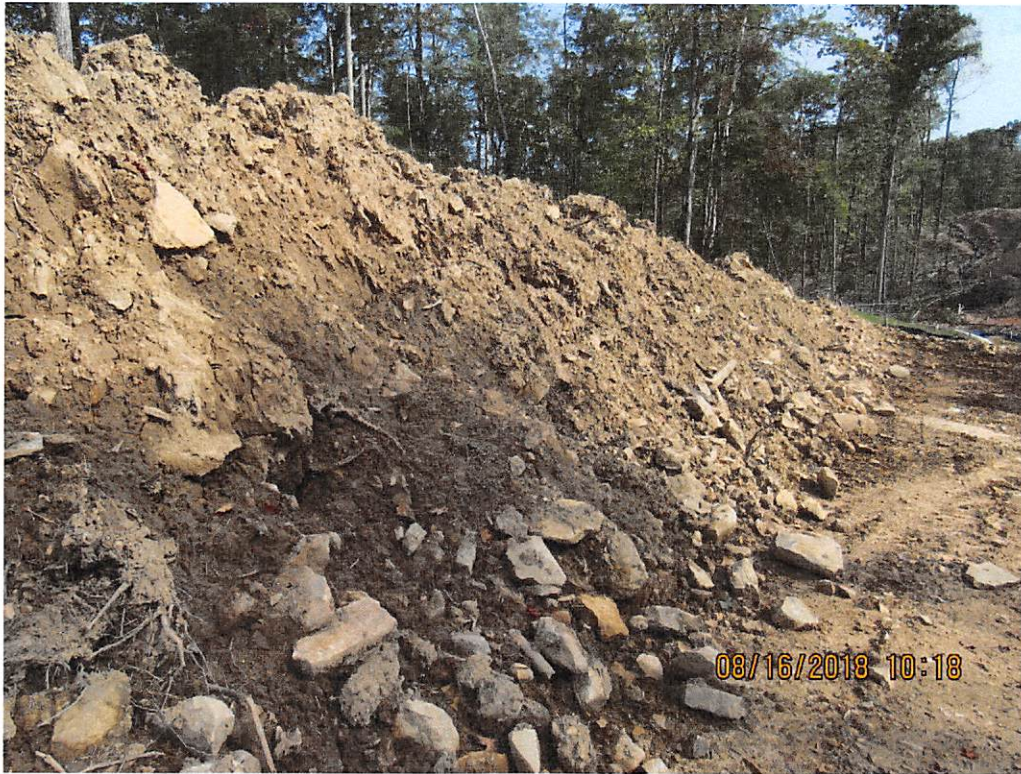
Photo 19: Northern view of waste pile with inadequate stabilization. (Photo taken near Bingham Road station 7450+00)

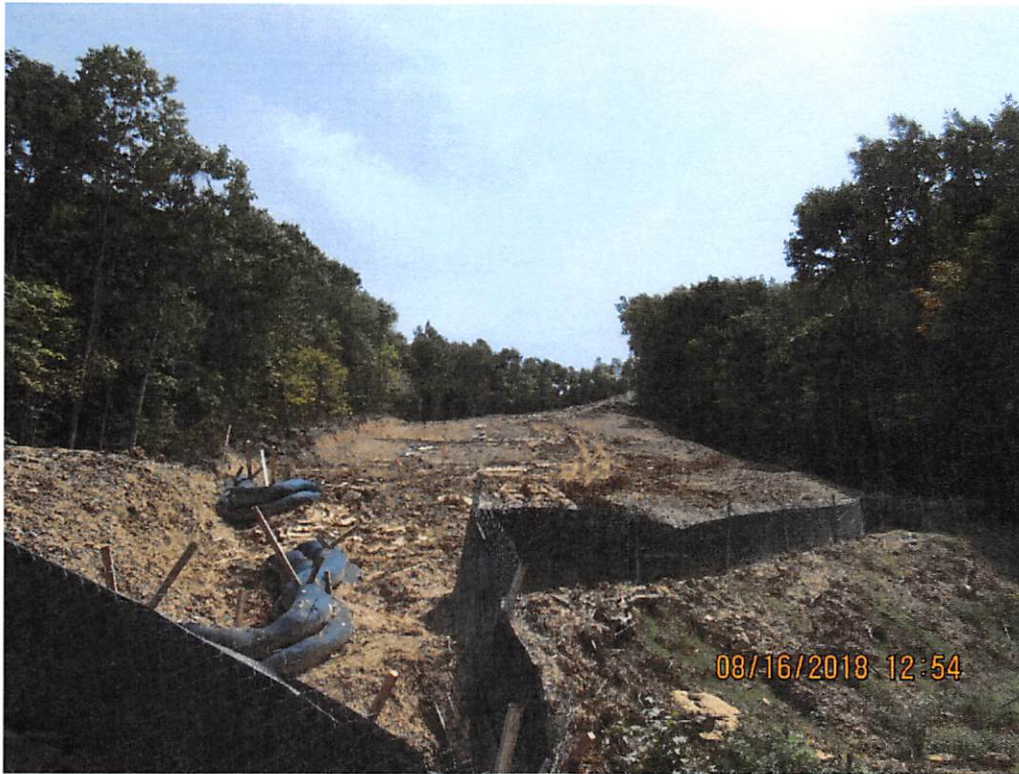
Photo 21: ROW slope between stations 7084+00- 7093+50 with inadequate number of water bars.

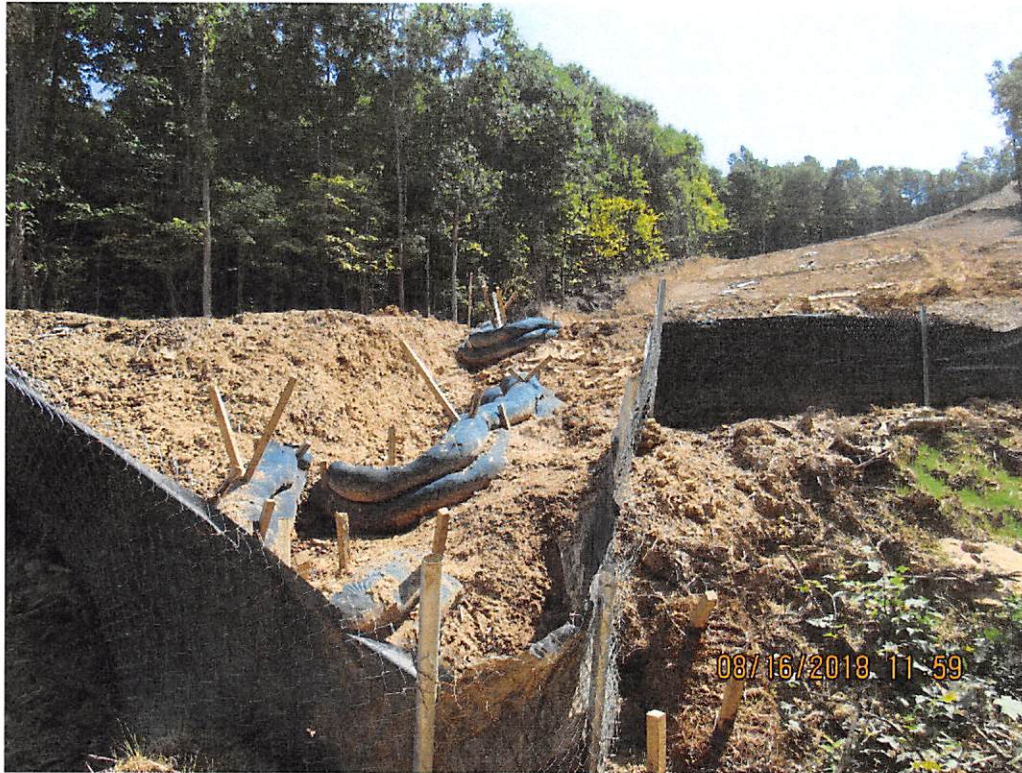
Photo 22: Failure of installed water bars between stations 7084+00 – 7093+50.

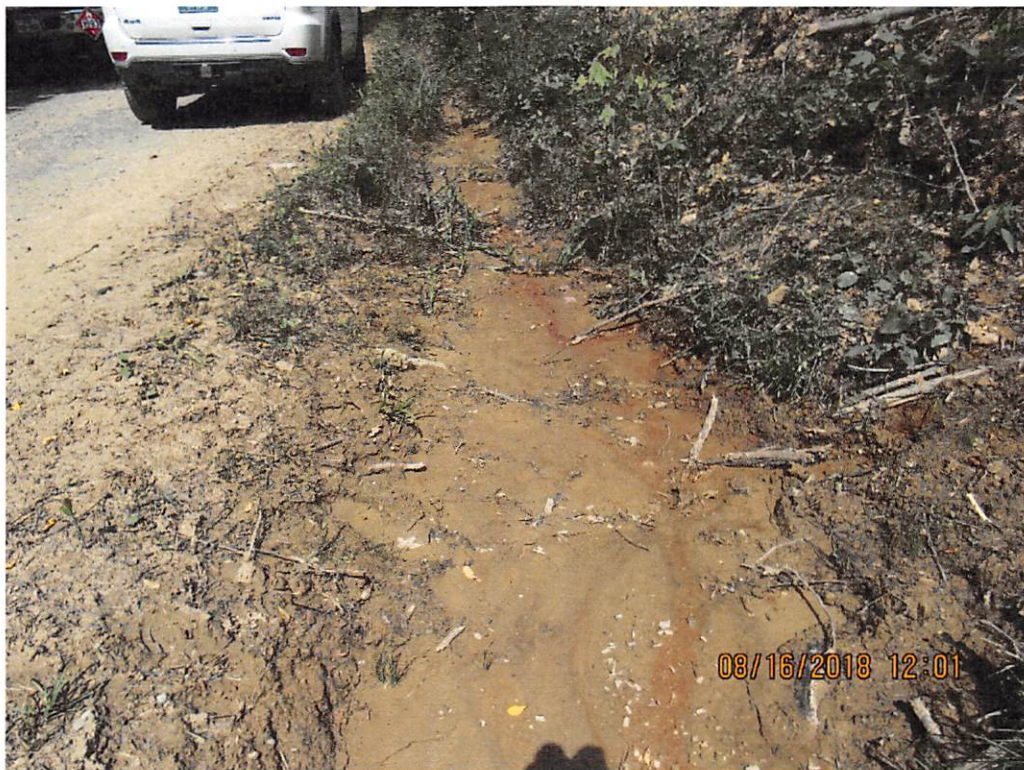
Photo 25: Controls and sediment deposits in road side ditch at water bar terminus at station 7084+00.

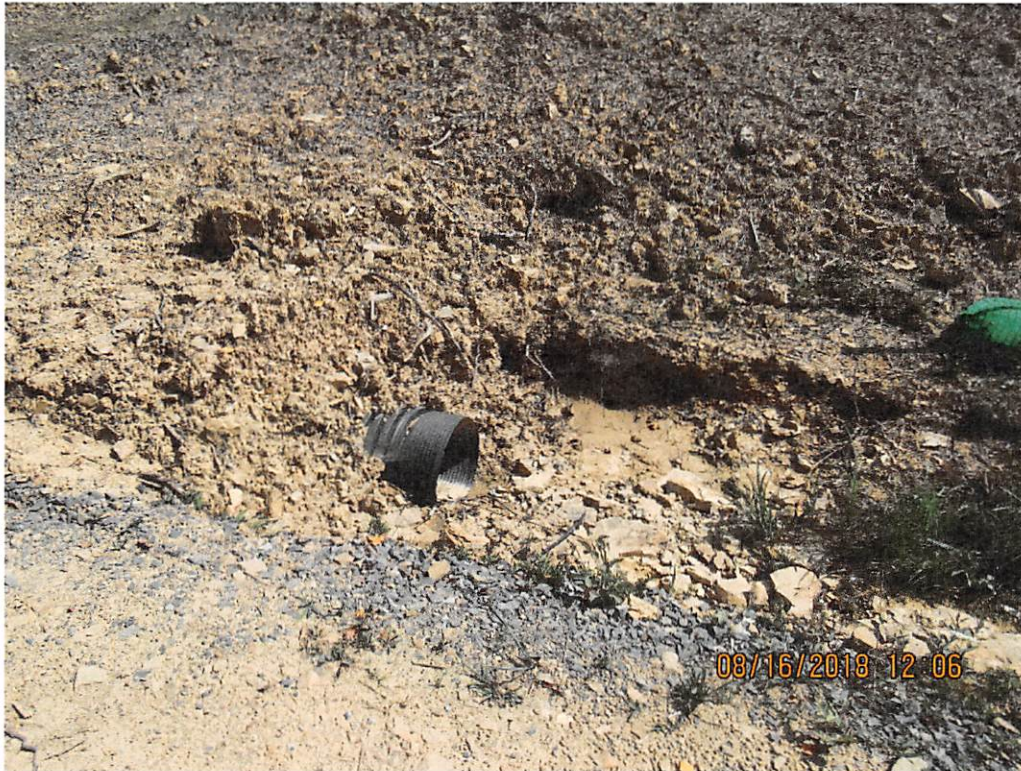
Photo 26: Road side ditch below water bar terminus in photos 23-25 conveying sediment laden water to installed culvert.

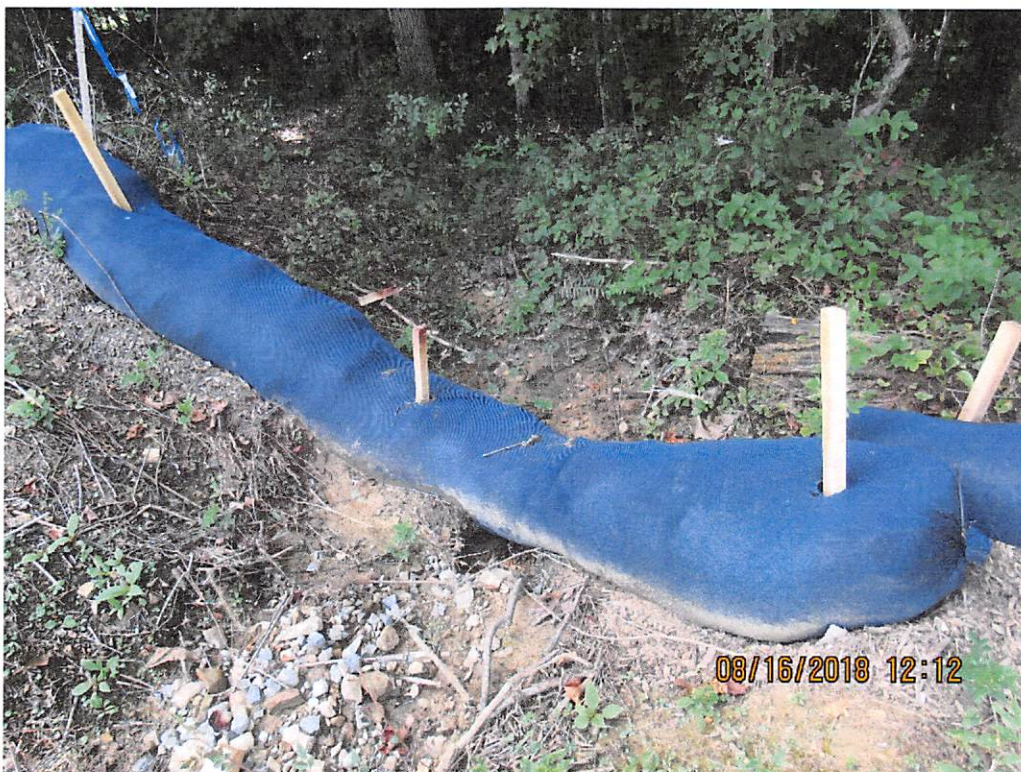
Photo 29: Outlet to SR culvert connected to installed culvert in photo 27.

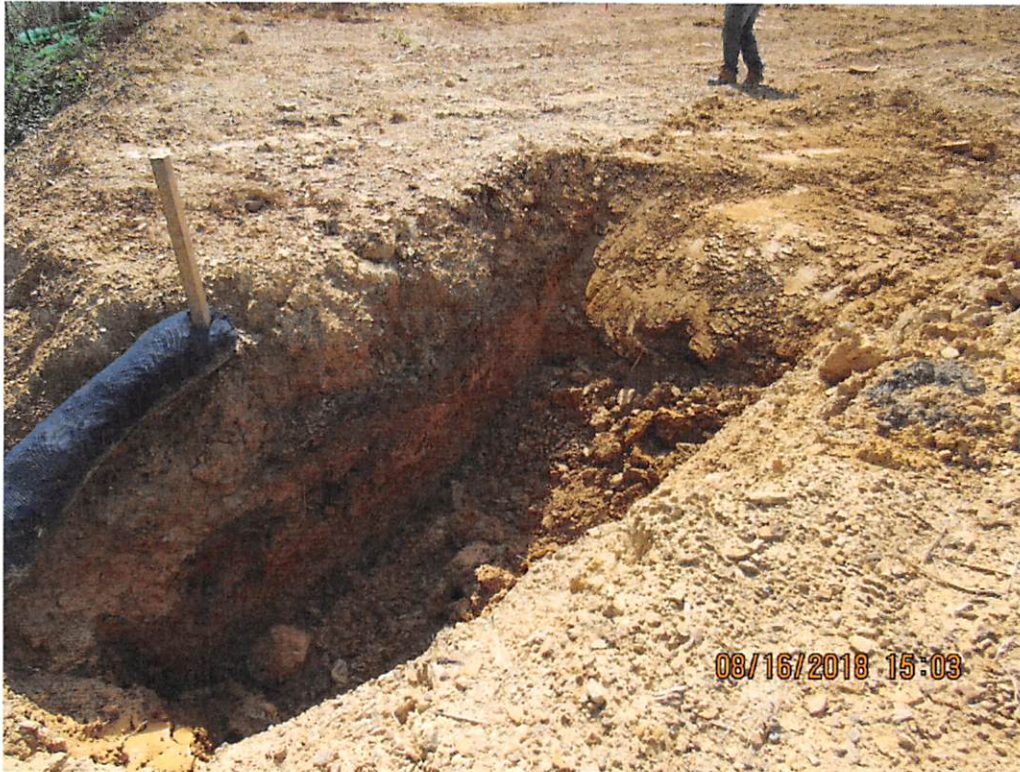
Photo 30: Perimeter controls failure downslope of SR culvert outlet allowing sediment laden water to leave site.

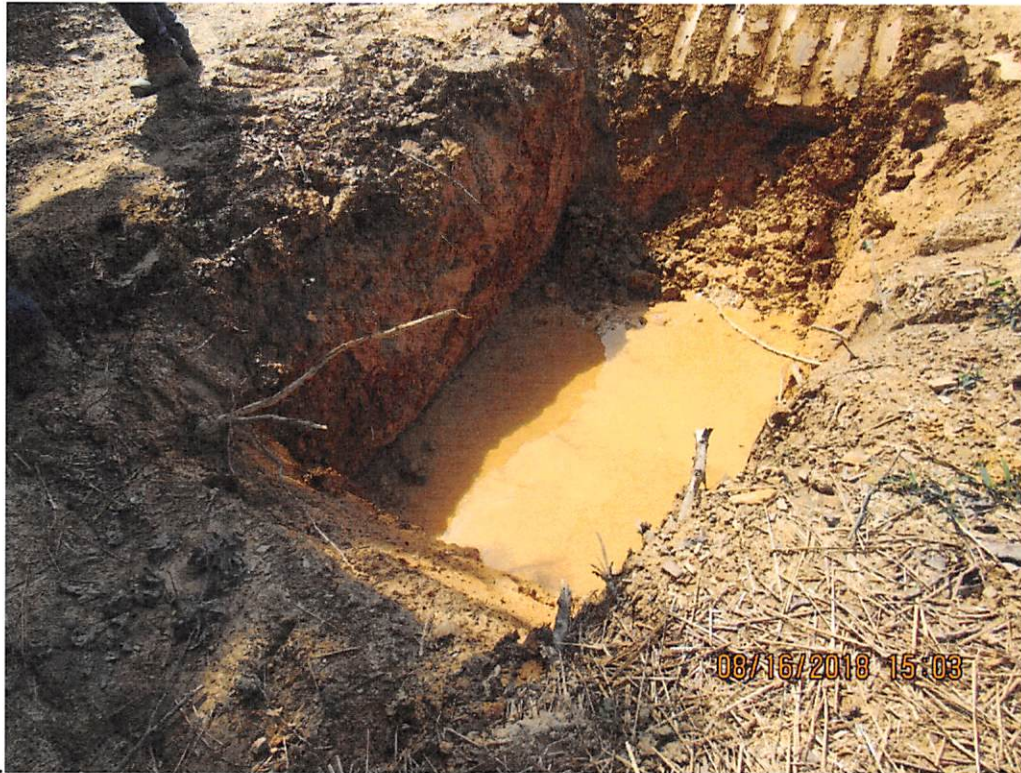
Photo 32: Site of historical water bar terminus control failure- sump installed has reduced failure.

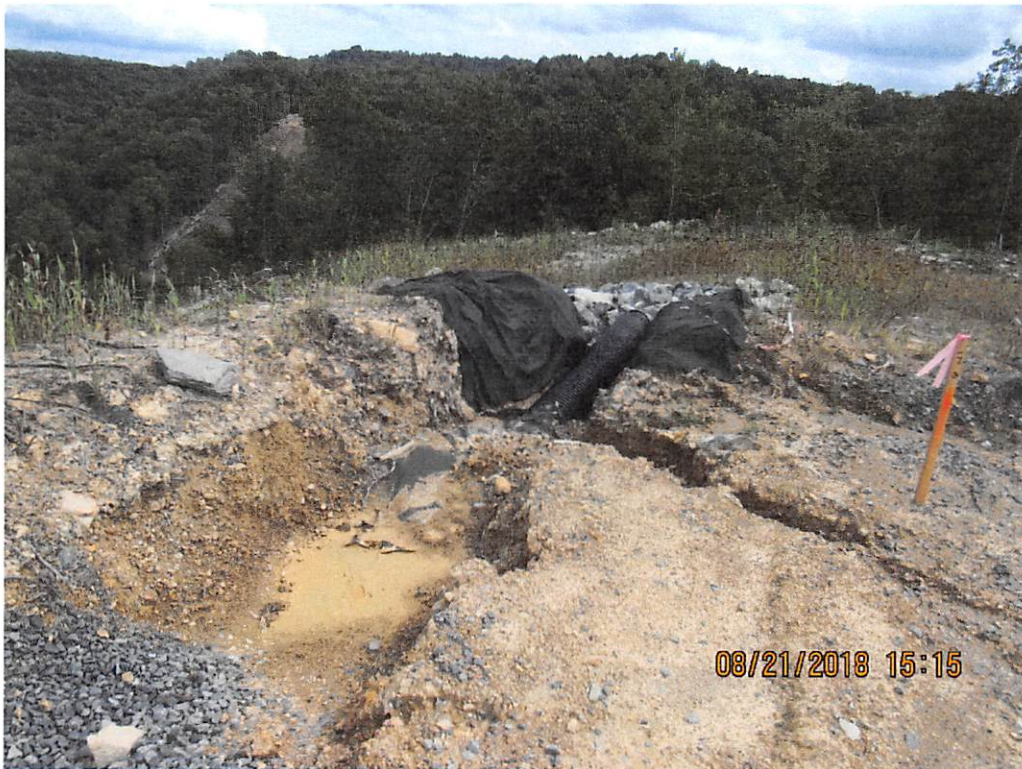
Photo 1: Unfinished underdrain installation.

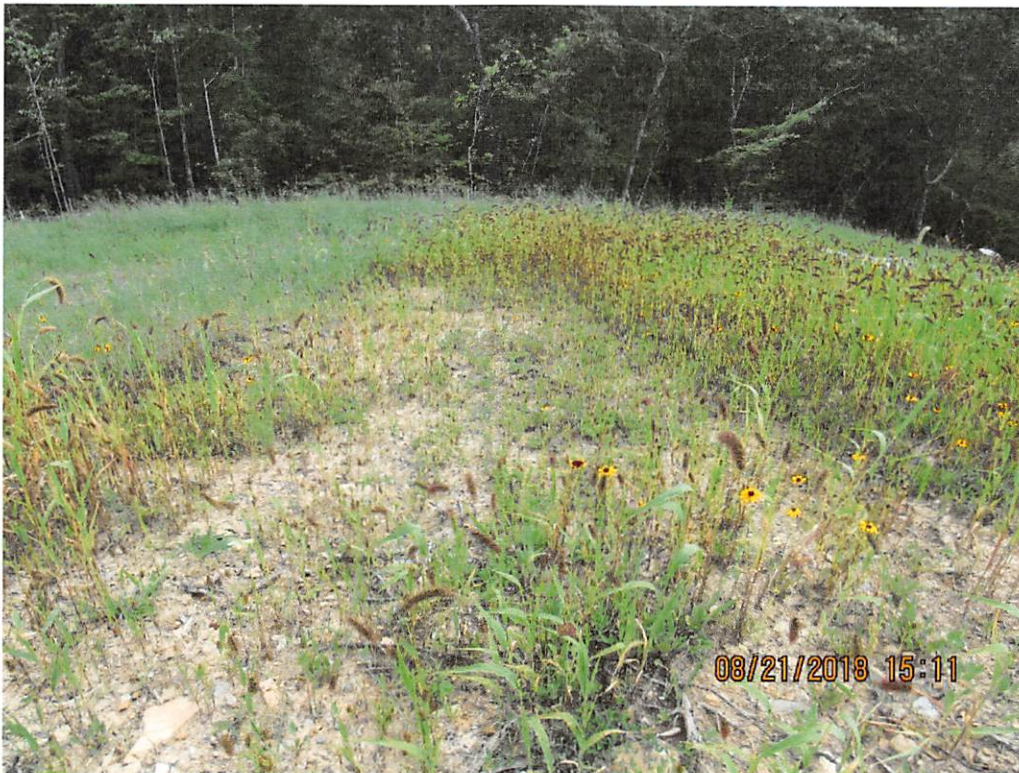
Photo 4: Slope on northwest side of site which has not been reseeded.
