**CONSENT ORDER  
ISSUED UNDER THE  
WATER POLLUTION CONTROL ACT  
WEST VIRGINIA CODE, CHAPTER 22, ARTICLE 11**

TO: Mountain Valley Pipeline, LLC

DATE: April 19, 2019

ORDER NO.: 8951

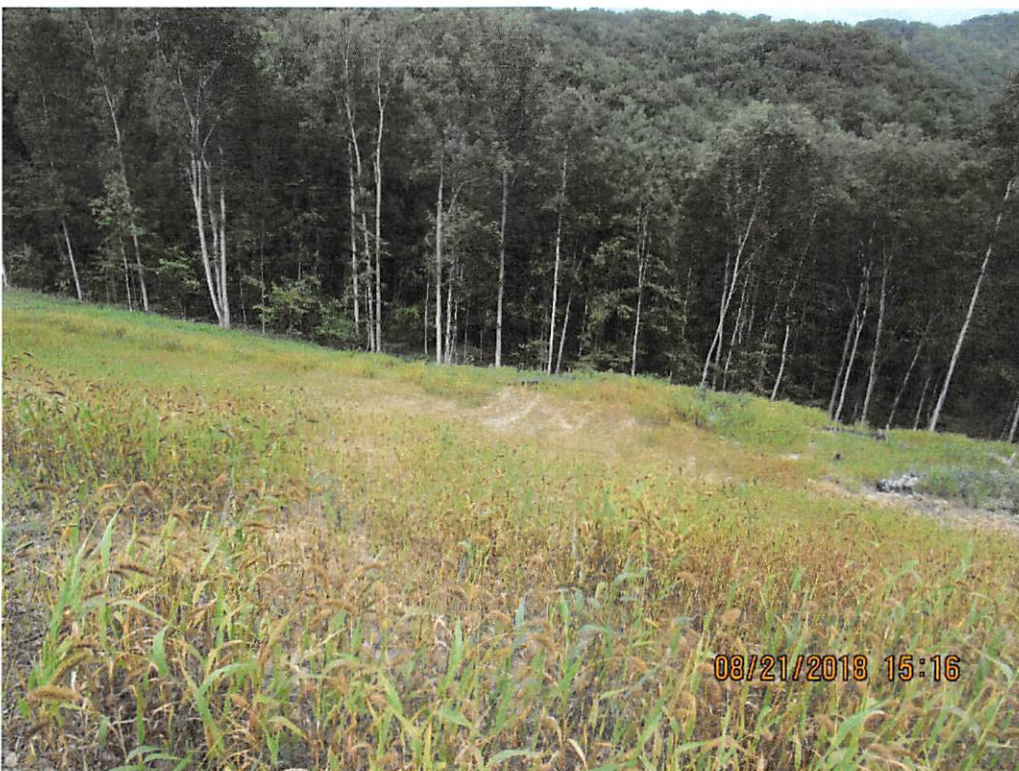
Photo 5: Area reseeded but growth not observed due to lack of sufficient rain.

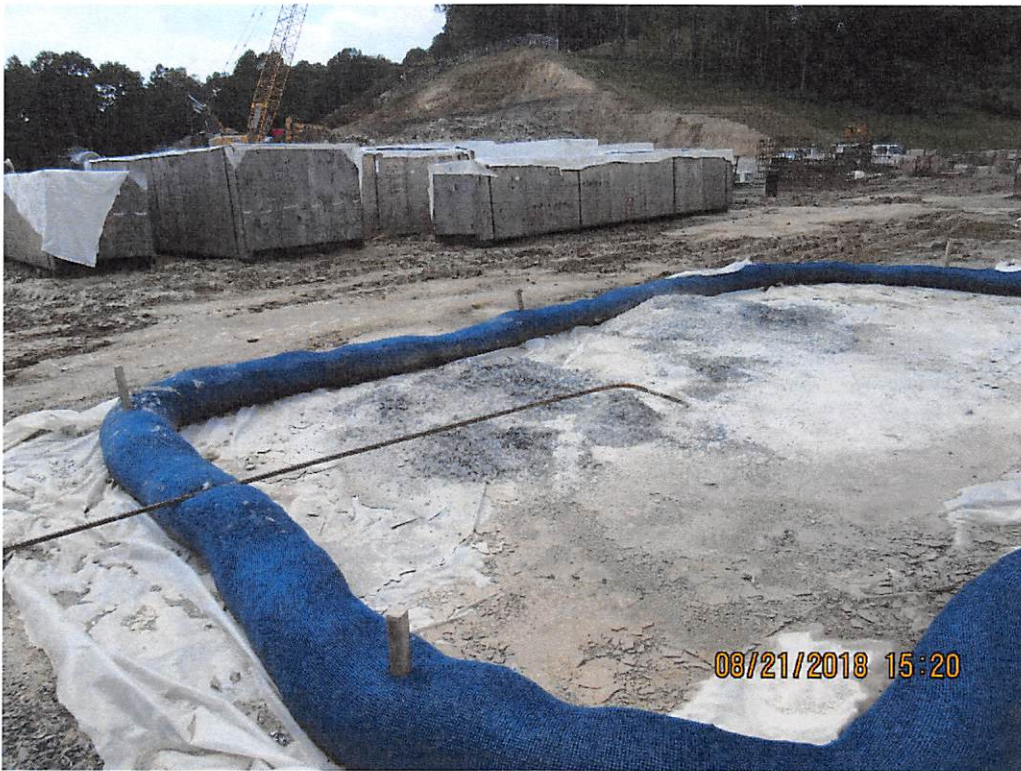
Photo 7: Improperly implemented control for concrete wash out area.

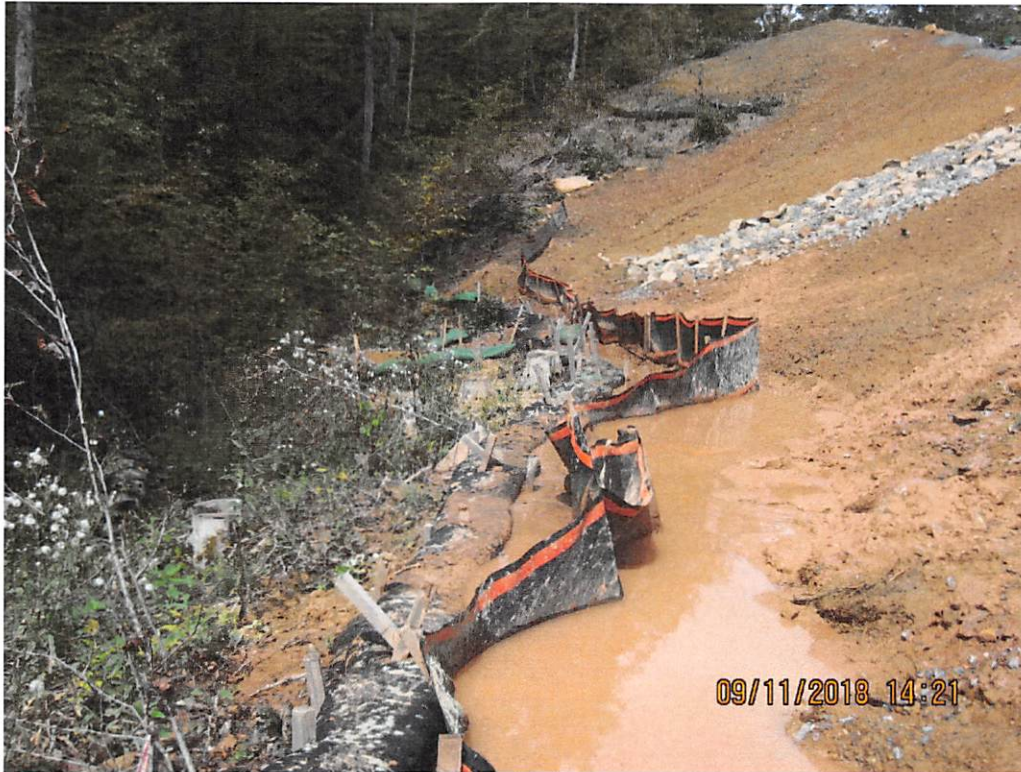
Photo 6: Station 900- Culvert outlet concentrating flow from diversion ditch.

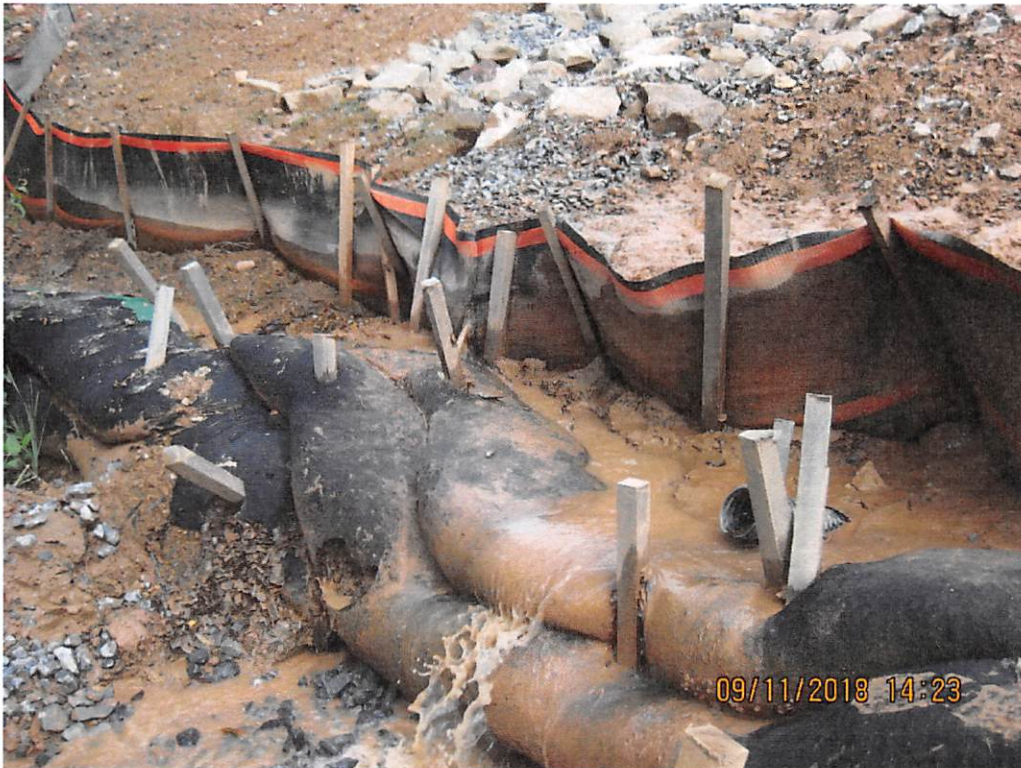
Photo 7: Station 900 (approximately) -Flow along silt fence from culvert outlet downslope to sump.

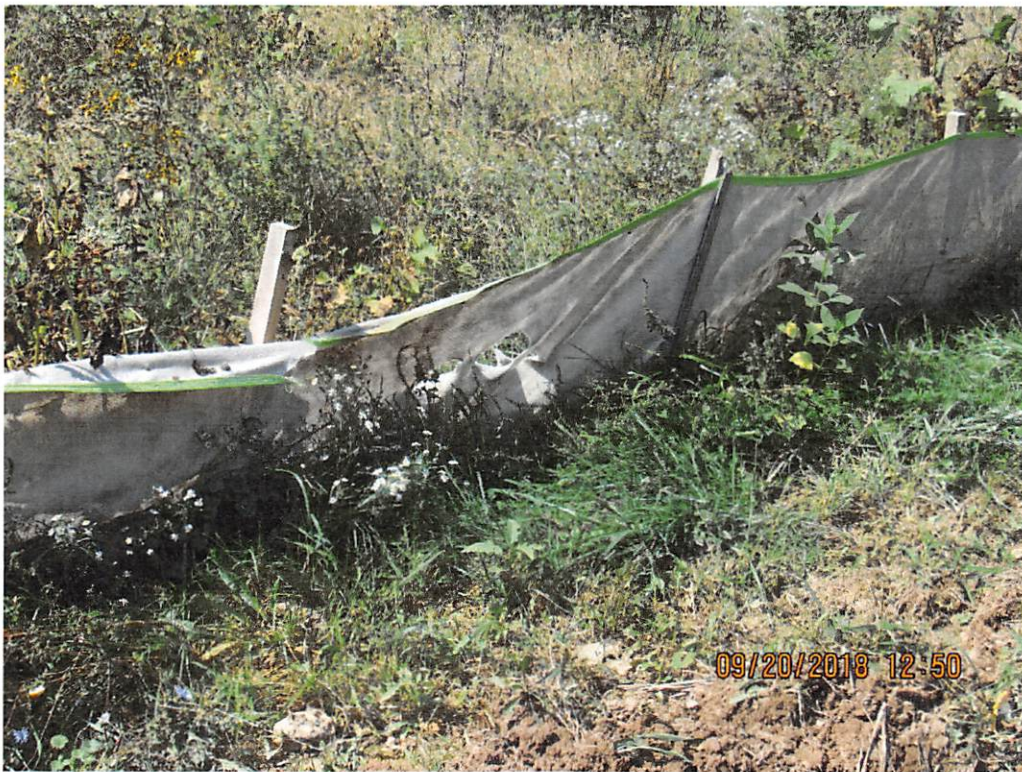
Photo 1: Plume in UNT of Painters Run from control failure off access road 231.01 near station 10270+49.

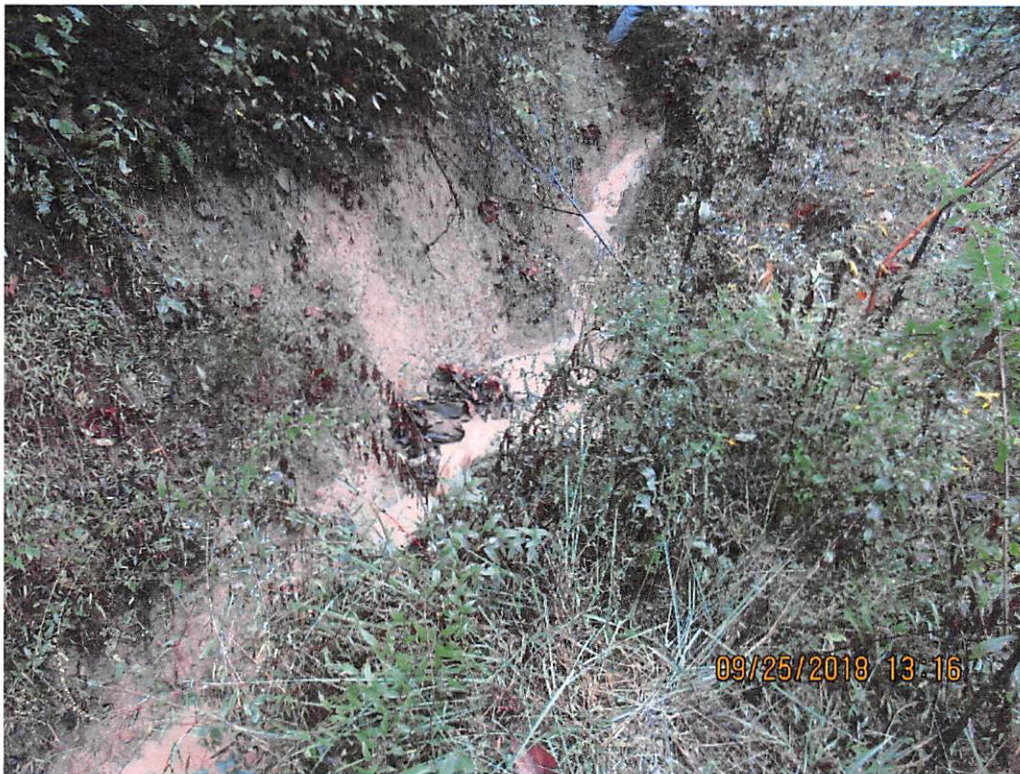
Photo 4: Sump above control failure off access road 231.01 near station 10270+49 Painters Run.

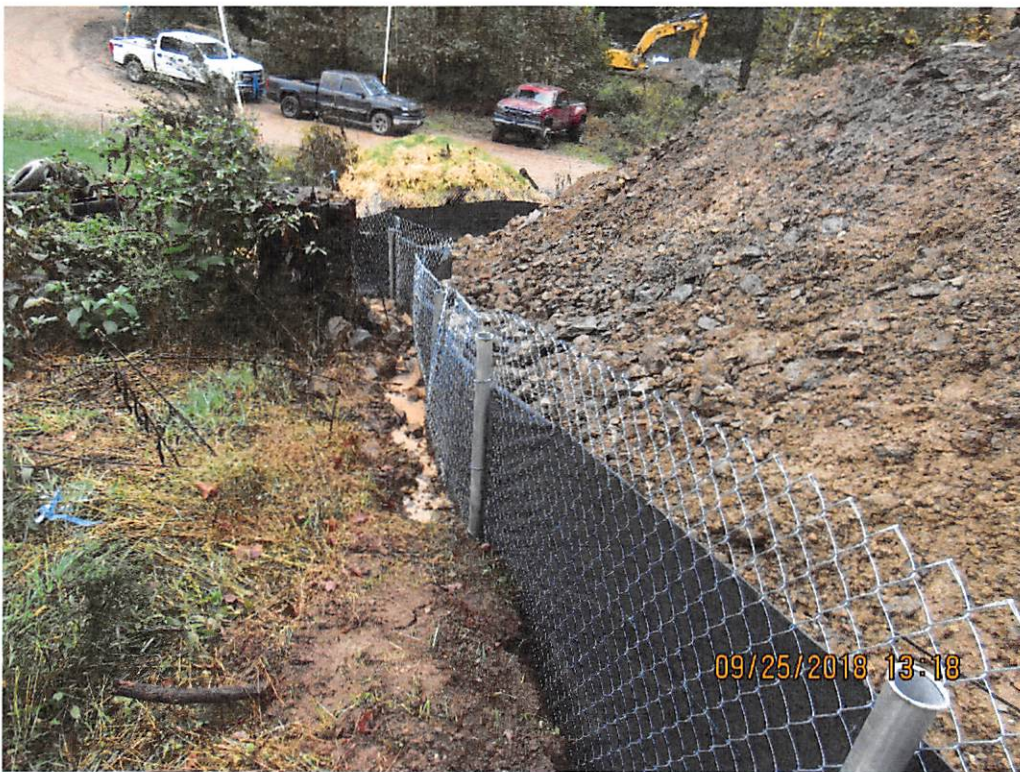
Photo 1: Sediment laden water from sumps near station 3625+00.

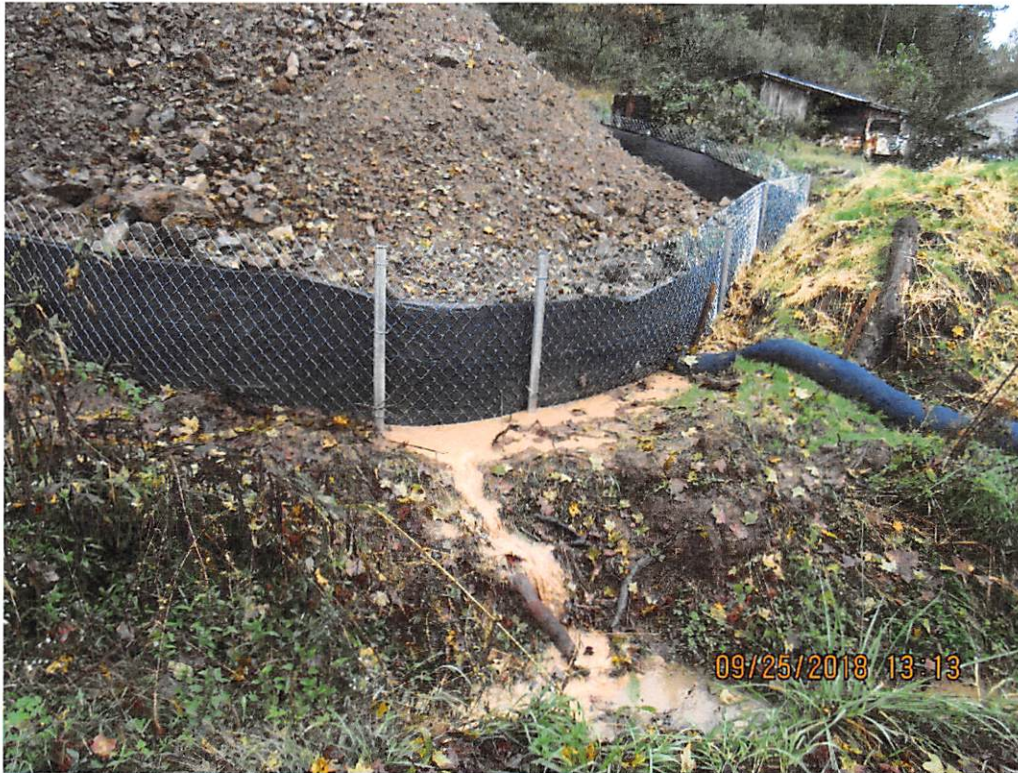
Photo 2: Undermined perimeter controls near 3634+00 which failed allowing sediment laden water to leave site.

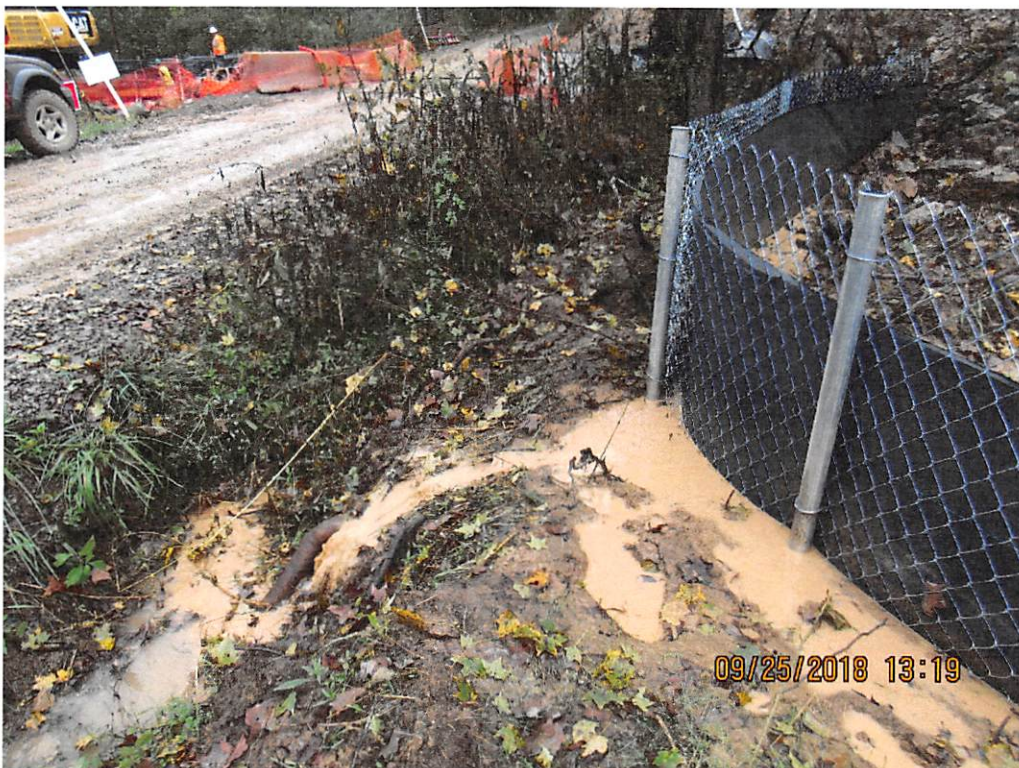
Photo 3: Failure of perimeter controls near 3634+00 allowing sediment laden water to leave site.

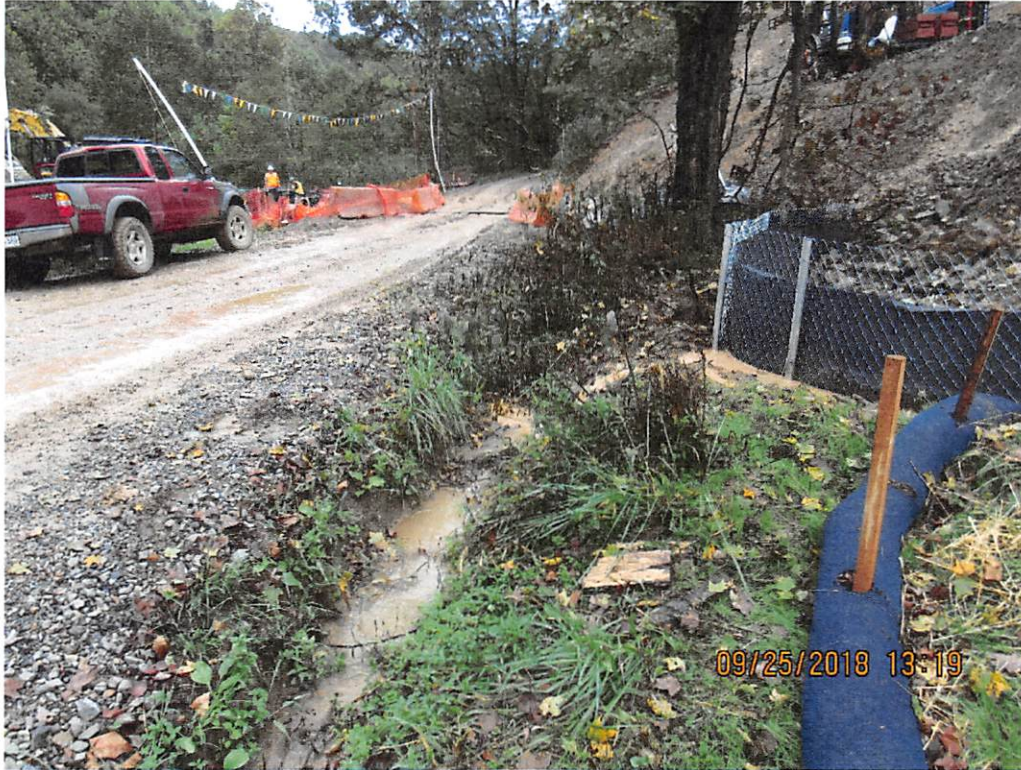
Photo 4: Close-up of failed perimeter controls near station 3634+00 where sediment laden water is entering UNT of Knawls Creek.

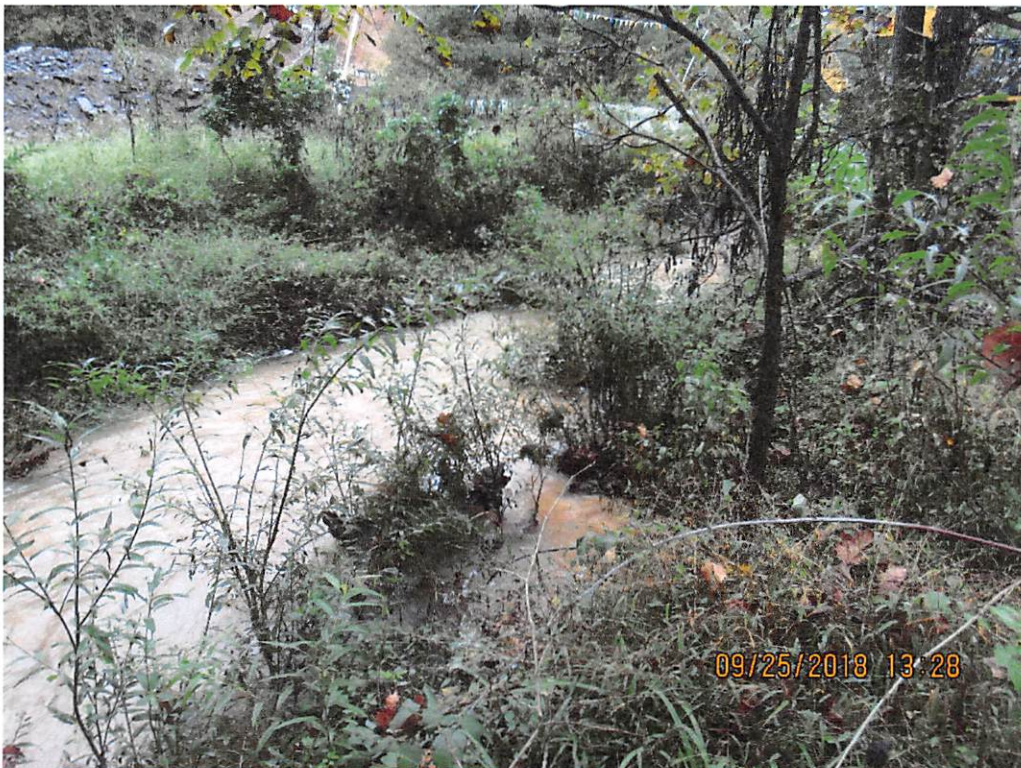
Photo 5: Sediment laden water entering UNT of Knowls Creek near station 3634+00 from failed perimeter controls.

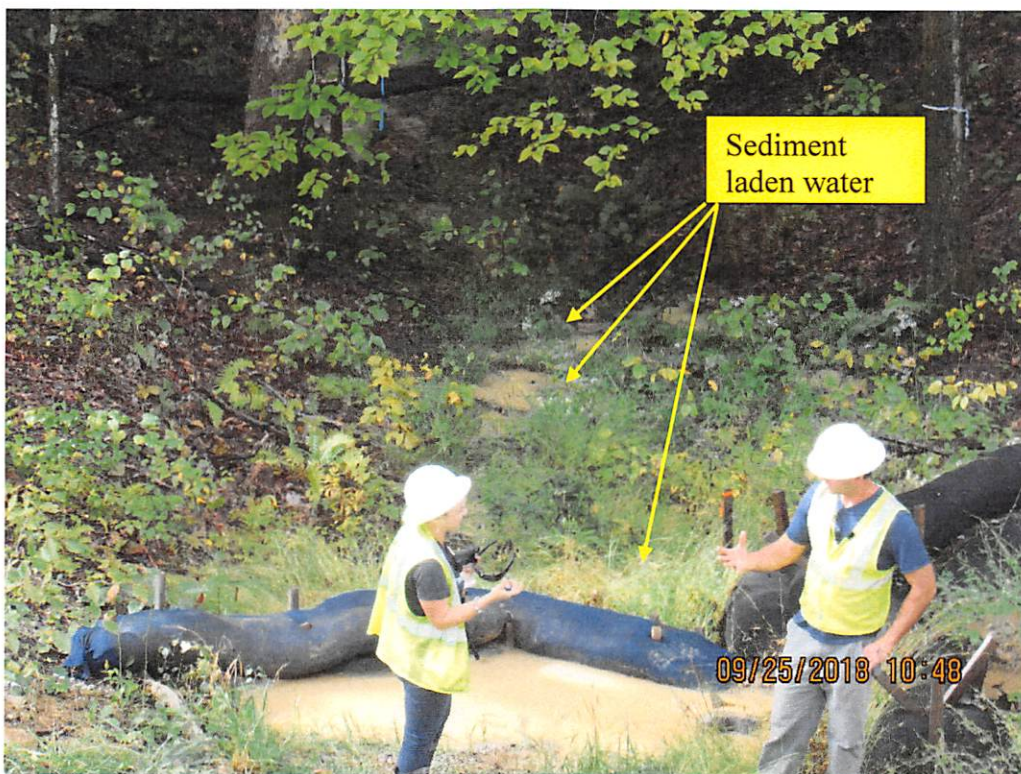
Photo 1: Station 550 outlet and sump at base of fill slope where perimeter controls failed allowing sediment laden water to leave site and create conditions not allowable in UNT of Little Kanawha.

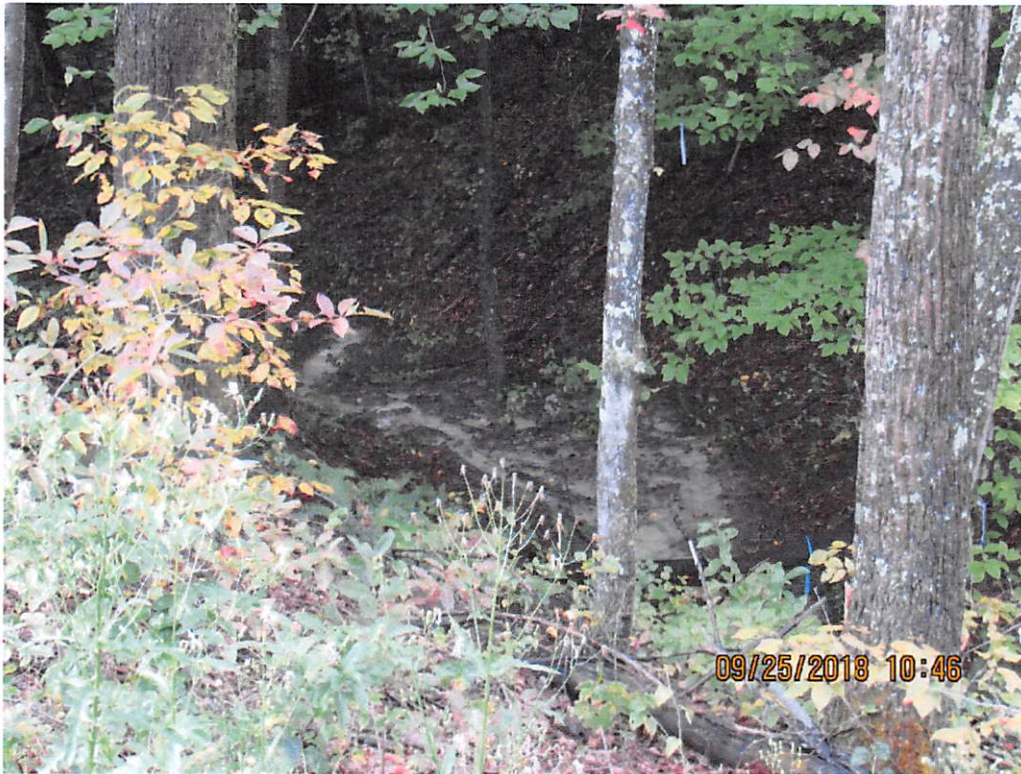
Photo 2: Station 550 sump at base of fill slope where perimeter controls failed and sediment laden water leaving site.

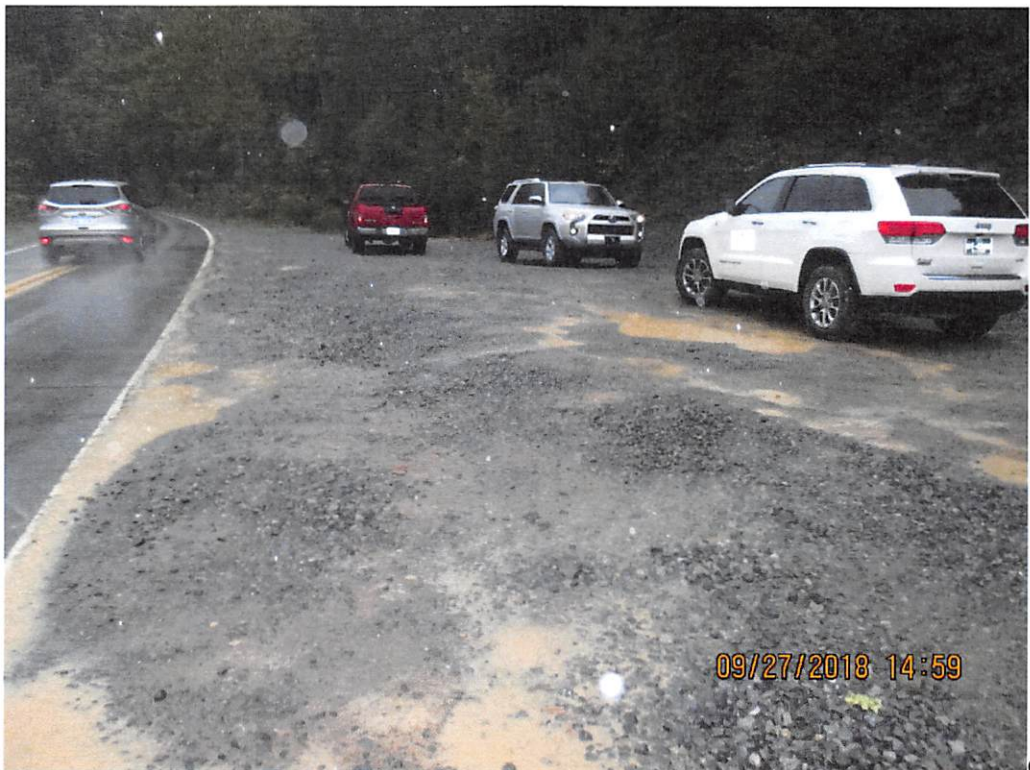
Area where sediment laden water was leaving site and being intercepted by road side ditch along Route 122.

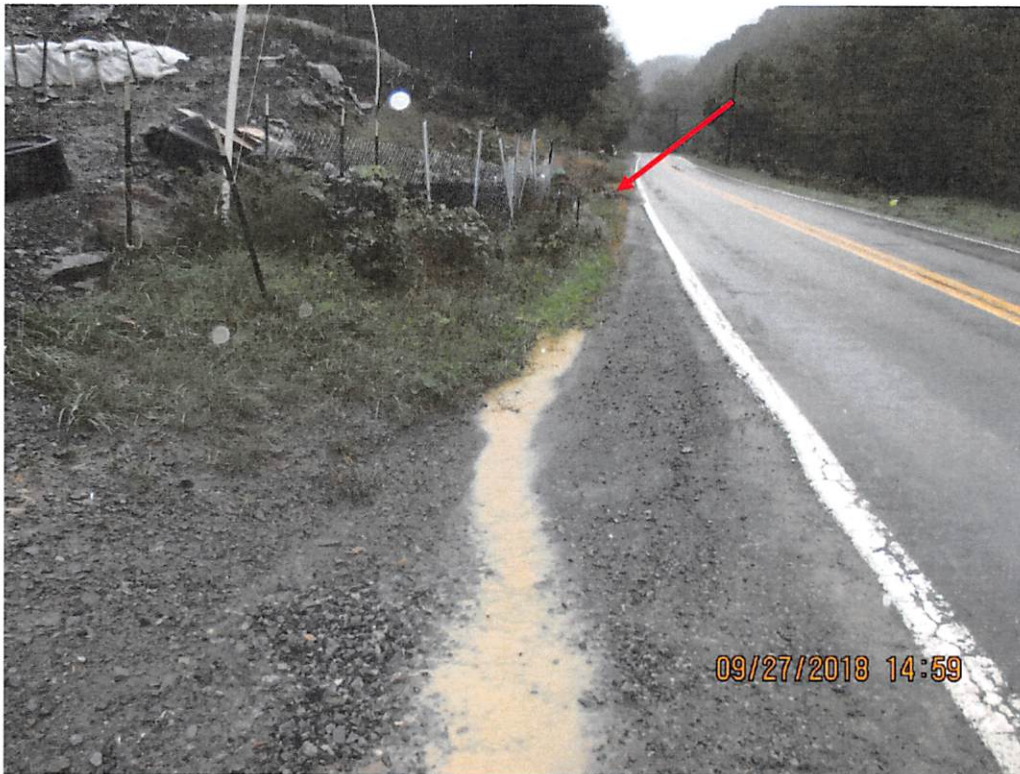
Sediment laden water accumulating and draining towards roadside ditch that intersects with S-A60 along Route 122.

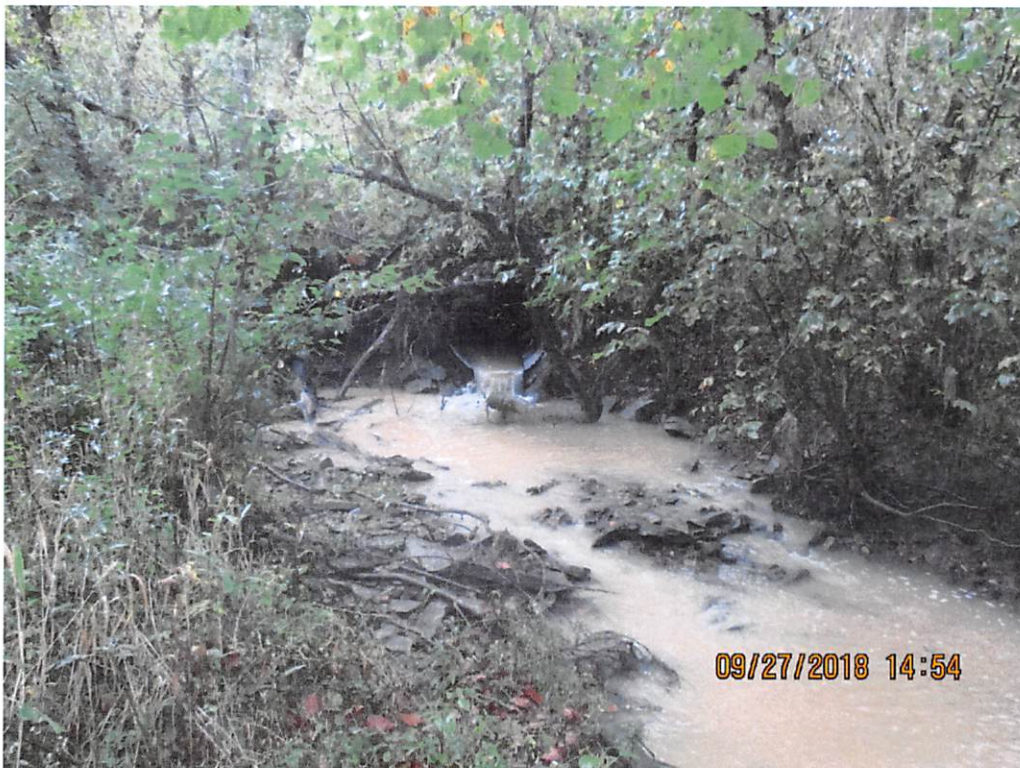
Sediment laden water leaving ROW intercepted by ditch flowing towards Stream (S-A60). Arrow depicts where ditch connects to stream S-A60 and flows under road via culvert.

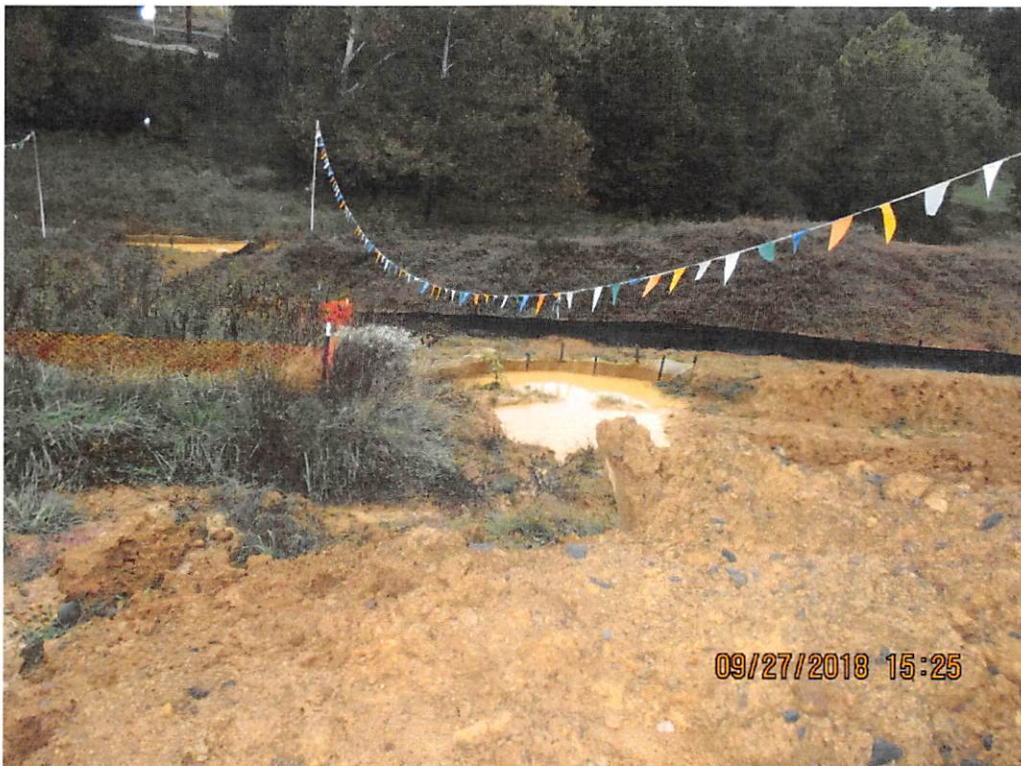
Sediment laden water entering Indian Creek on 9/27/18 via Stream (S-A60).

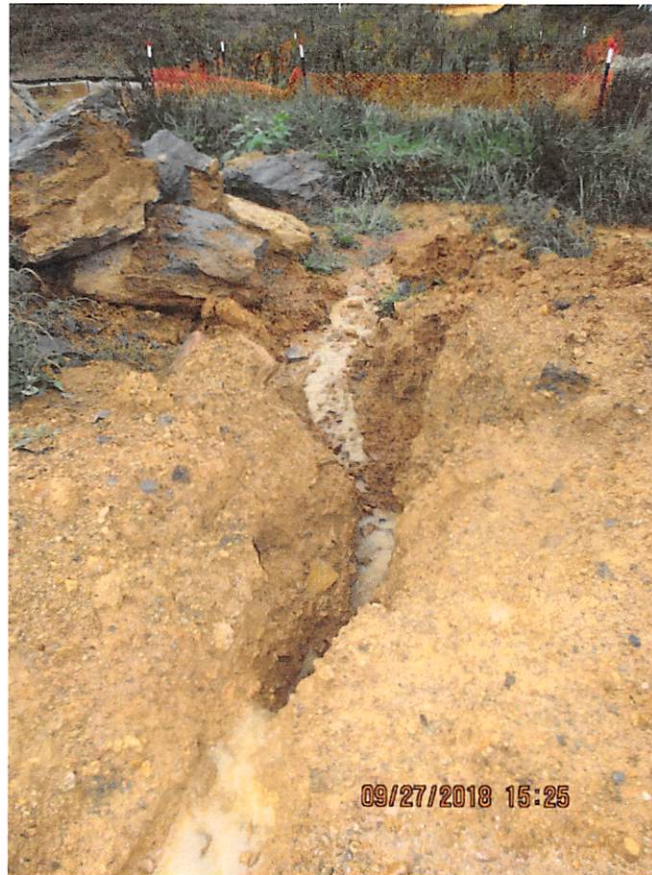
Overview of slope leading towards Stream (S-A60) near station number 9639+00.

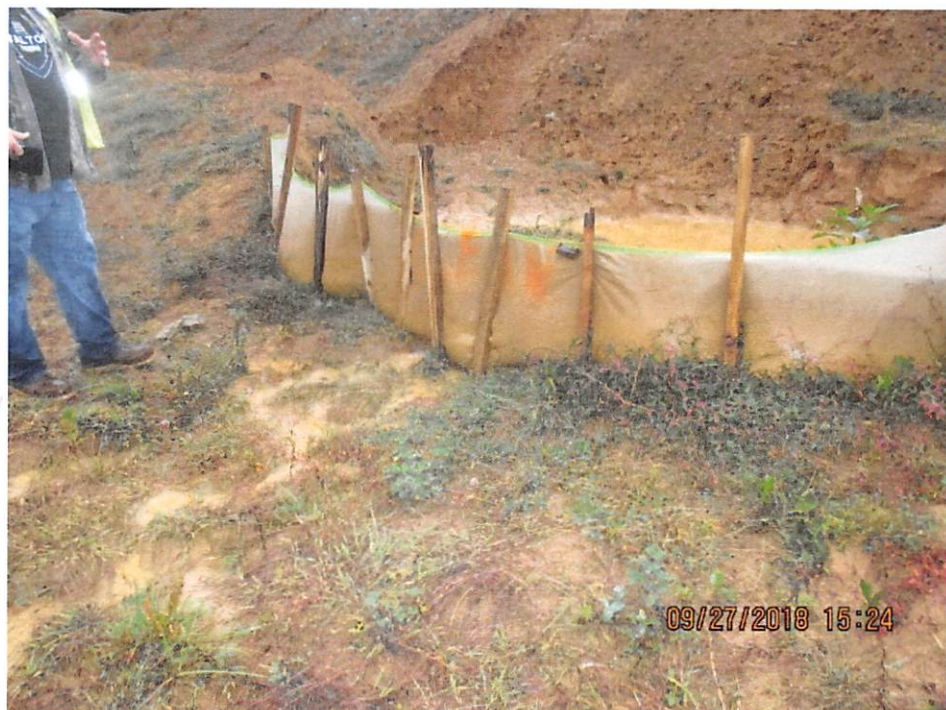
Water bar terminus leading to BMP. Erosion occurring due to channel not being stabilized.

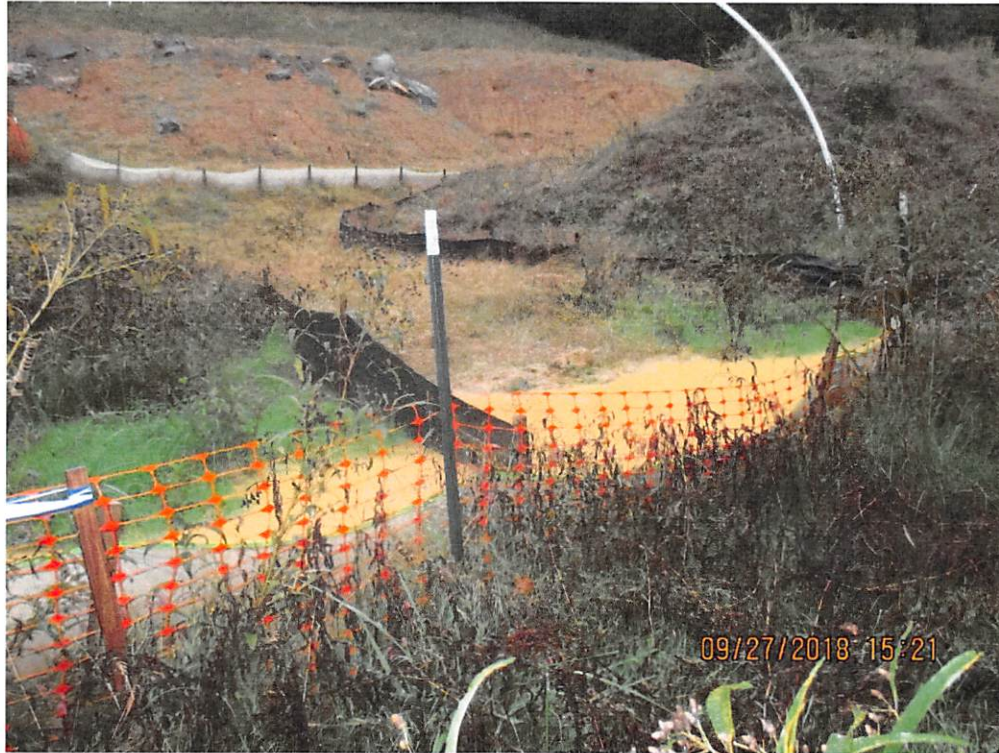
Sediment laden water passing through/under BMP.

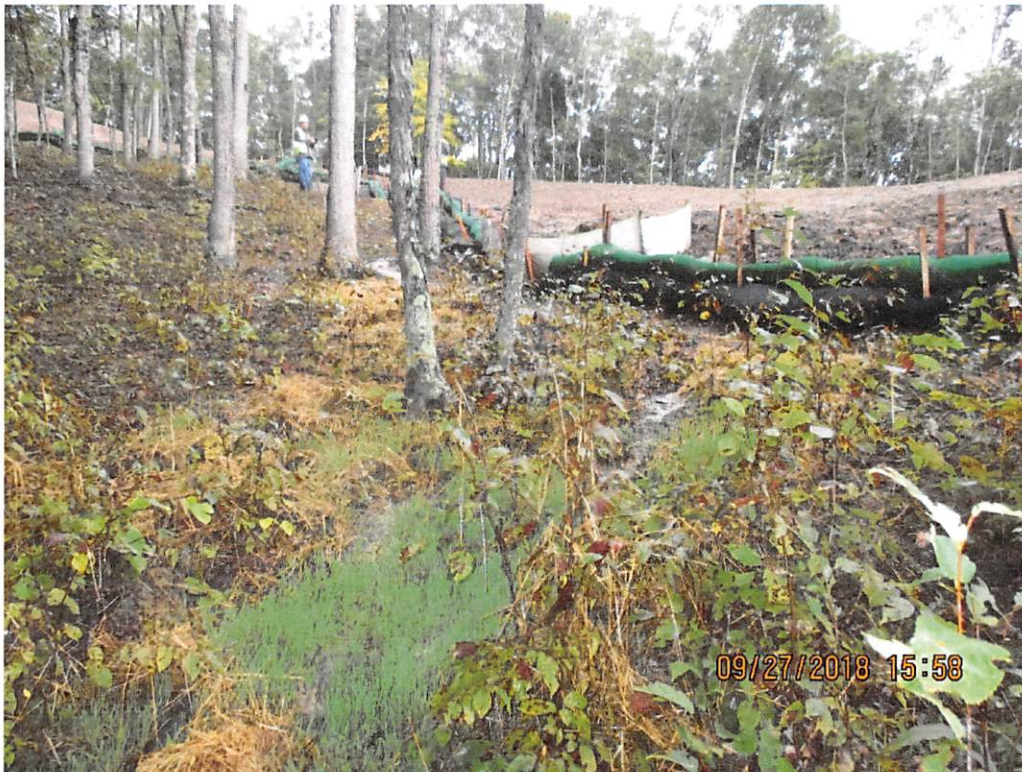
Sediment laden water leaving project and entering stream (S-A60).

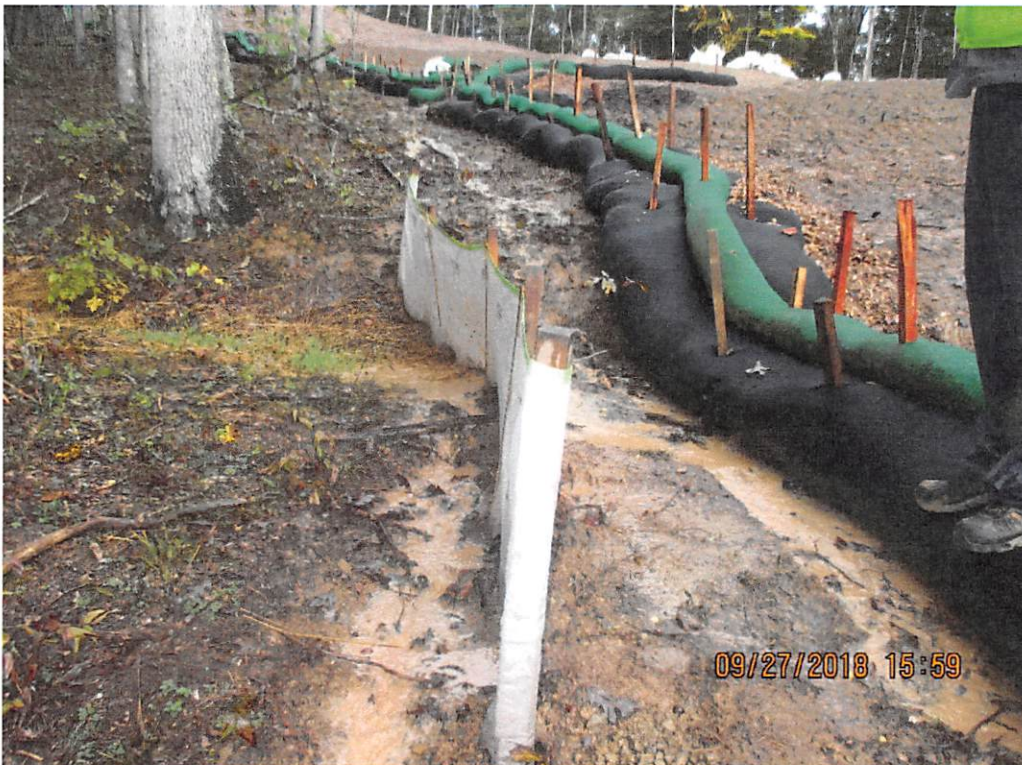
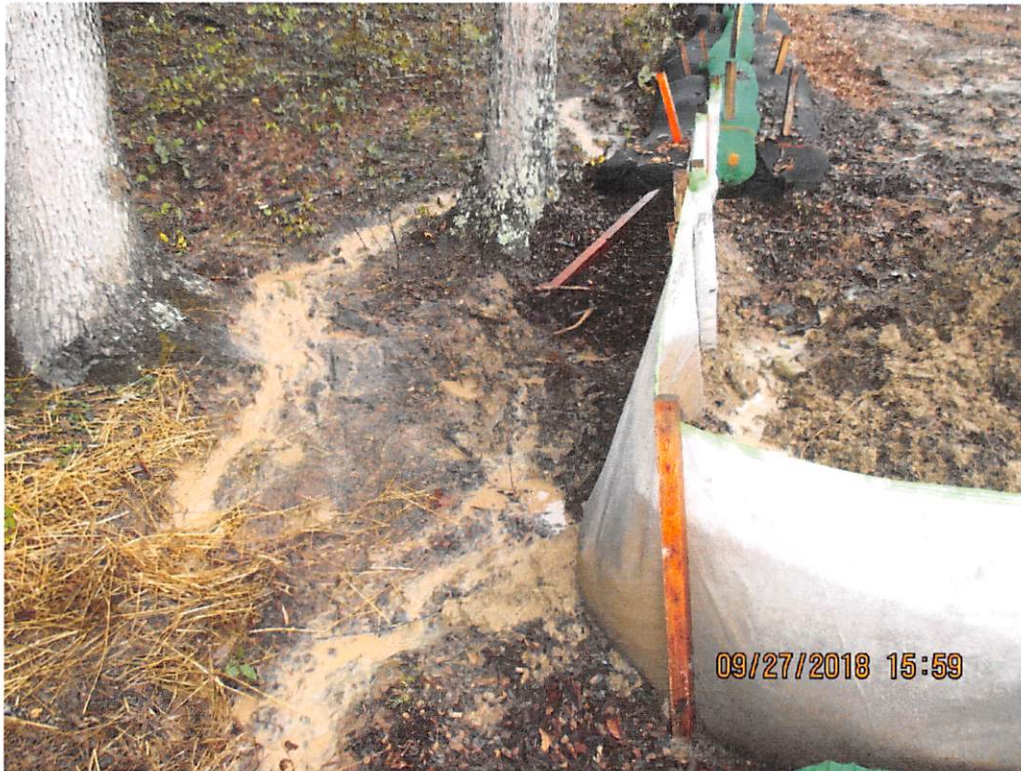
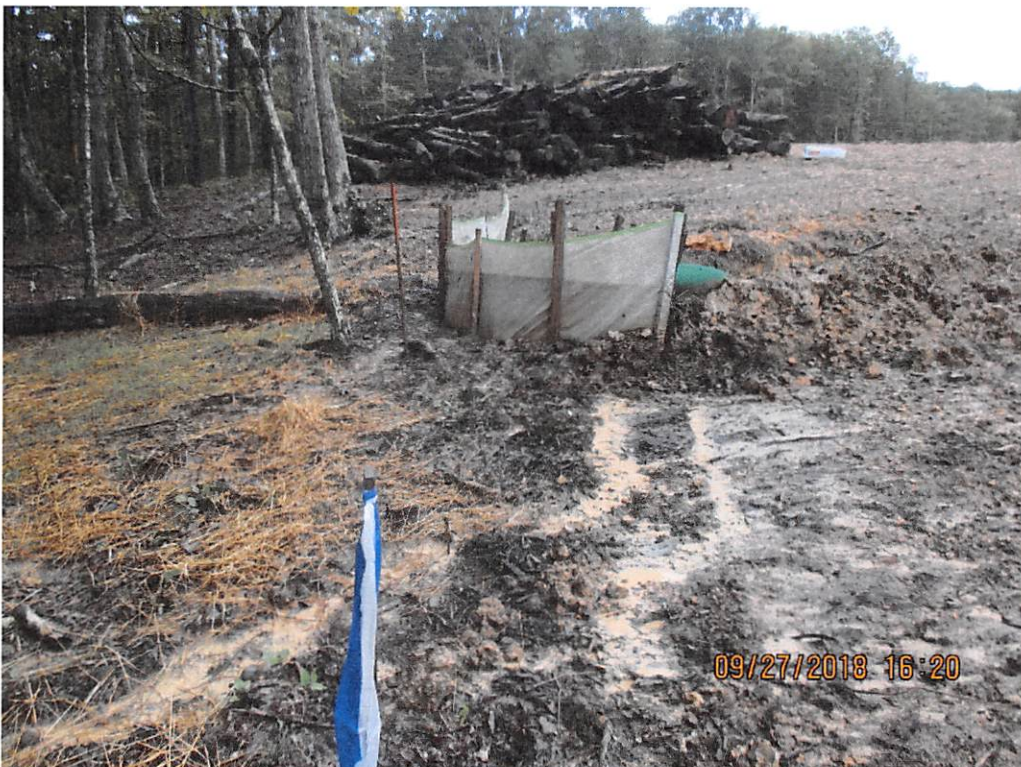
Areas near station number 9417+75 where water bar terminus being overwhelmed with sediment laden water.

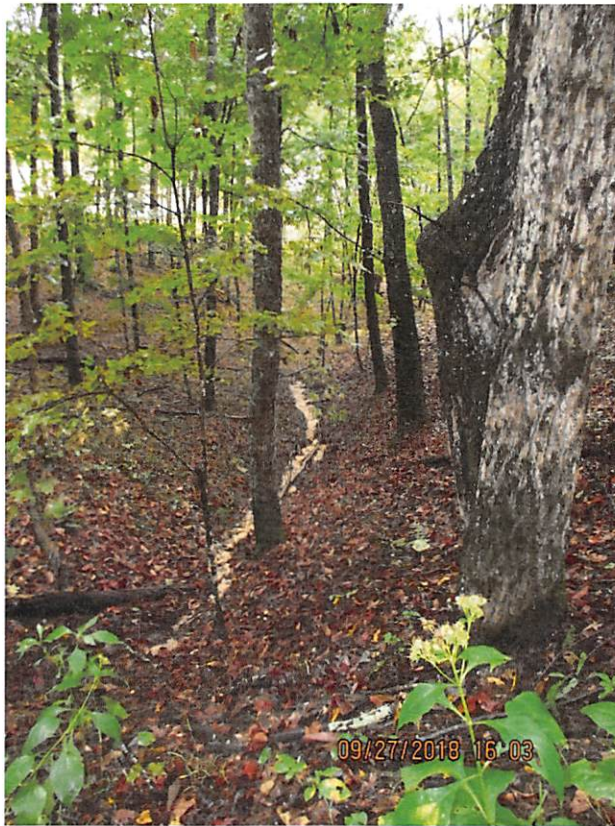
Main stem of ephemeral stream heading towards Stream S-A60 transporting sediment laden water into Indian Creek.

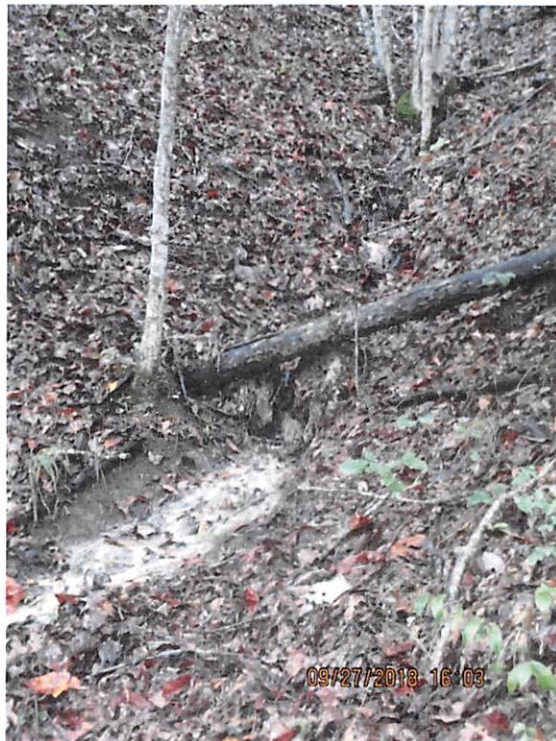
Standing on top of ridge looking down at spring seeping out of hillside transporting sediment laden water.

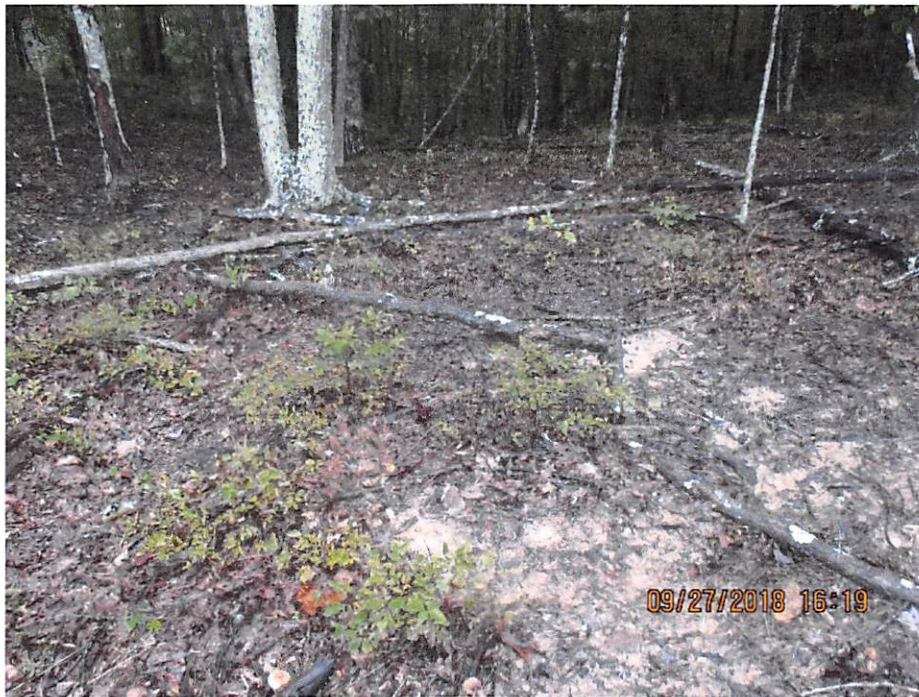
Spring/seep transporting sediment laden water.

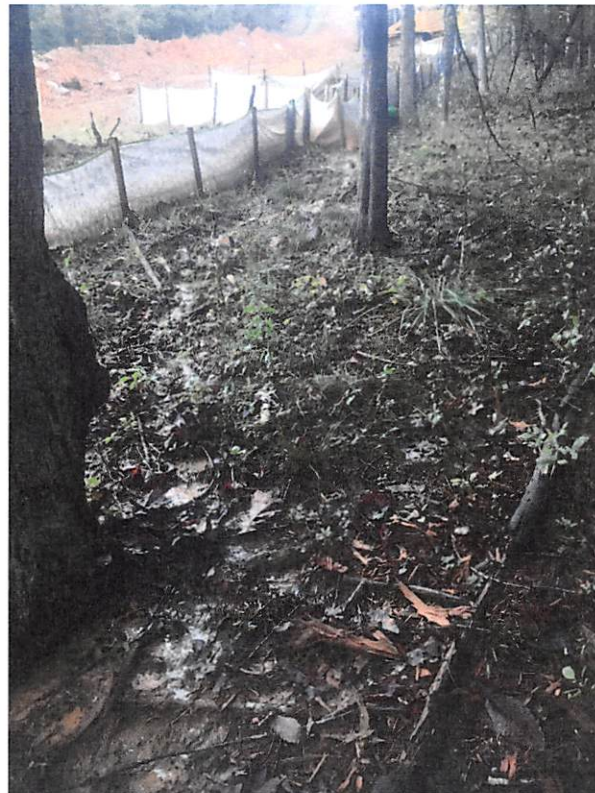
Area above spring/seep where off site sediment deposits were observed past LOD.

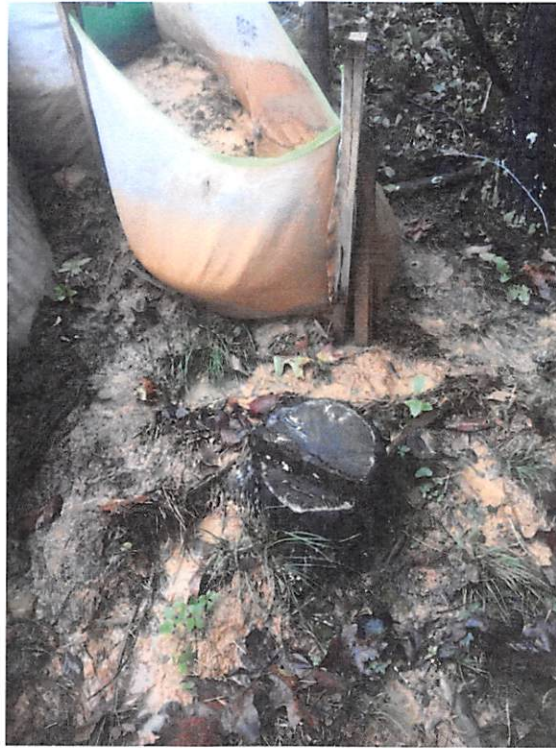
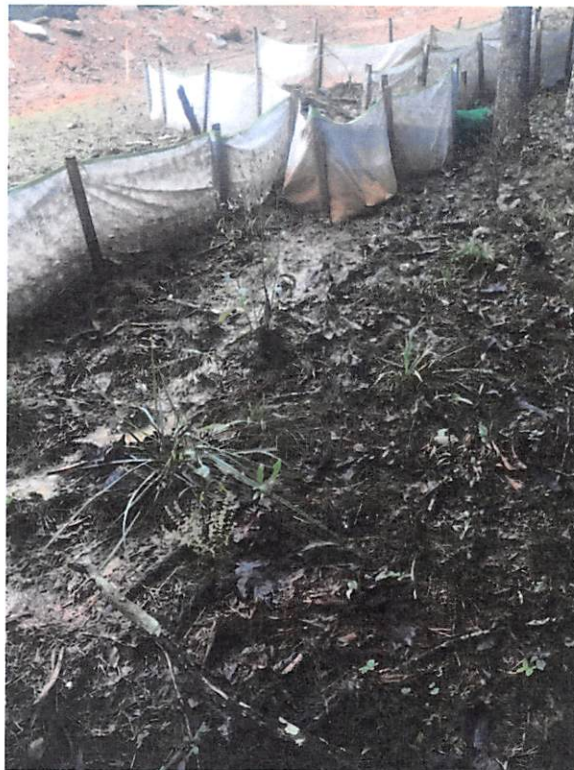
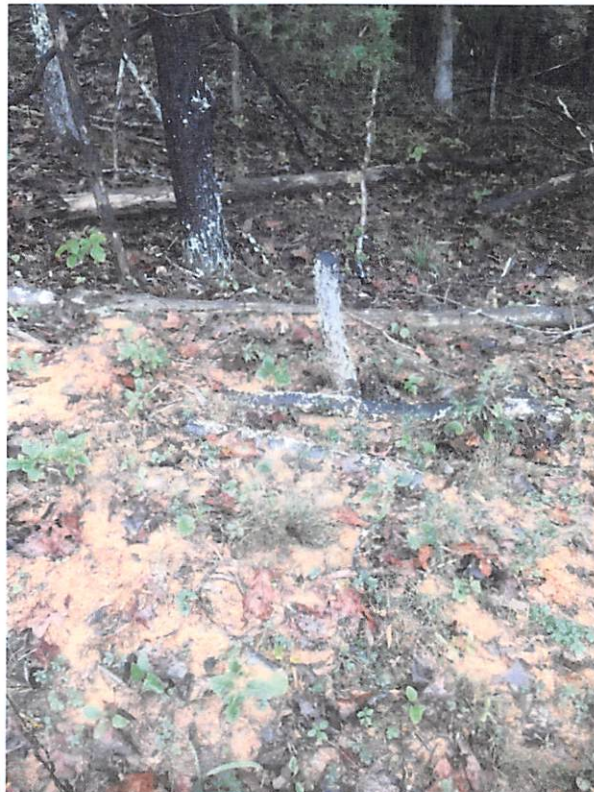
ROW near station numbers 9779+00 and 9778+00 where water bar outlets were being overwhelmed and sediment laden water was passing through and under and being transported past LOD.

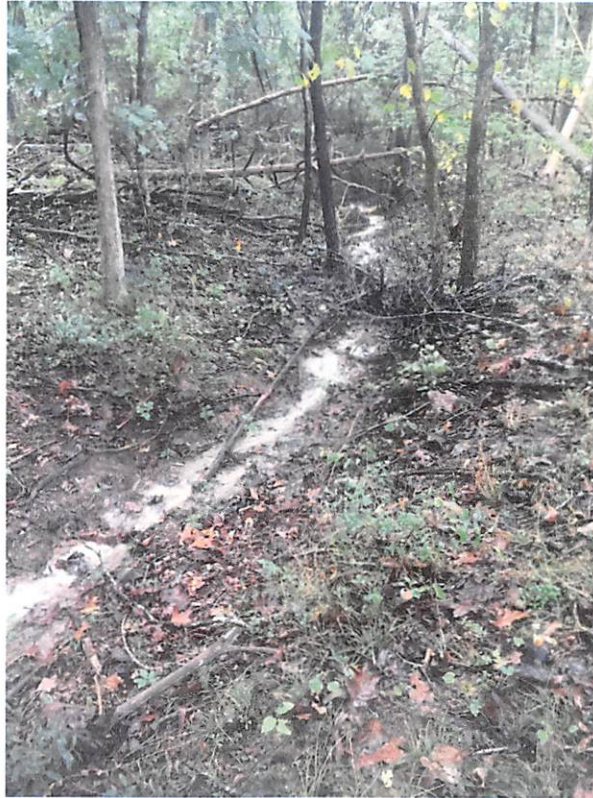
Off-site sediment deposits near station number 9779+00.
