**CONSENT ORDER  
ISSUED UNDER THE  
WATER POLLUTION CONTROL ACT  
WEST VIRGINIA CODE, CHAPTER 22, ARTICLE 11**

TO: Mountain Valley Pipeline, LLC

DATE: April 19, 2019

ORDER NO.: 8951

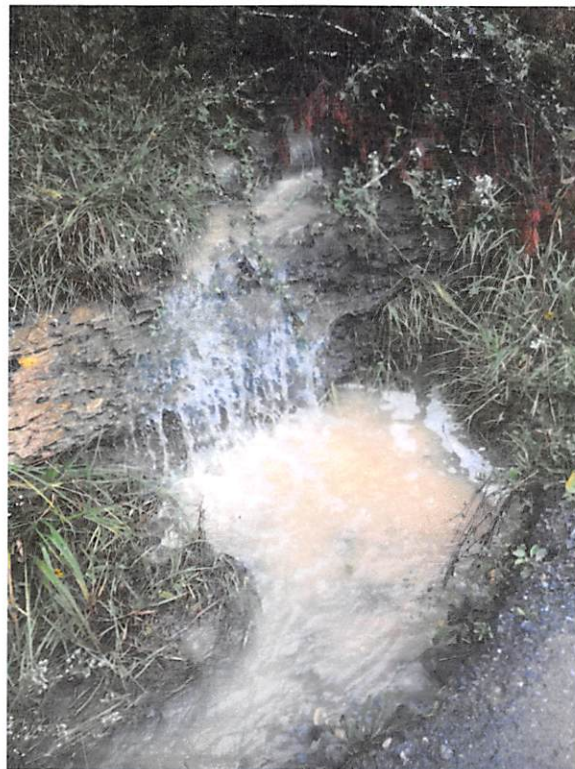
Ephemeral stream near Station #9778+00 being impacted by sediment laden water and flowing downhill and entering roadside ditch at Ellison ridge road.

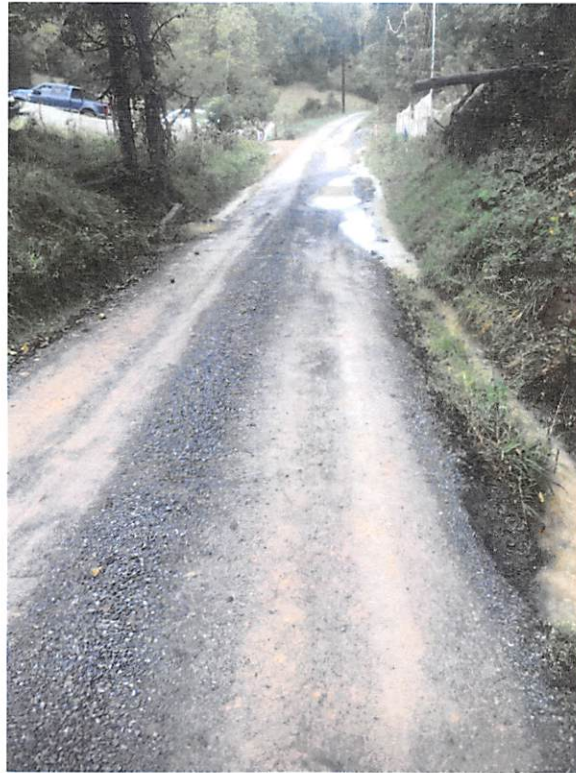
Ephemeral stream discharging into roadside ditch along Ellison Ridge Road.

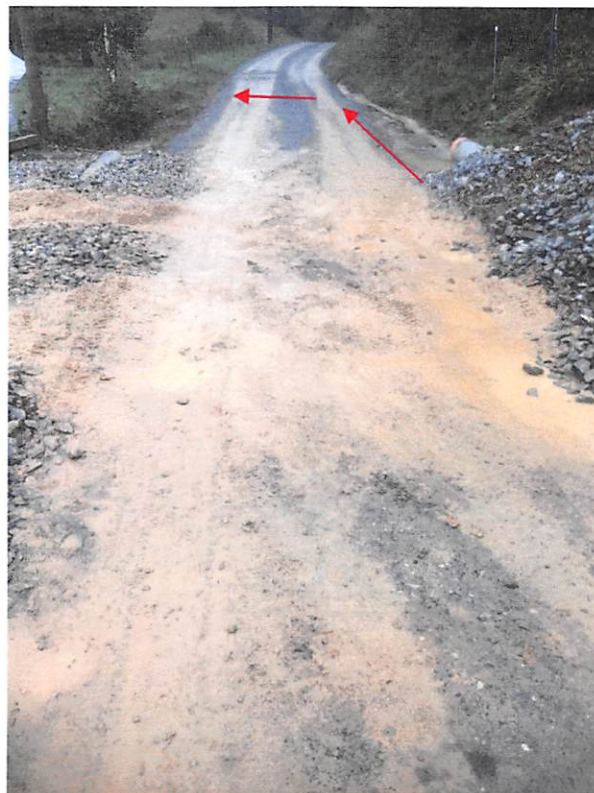
Photo looking down Ellison ridge road towards culverted stream crossings S-Z5 and S-Z4.

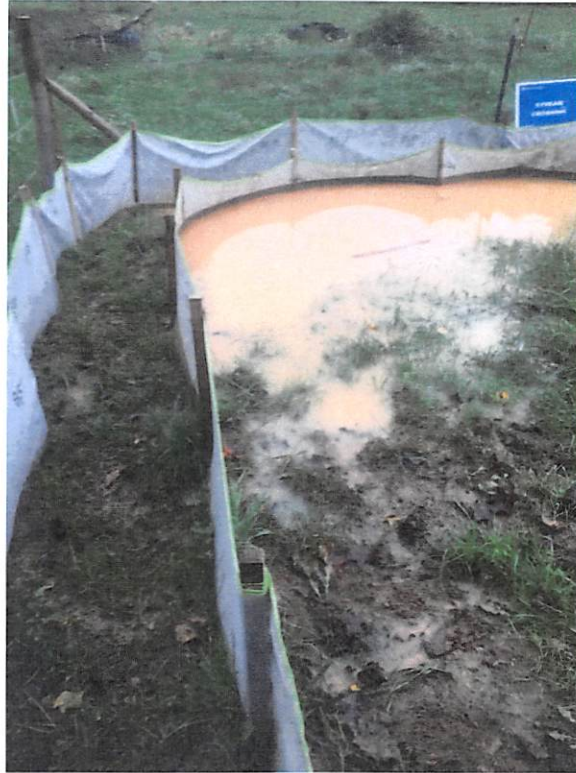
Sediment laden water flowing through culverted stream crossing and under road through culvert and into stream on other side of Ellison ridge road. Mud also present on road.

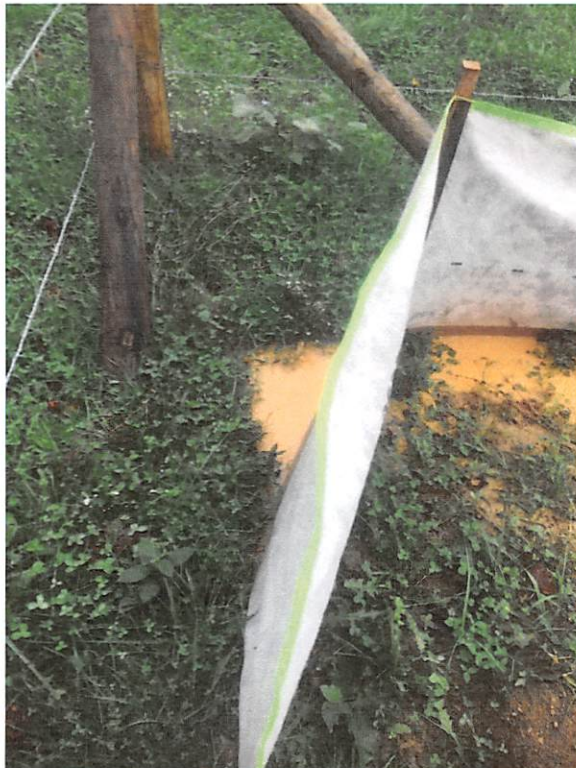
Area on south side of Ellison ridge road and ROW near station number 9784+00.

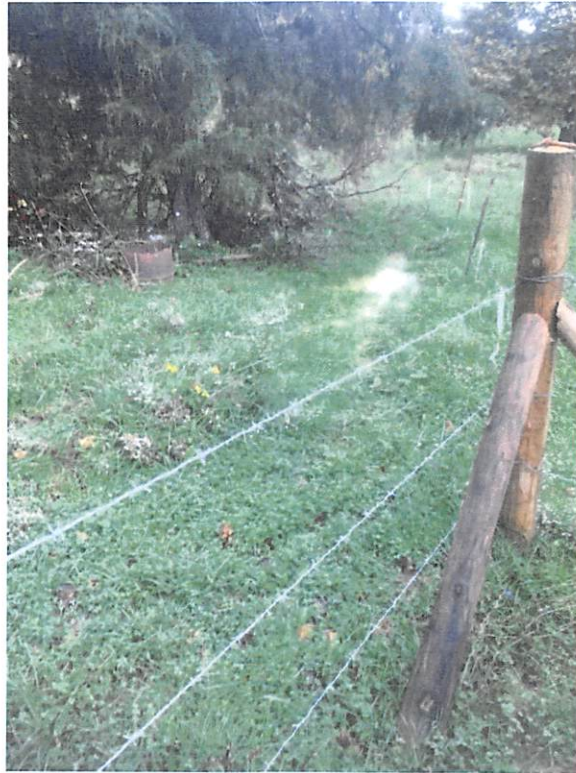
Sediment laden water flowing under and through BMP near station number 9784+00.

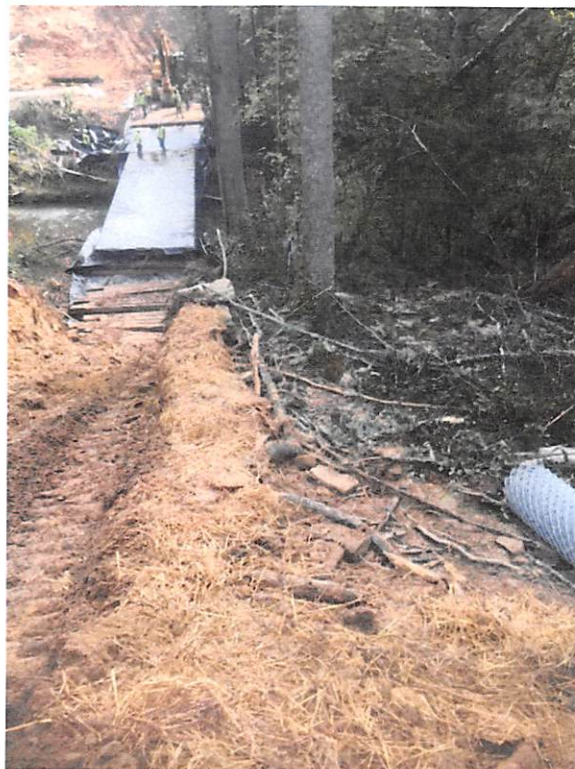
Sediment laden water infiltrating past LOD and seeping into wetland (W-22) and entering stream (S-Z3) near station number 9784+00.

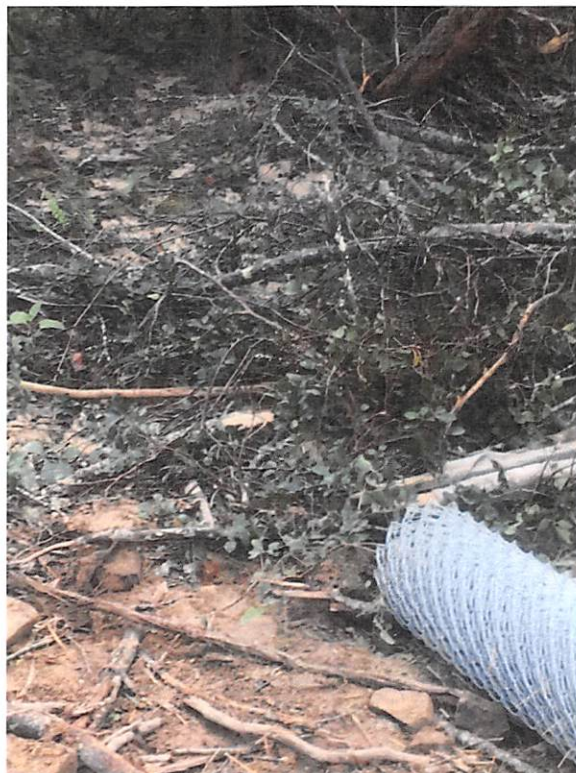
Facing Hans Creek near Station #9907+00. Super Silt fence located next to chain link had failed and sediment deposits were observed migrating towards Hans Creek.

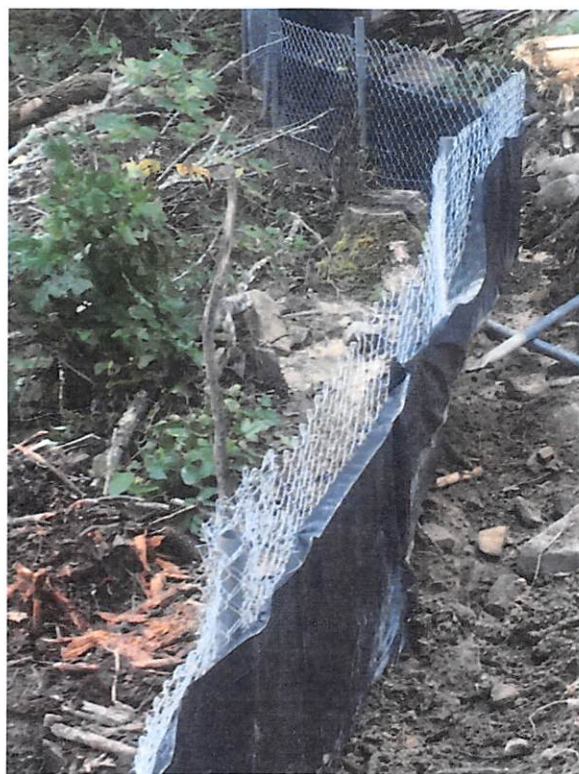
Close up of sediment that has been deposited past BMP.

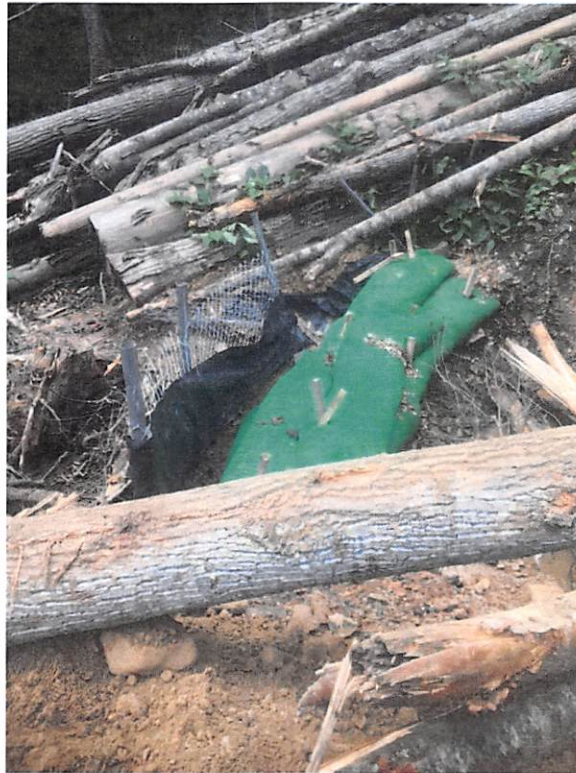
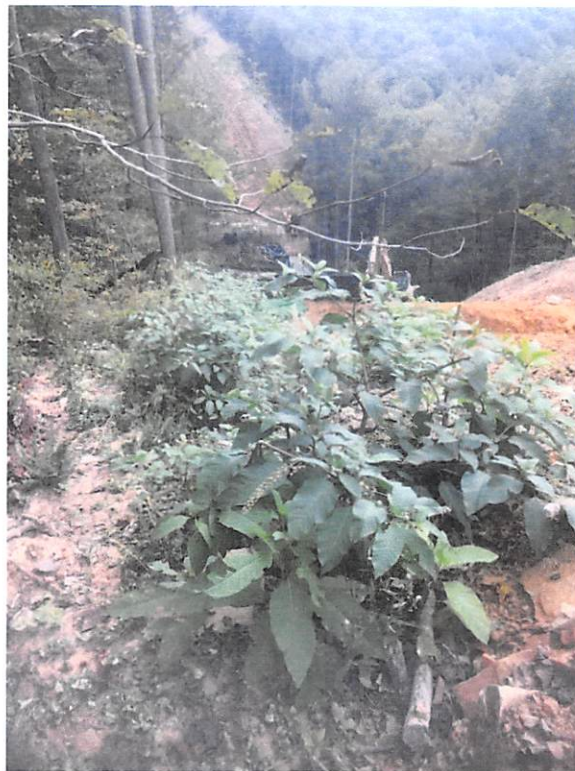
Area near station number 9907+00. Super silt fence had been undermined and damaged by logs.

Area near station number 9907+00. Super silt fence had been undermined and damaged by logs

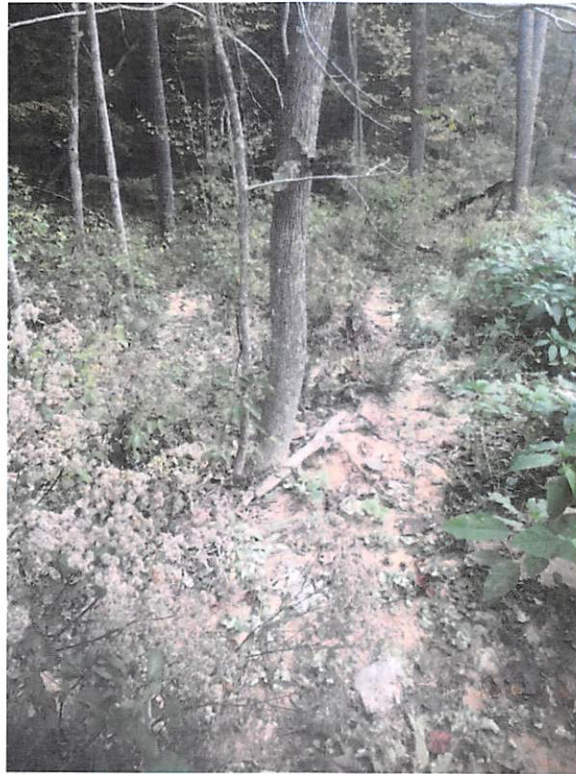
Near Station # 9911+00 where BMP was being overwhelmed and off-site sediment deposits were observed.

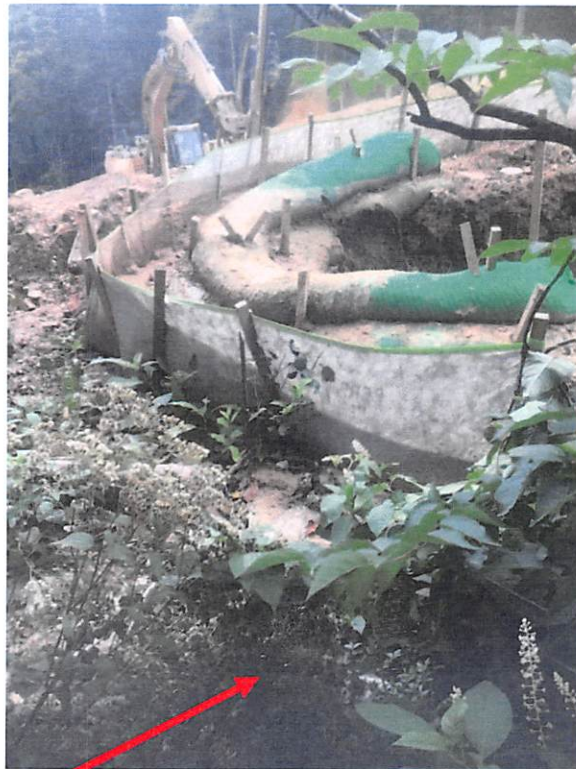
Off-site sediment deposits near station #9911+00.

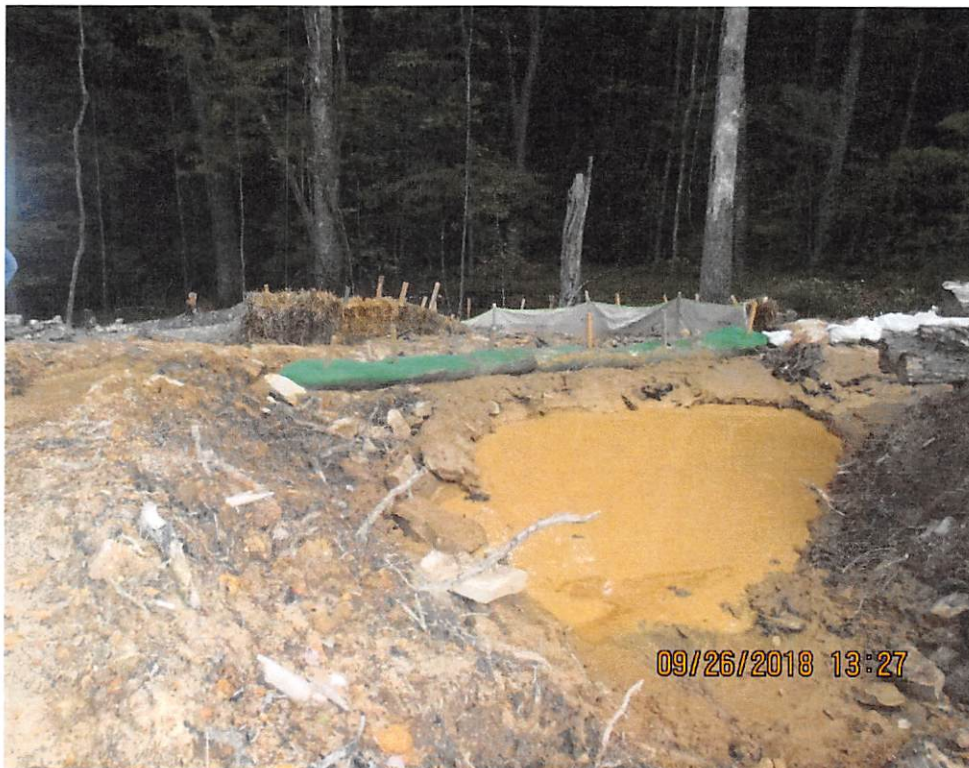
Area of ROW near Station #9897+00 looking towards Hans Creek drainage.

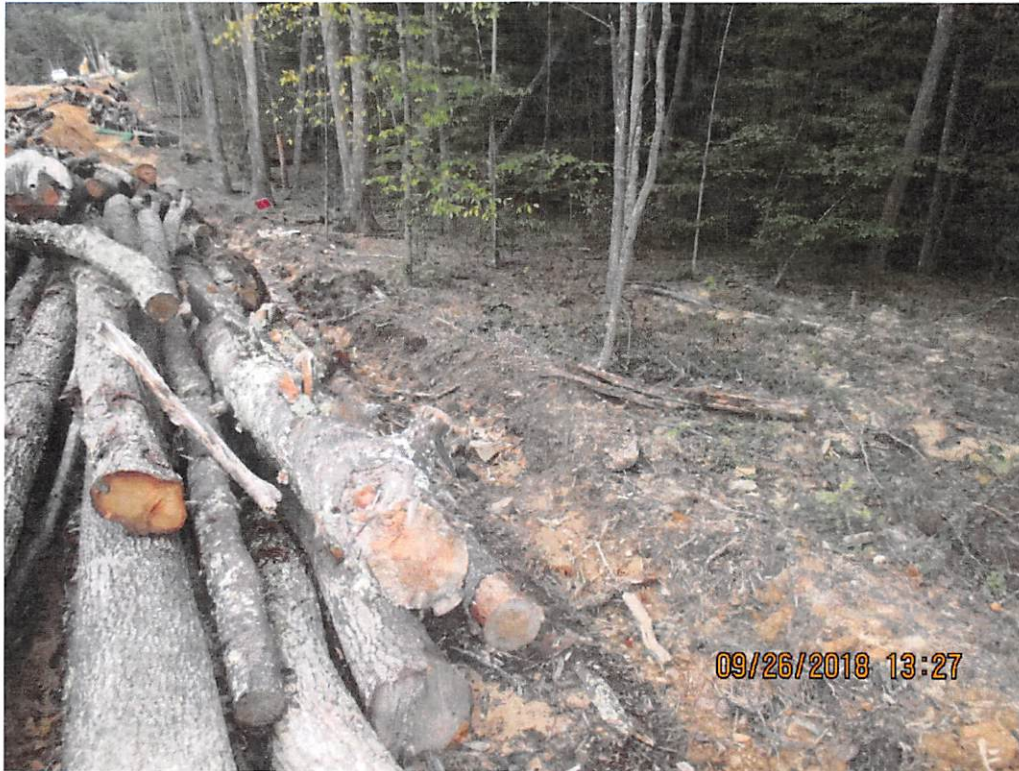
Waterbar terminus near being overwhelmed near Station #9899+00.

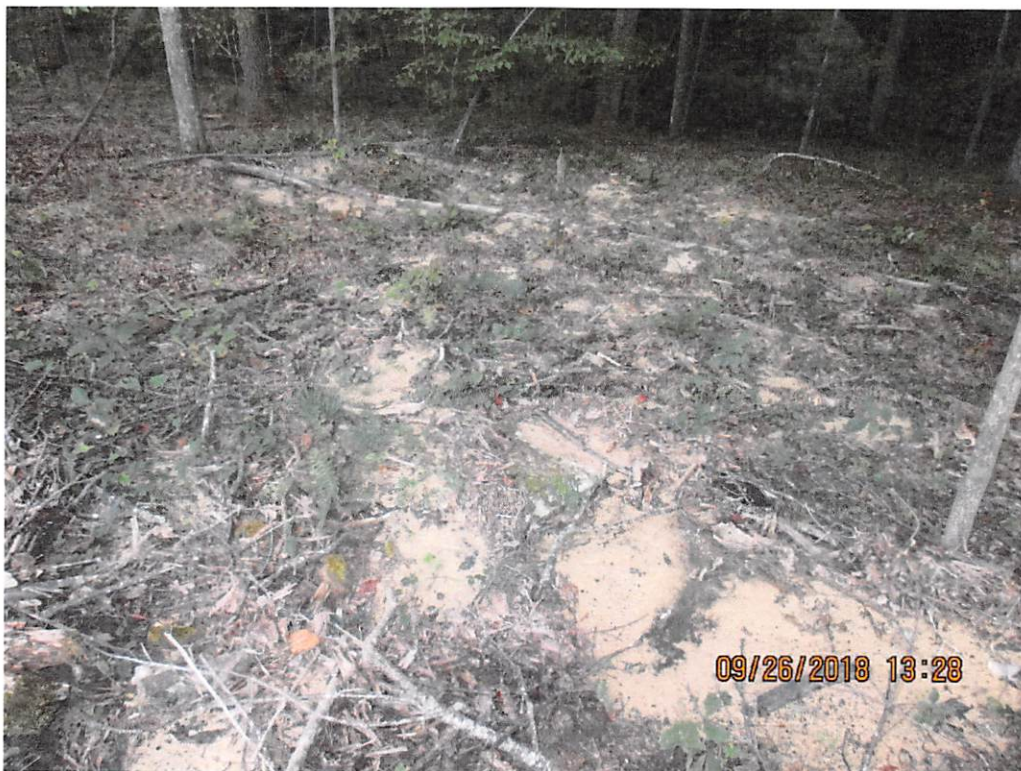
Off-site sediment deposits near Station number 9899+00.

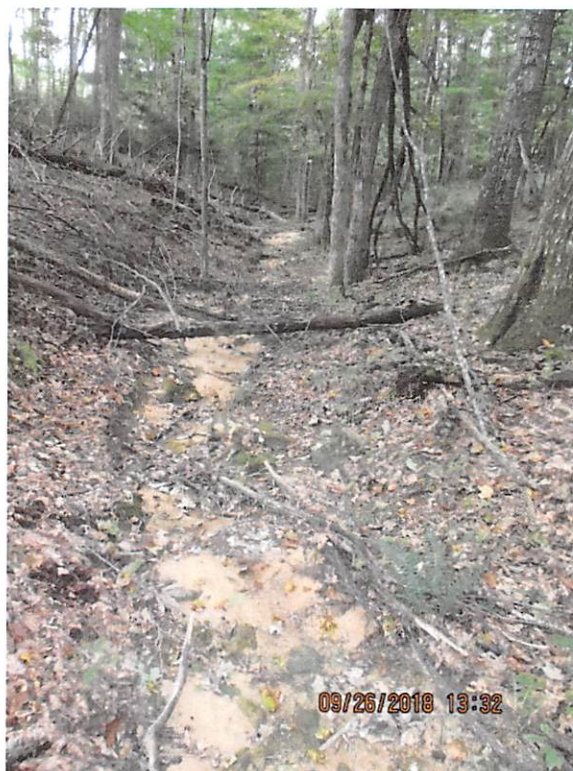
Arrow depicts where BMP was being undermined near Station number 9899+00.

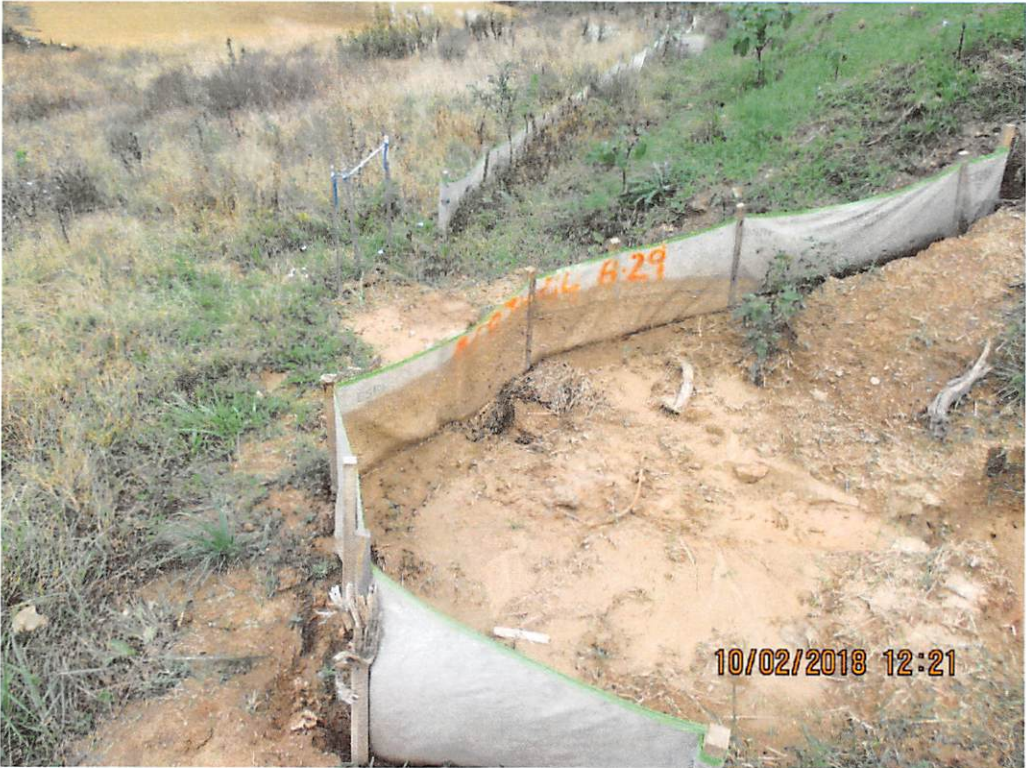
ROW near station #9687 where BMP is failing.

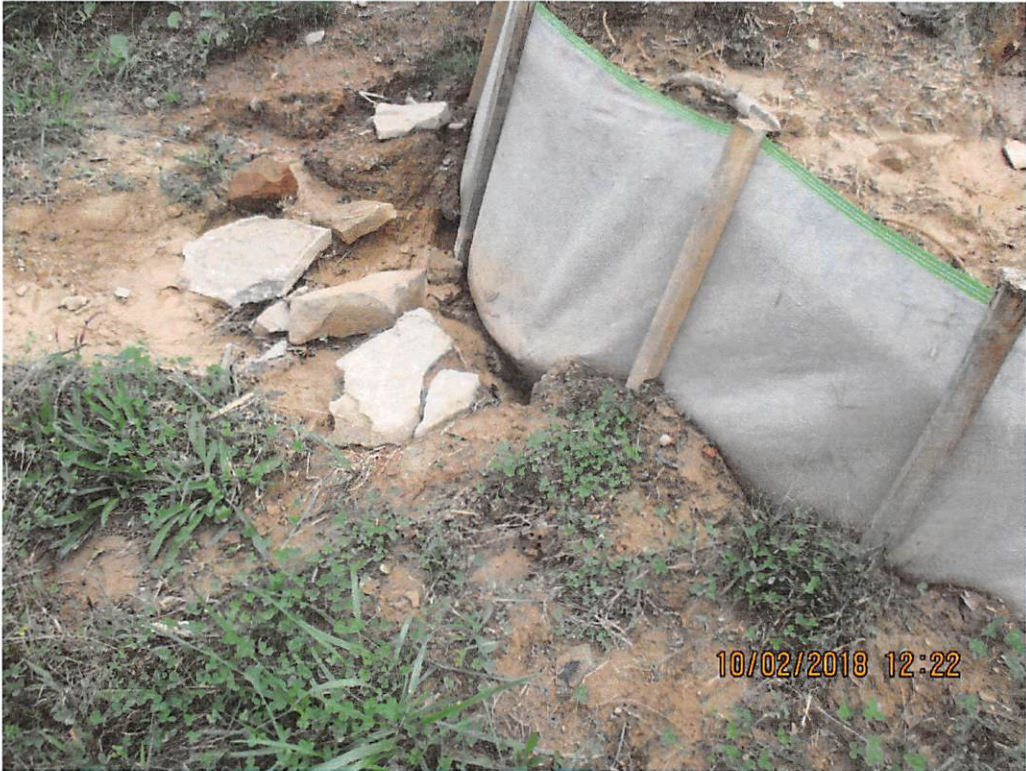
Off site sediment deposits past BMP near station number 9687.

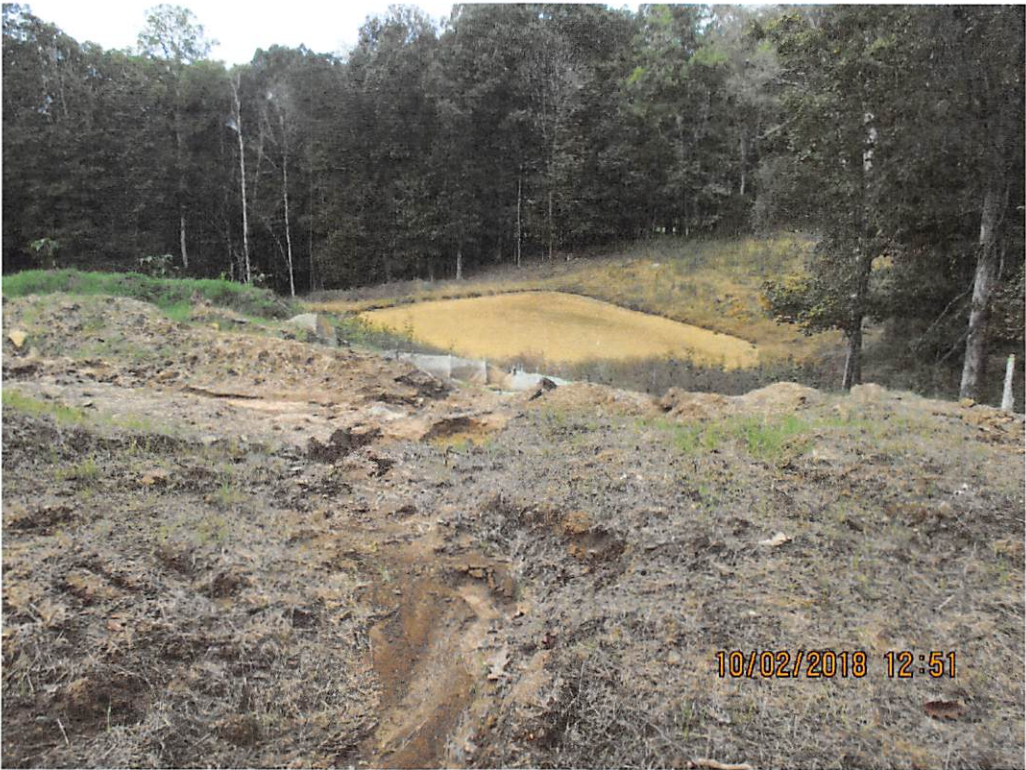
Above mentioned BMP being undercut from run-off.

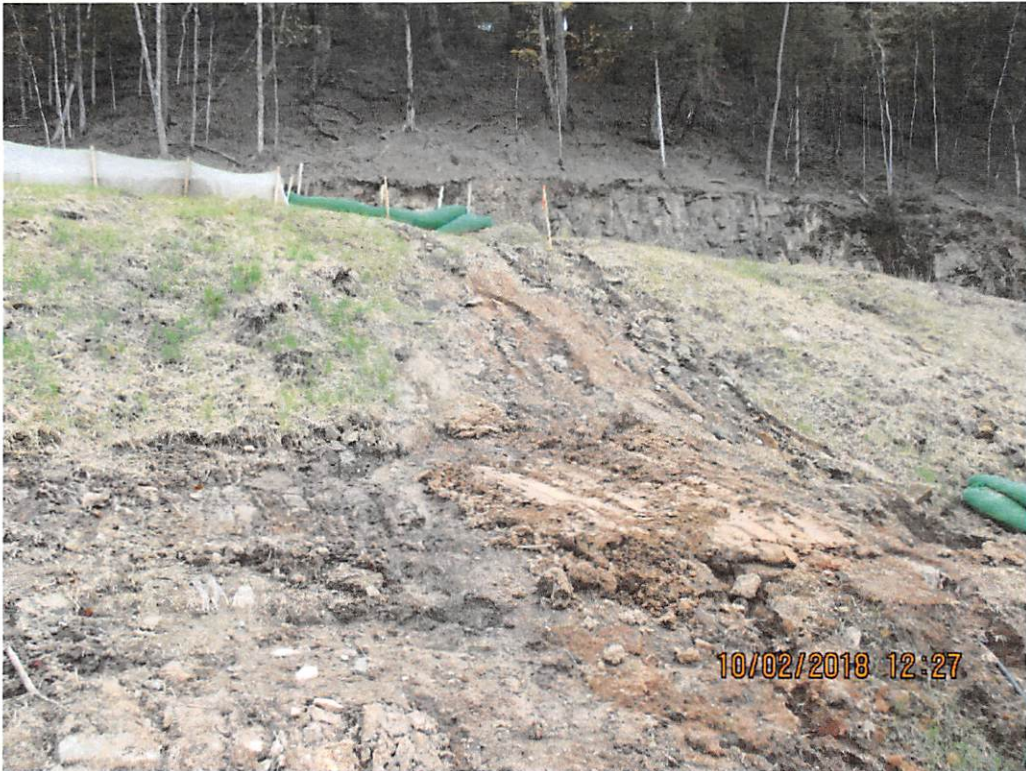
Un-stabilized channel flowing towards above mentioned BMP at station #9687.

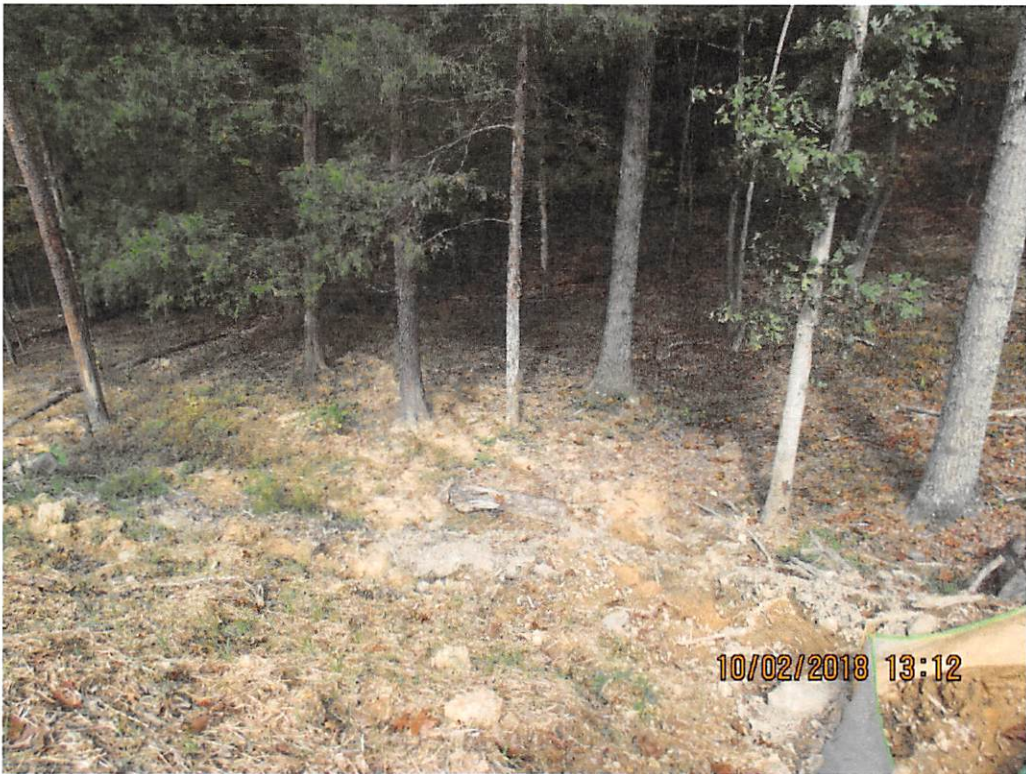
BMP outlet being overwhelmed near station number 9717+52.

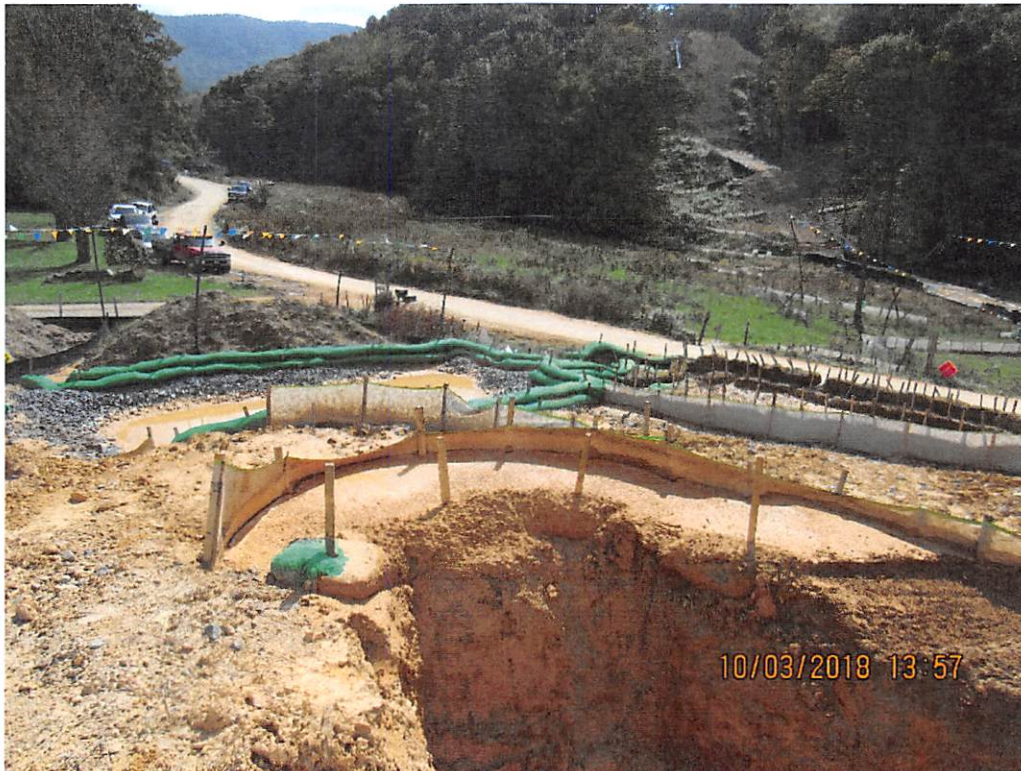
Photo 2: Excessive sediment in sumps after maintenance performed at Painter's Run station 10270.

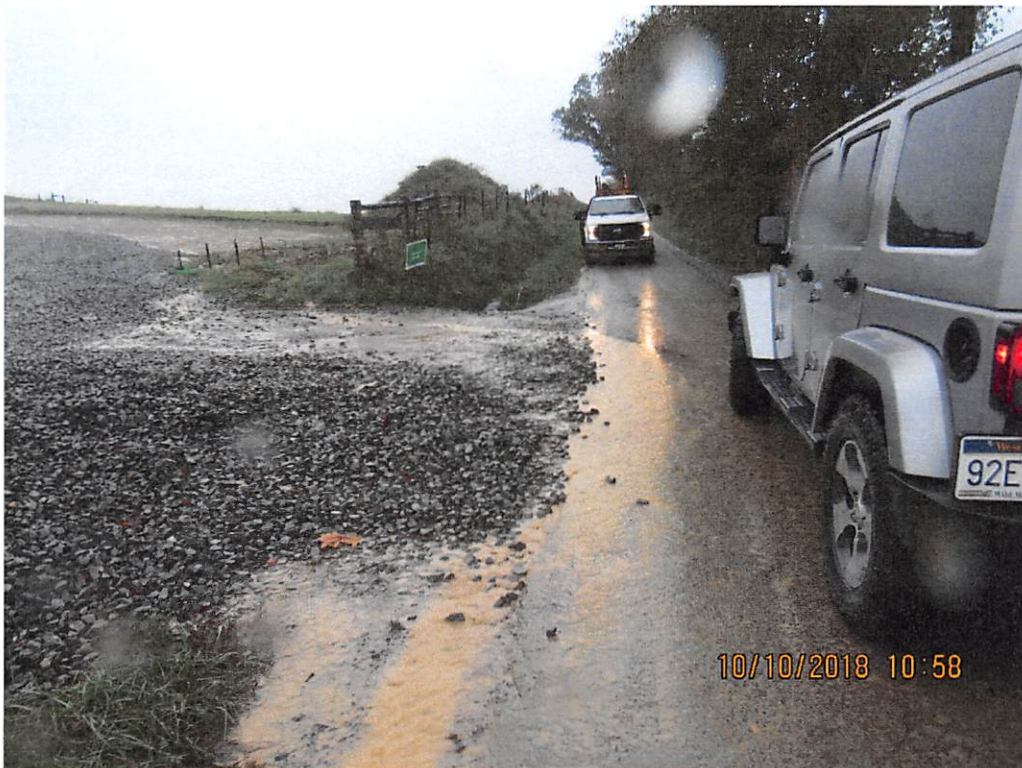
Photo 1: AR 210- sediment laden water leaving site.

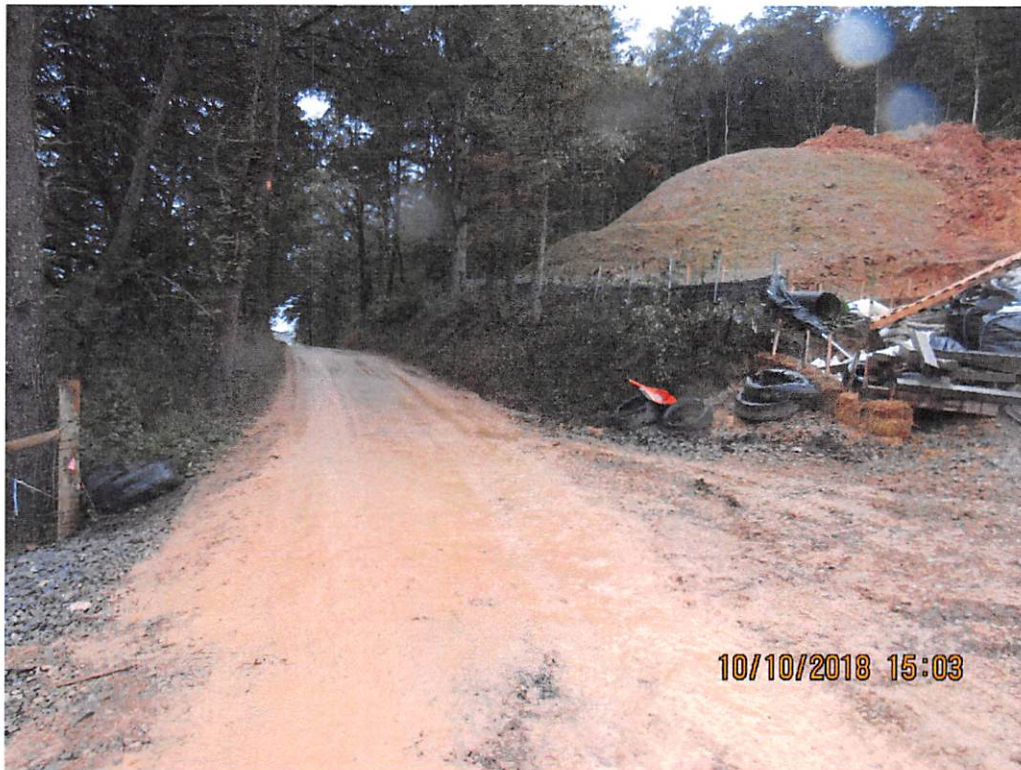
Photo 3: AR 210 sediment laden water crossing county road- down gradient view.

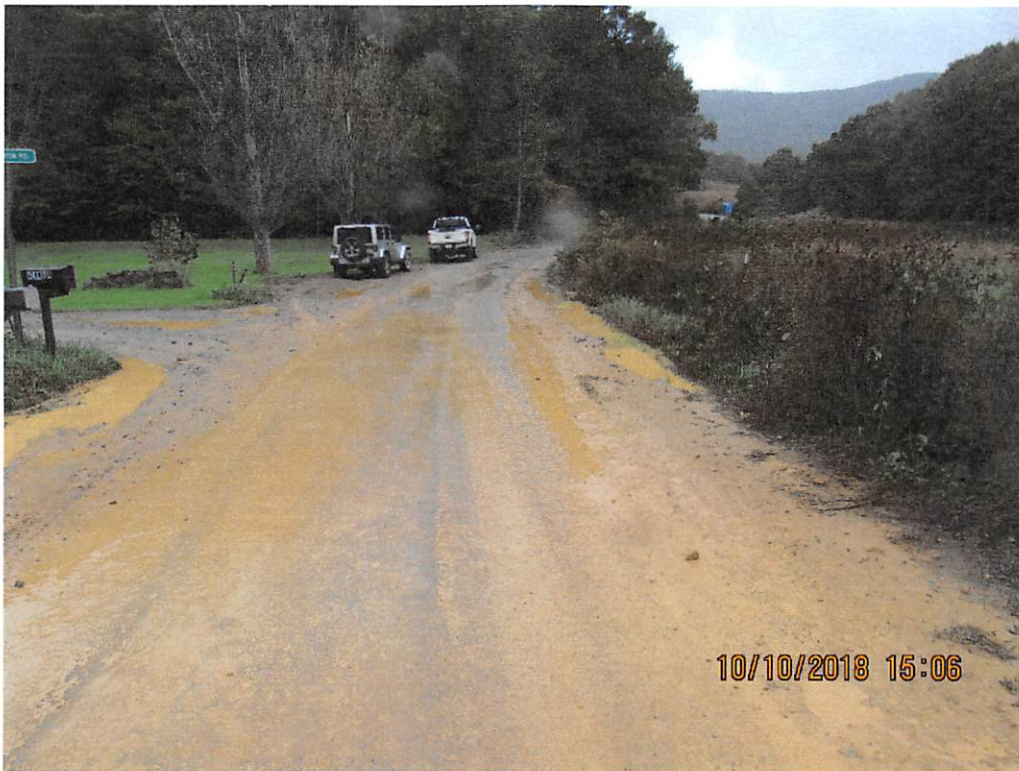
Photo 5: Painter's Run Road station 10270 upgradient of access road crossing.

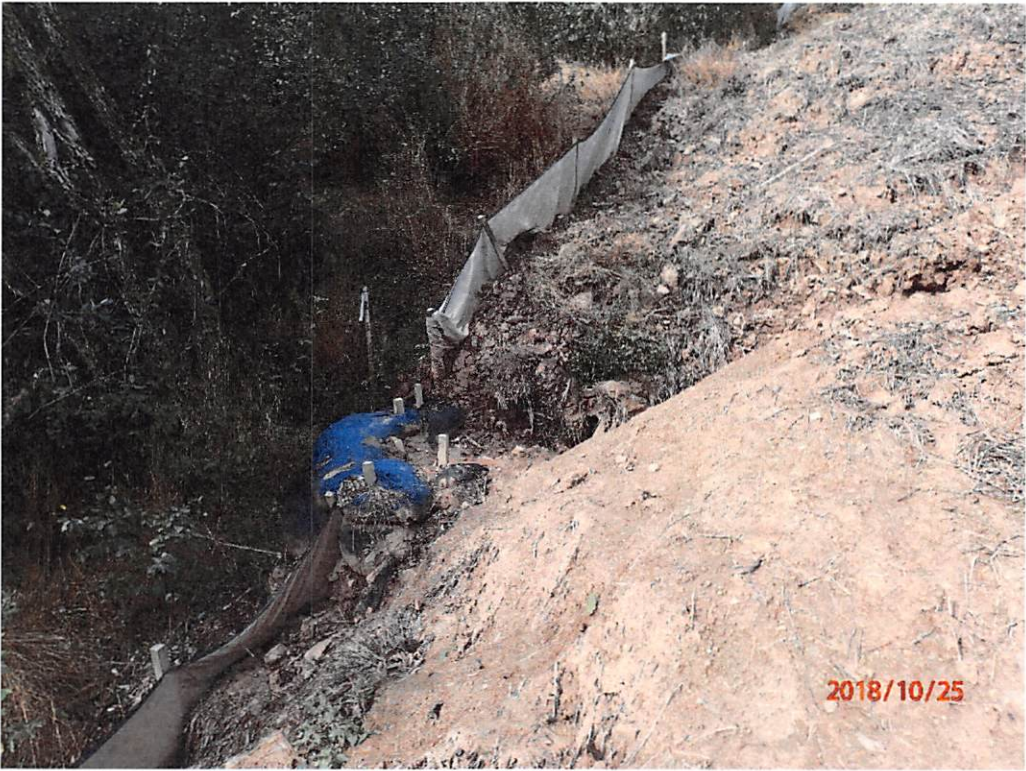
Overwhelmed sump near Sams Run.

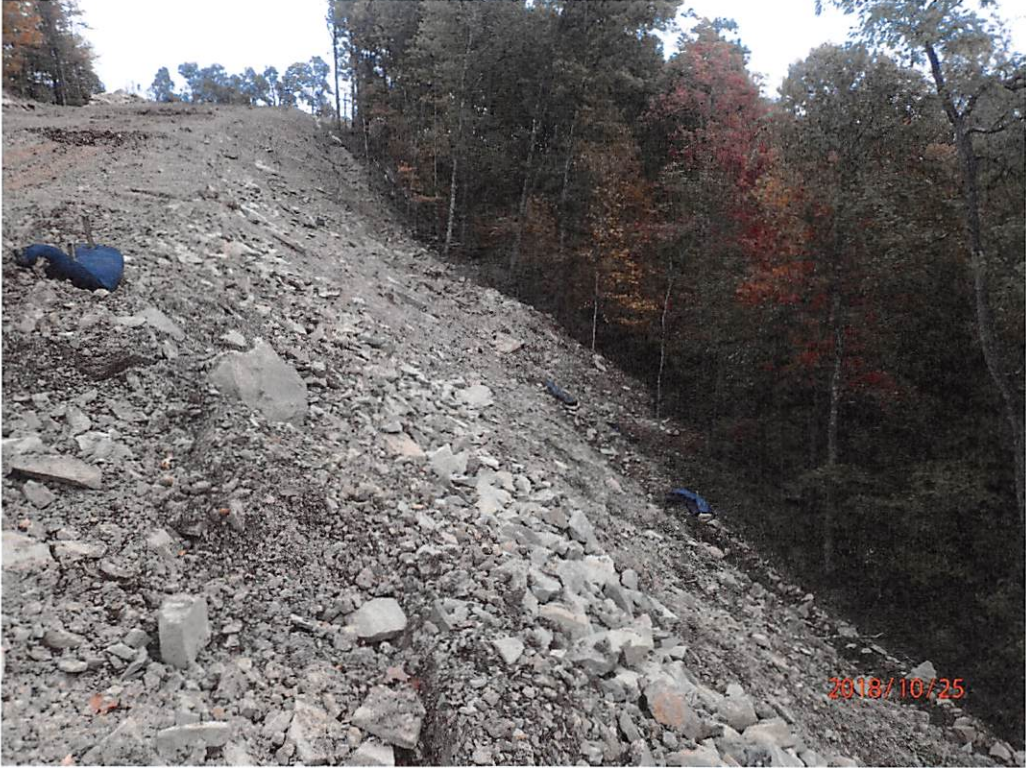
Damaged waterbar directly N of Sams Run.

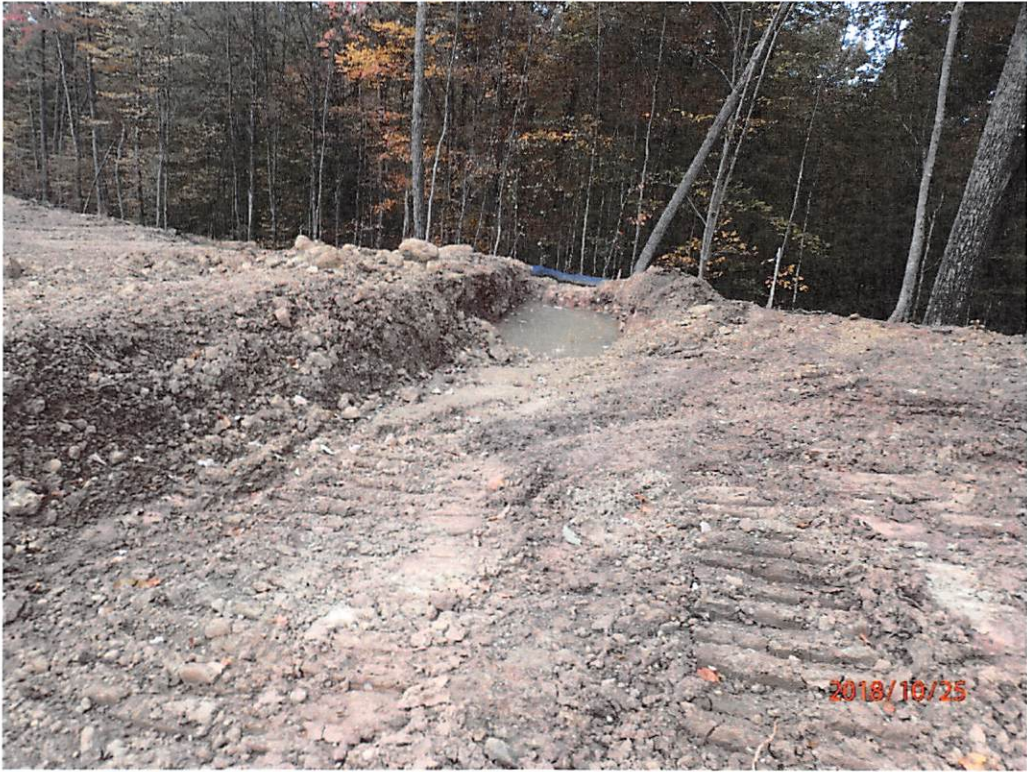
Slip at station 493 had entered the ditchline from a sideslope allowing sediment to leave the project ROW.

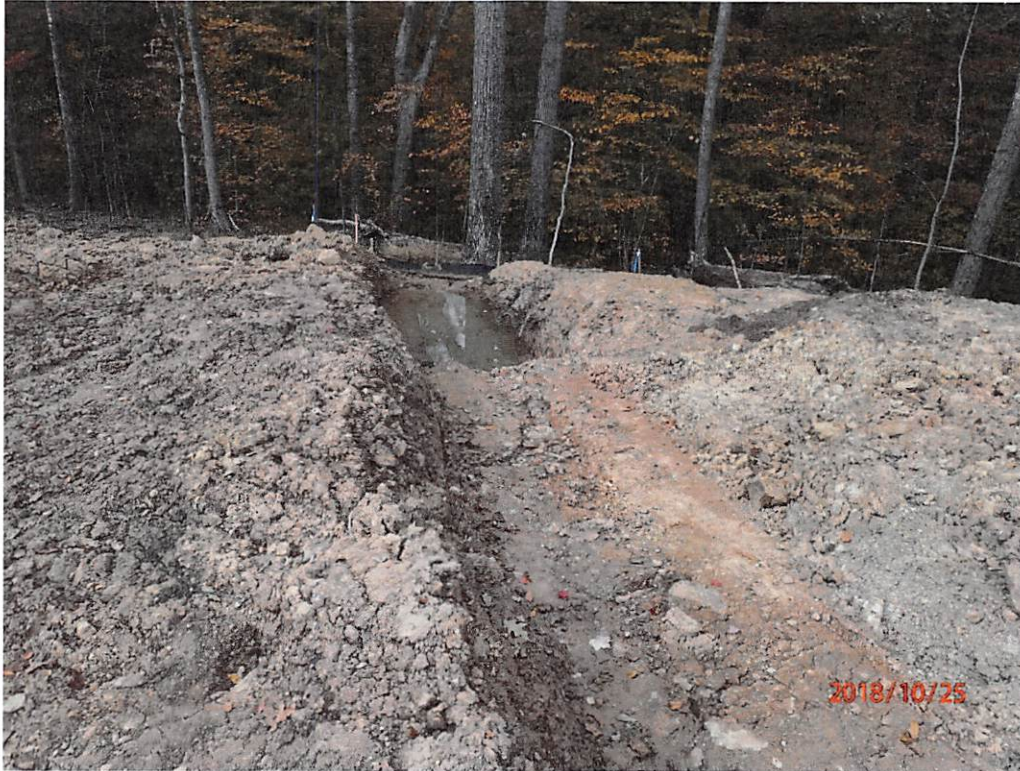
Sump at Station 286 in need of maintenance.

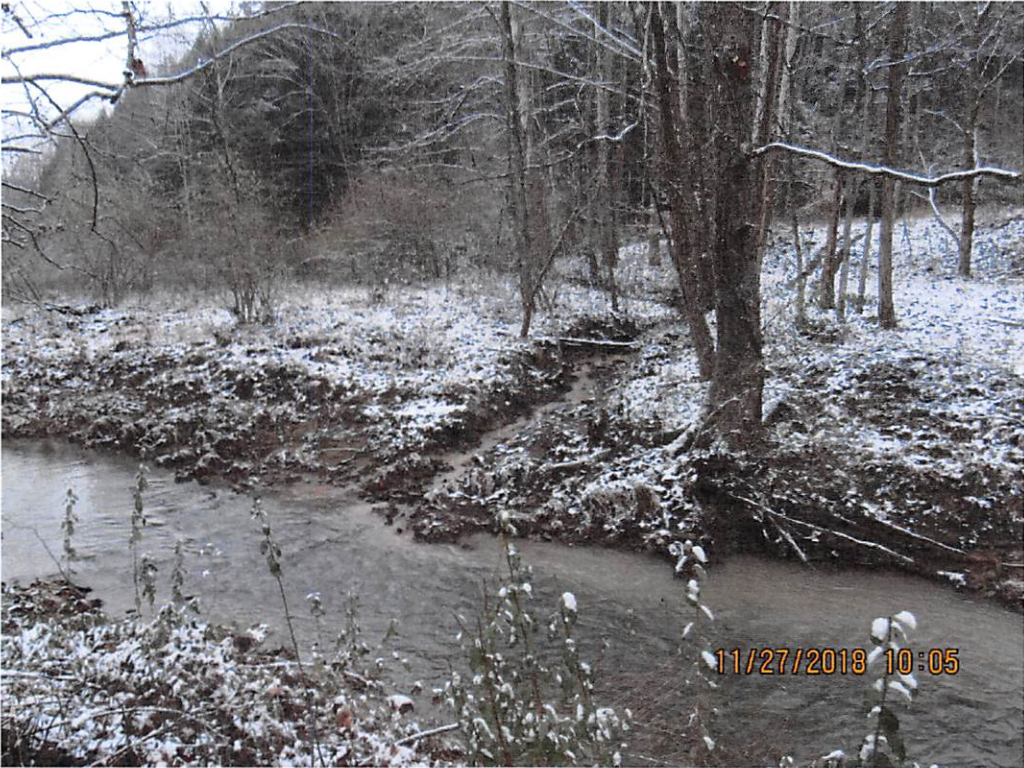
Downstream view of Knawl's Creek at location of convergence of UNT.

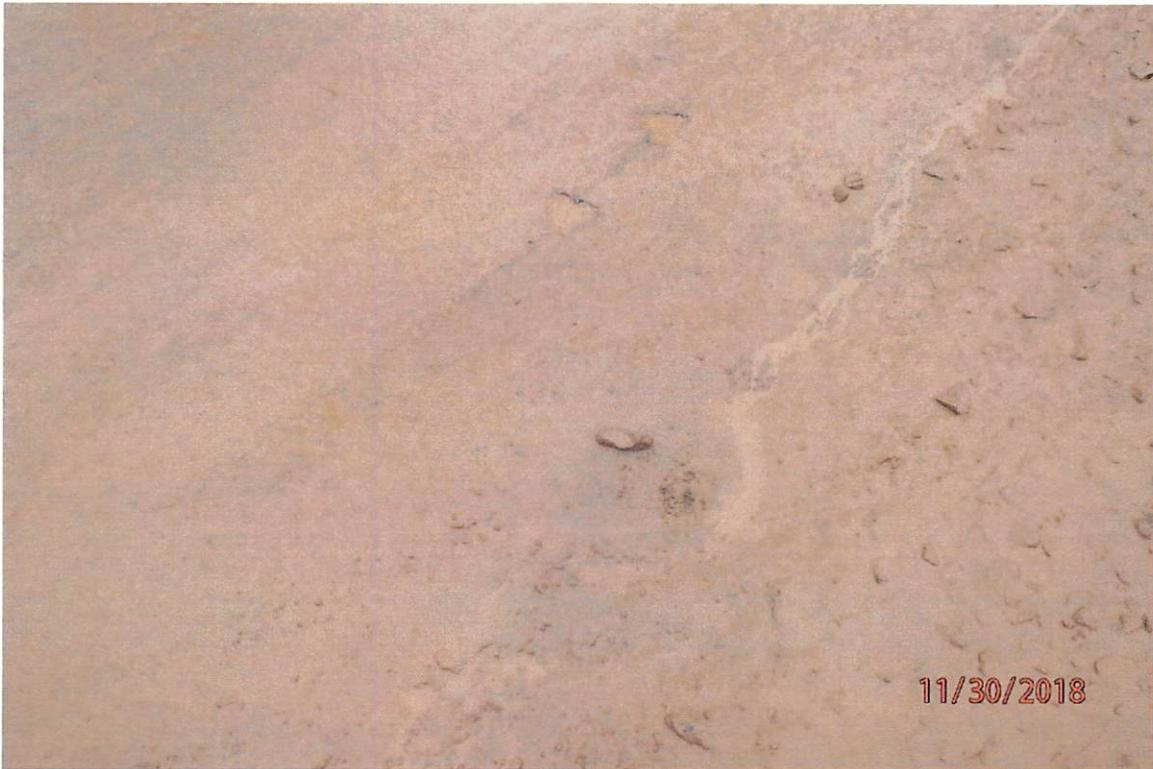
Slightly downstream of convergence point into Knawl's Creek below release point.

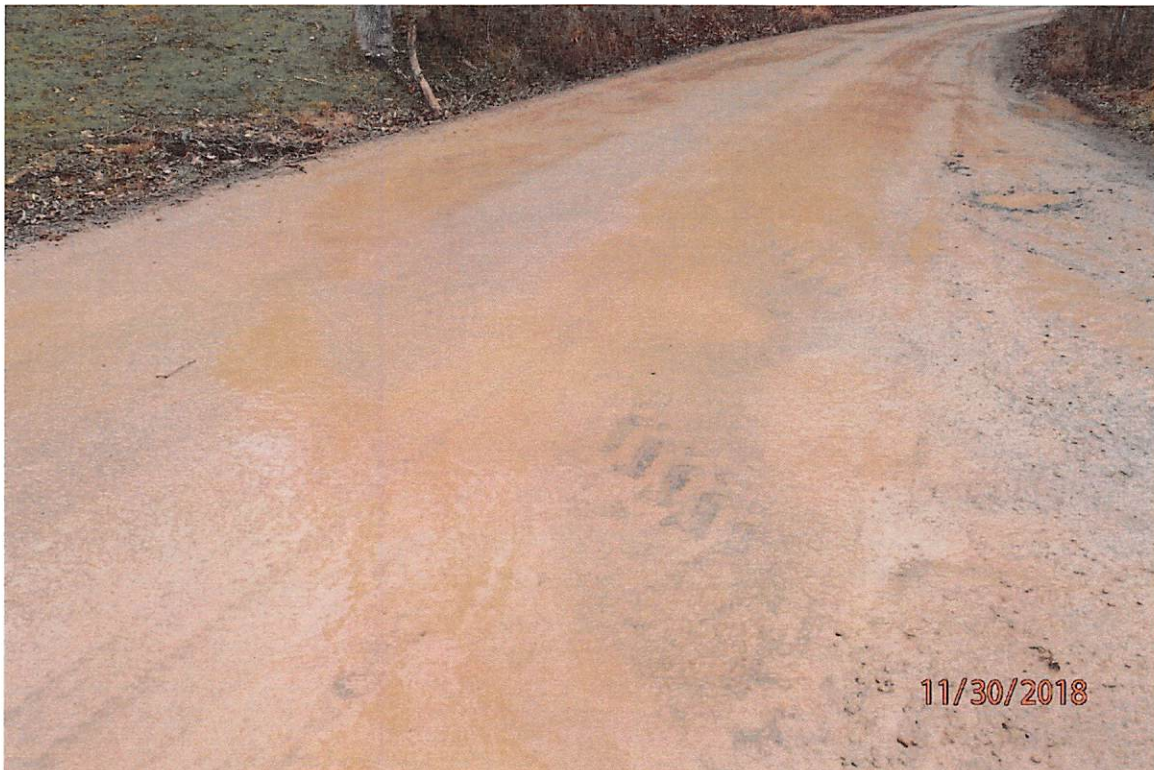
Access Road WV-HA - 29.04 off CR 50/5 showing the lack of an adequately stable construction entrance and the associated track out onto the public road.

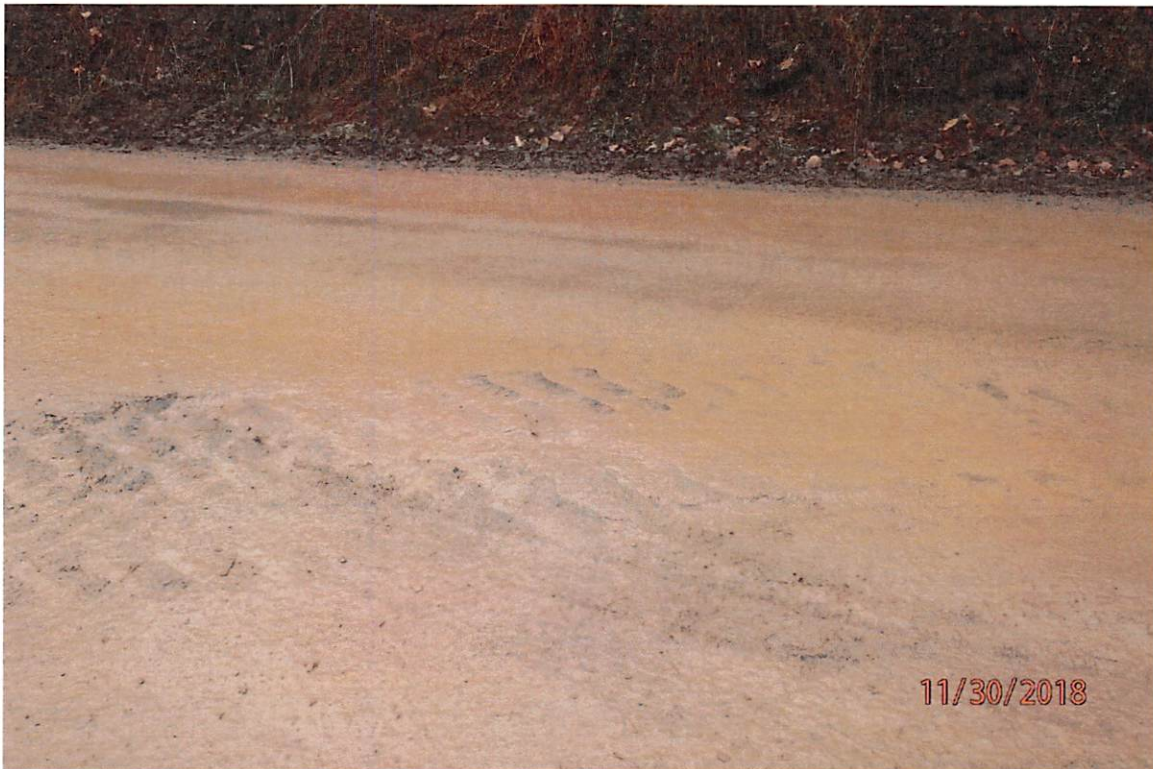
Access Road WV-HA - 29.5 off CR 50/5 showing the lack of an adequately stable construction entrance and the associated track out onto the public road.
