**CONSENT ORDER  
ISSUED UNDER THE  
WATER POLLUTION CONTROL ACT  
WEST VIRGINIA CODE, CHAPTER 22, ARTICLE 11**

TO: Mountain Valley Pipeline, LLC

DATE: April 19, 2019

ORDER NO.: 8951

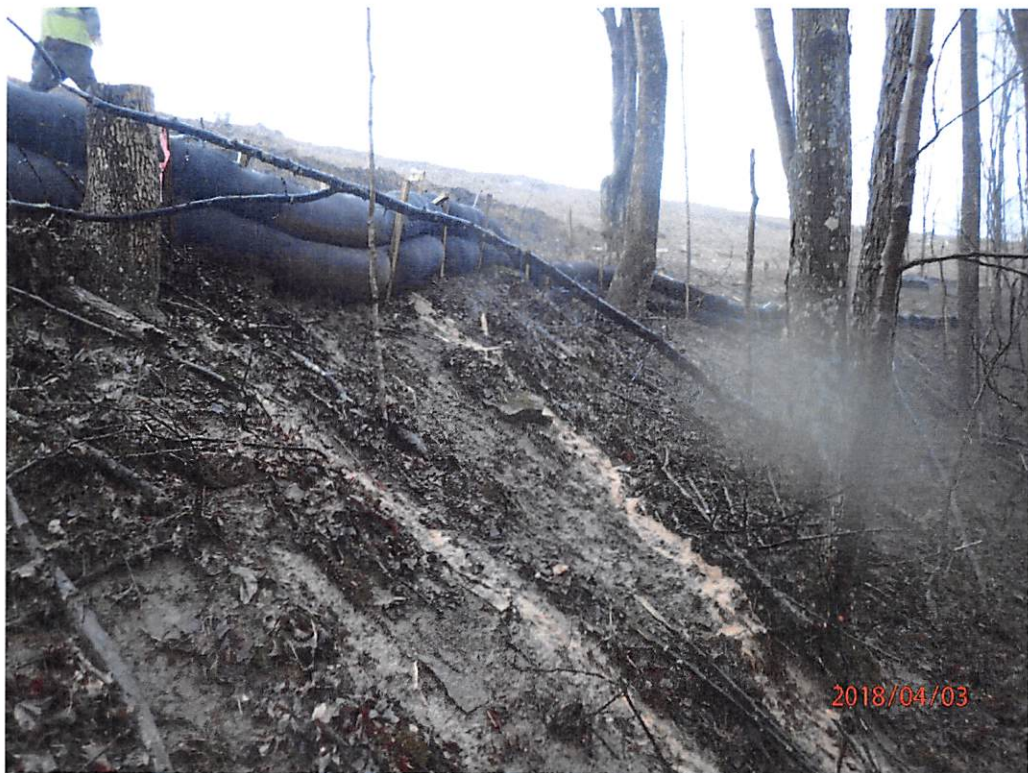
Sediment laden water leaving site at Bradshaw Compressor Station.

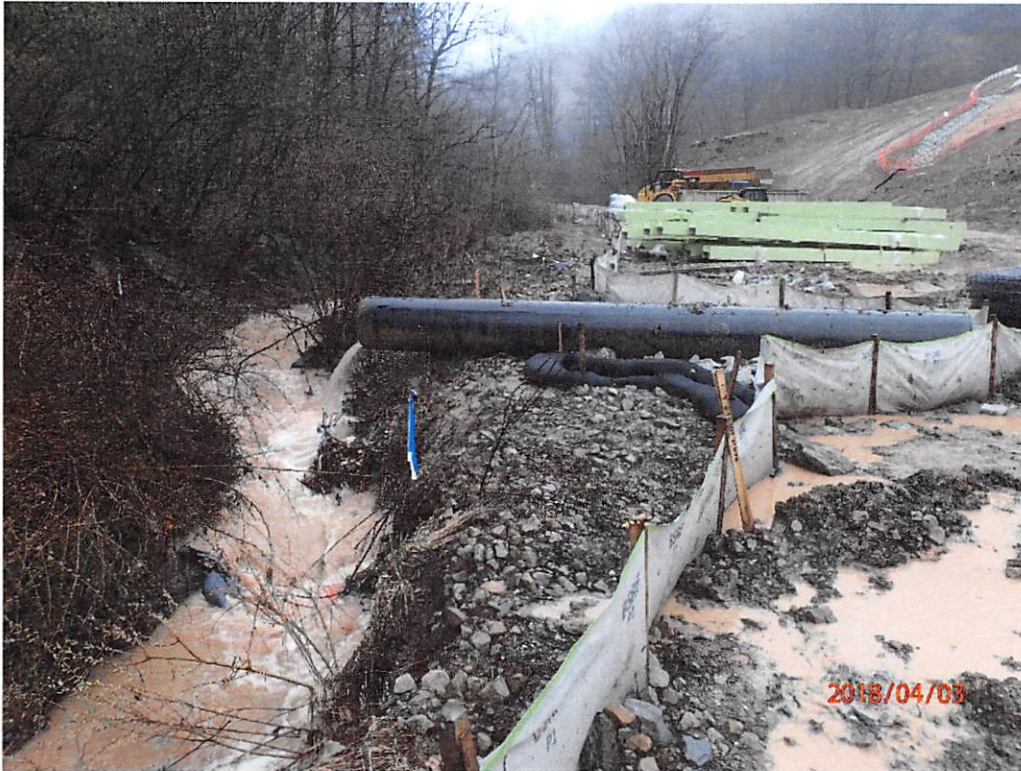
UT of Mobley Run near Mobley Compressor Station.

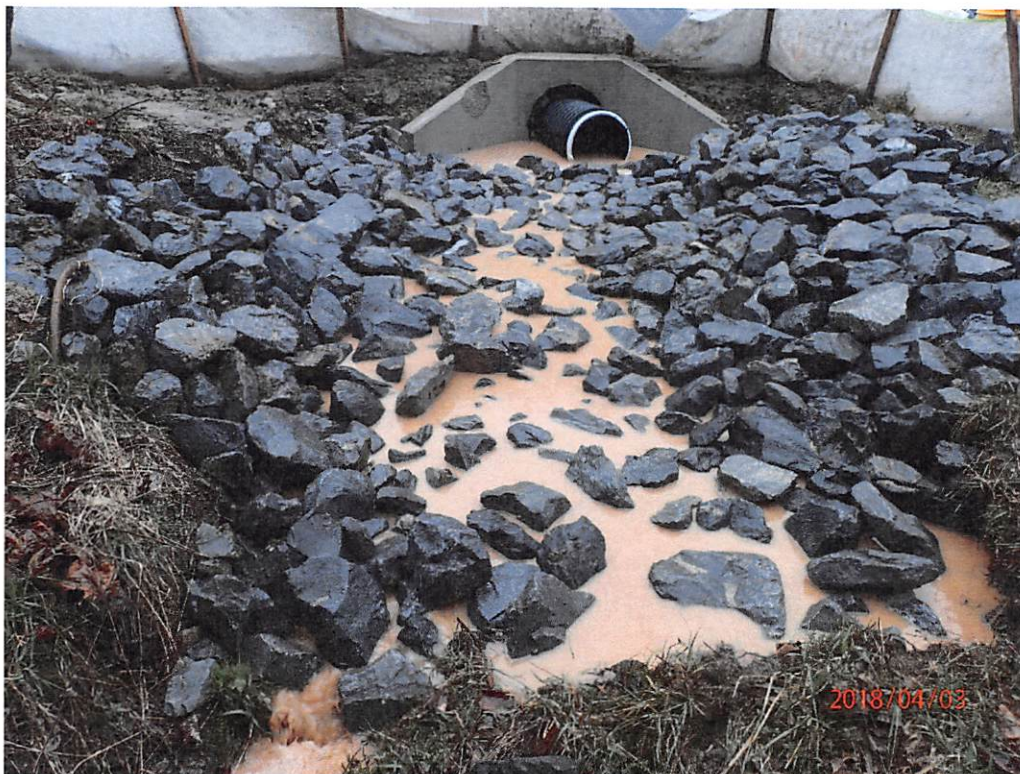
Sediment laden water leaving site into UT of Mobley Run.

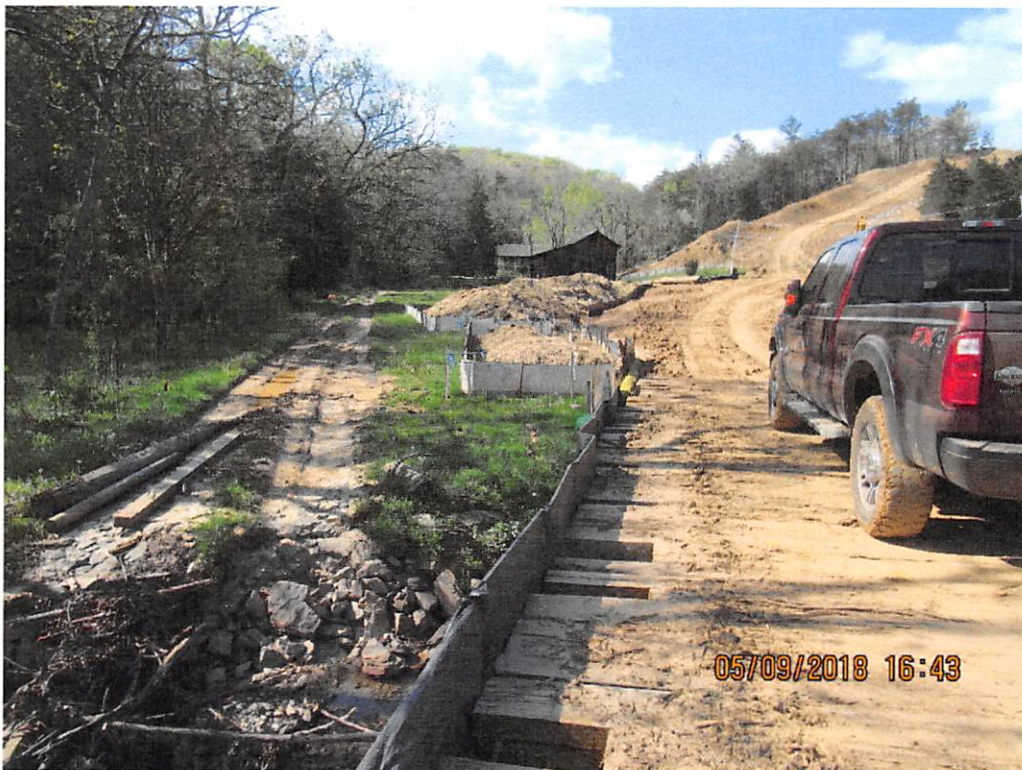
Photo 2: Topsoil delineation, sump, perimeter fencing and vegetative buffer prior to stream.

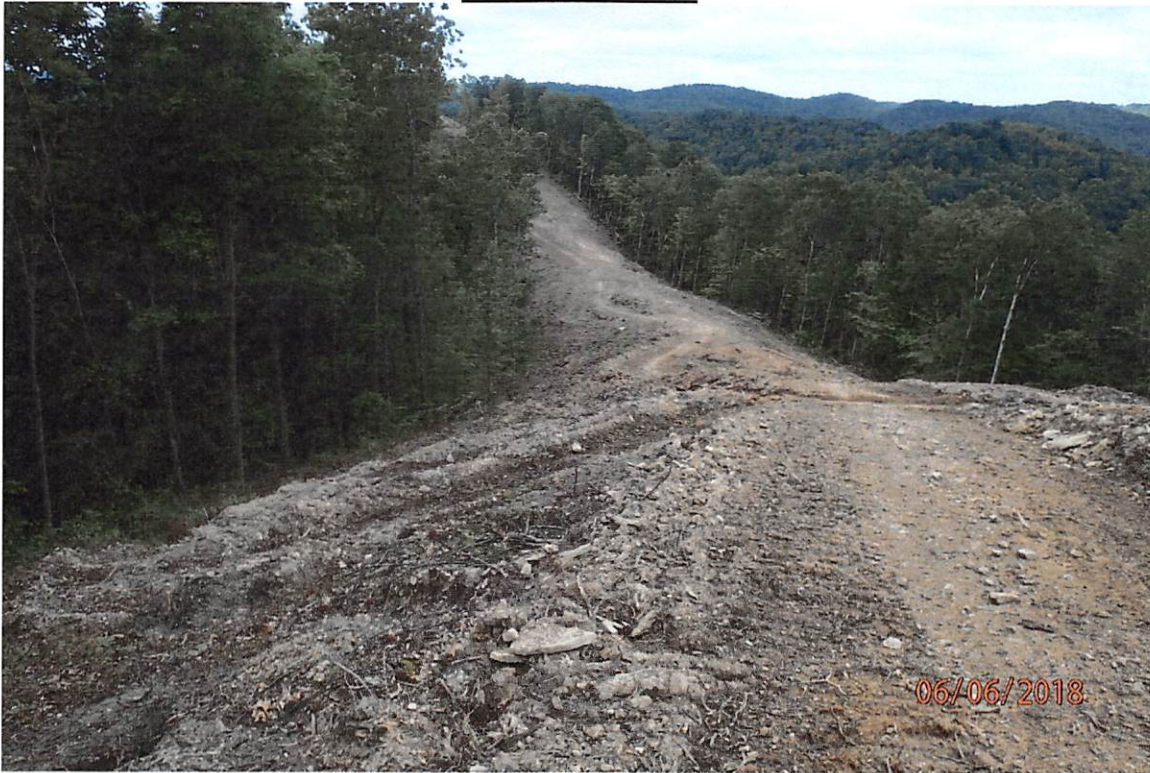
Areas of the project that have been cleared to mineral soil and BMPs are not in place as indicated in the SWPPP.

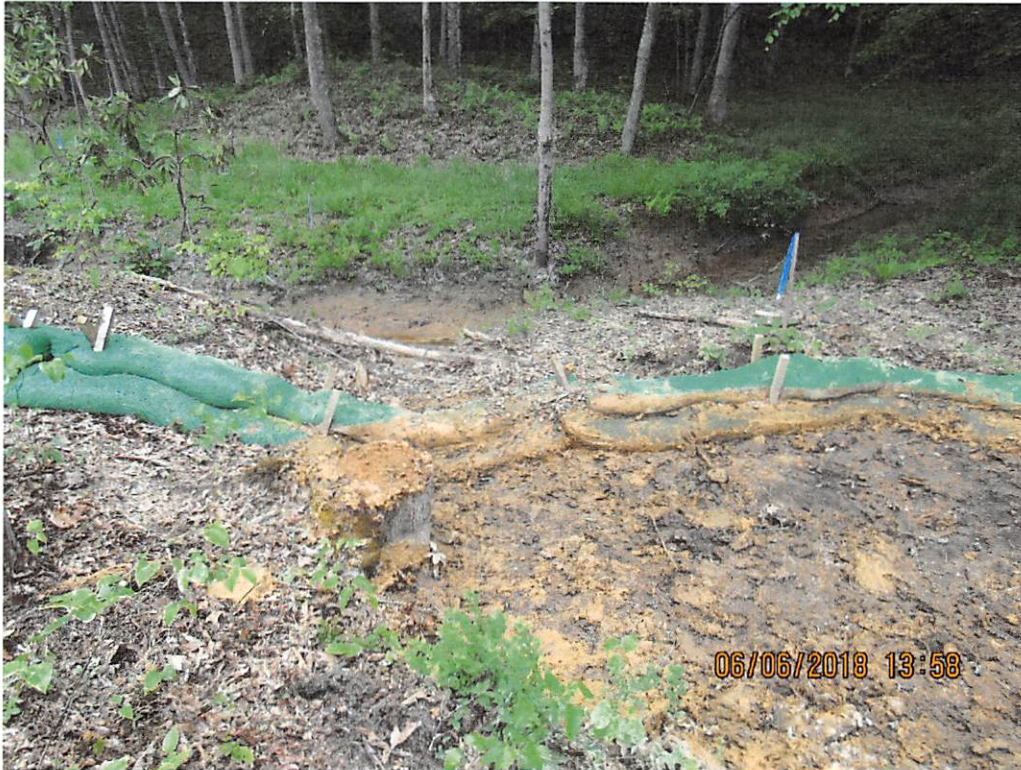
Photo 1: Station 6782+00 control failure repair but additional controls not added.

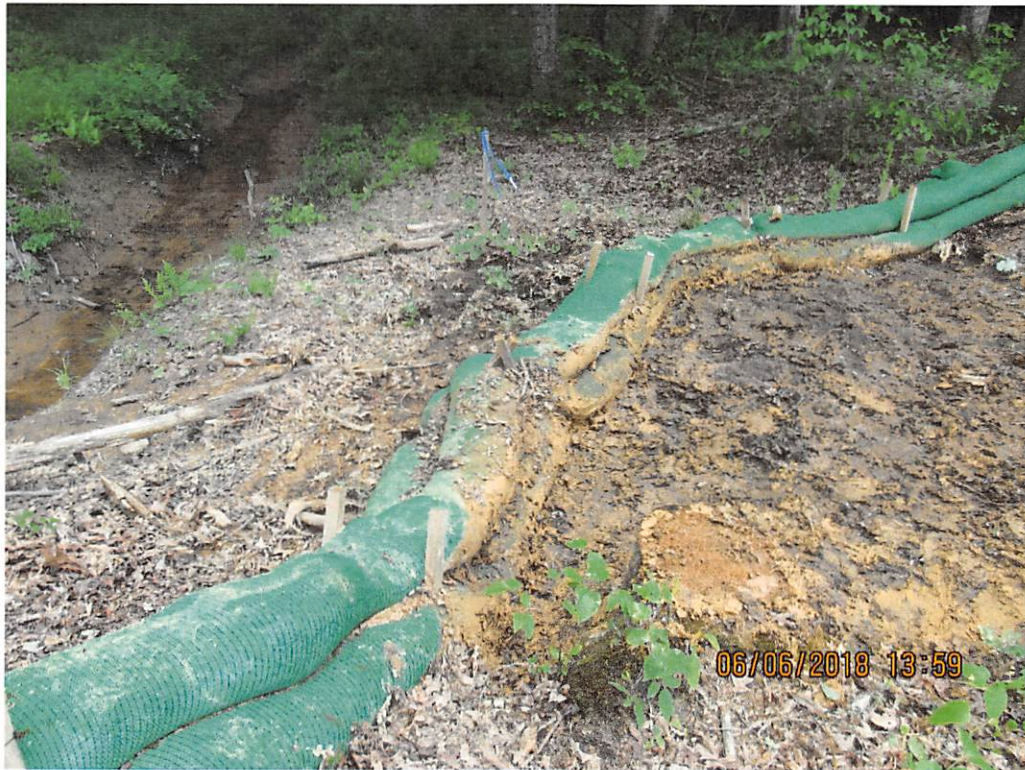
Photo 2: Station 6782+00 control failure repair but additional controls not added.

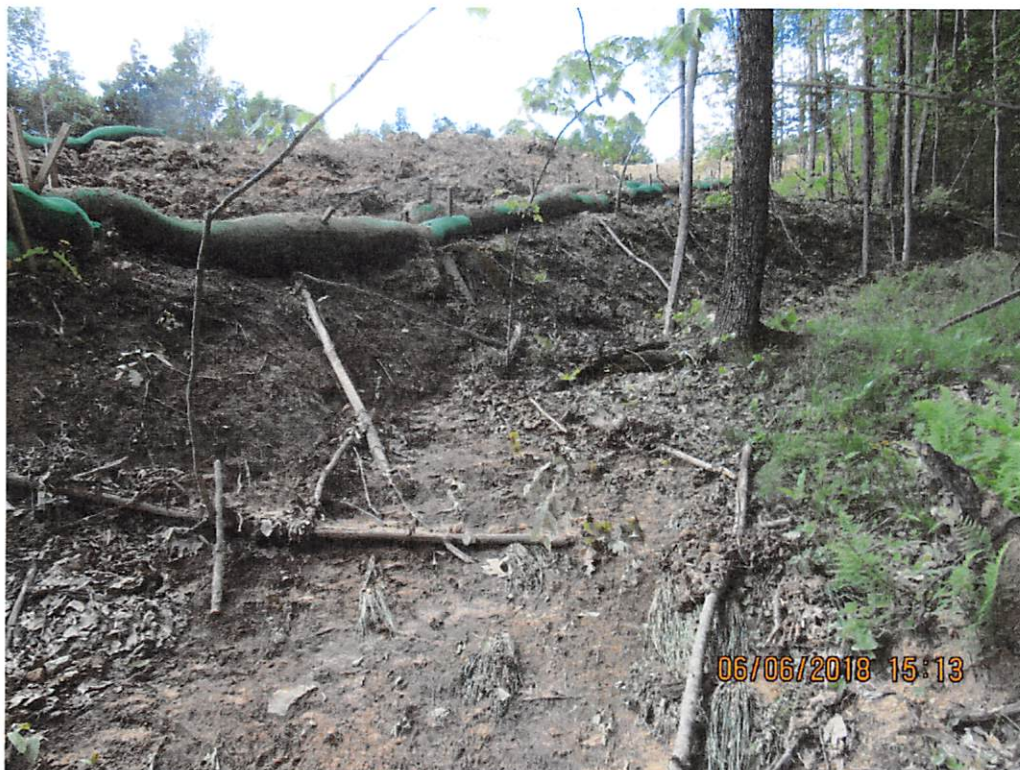
Photo 4: Control failure at station 6812+58 allowing sediment laden water to leave site.

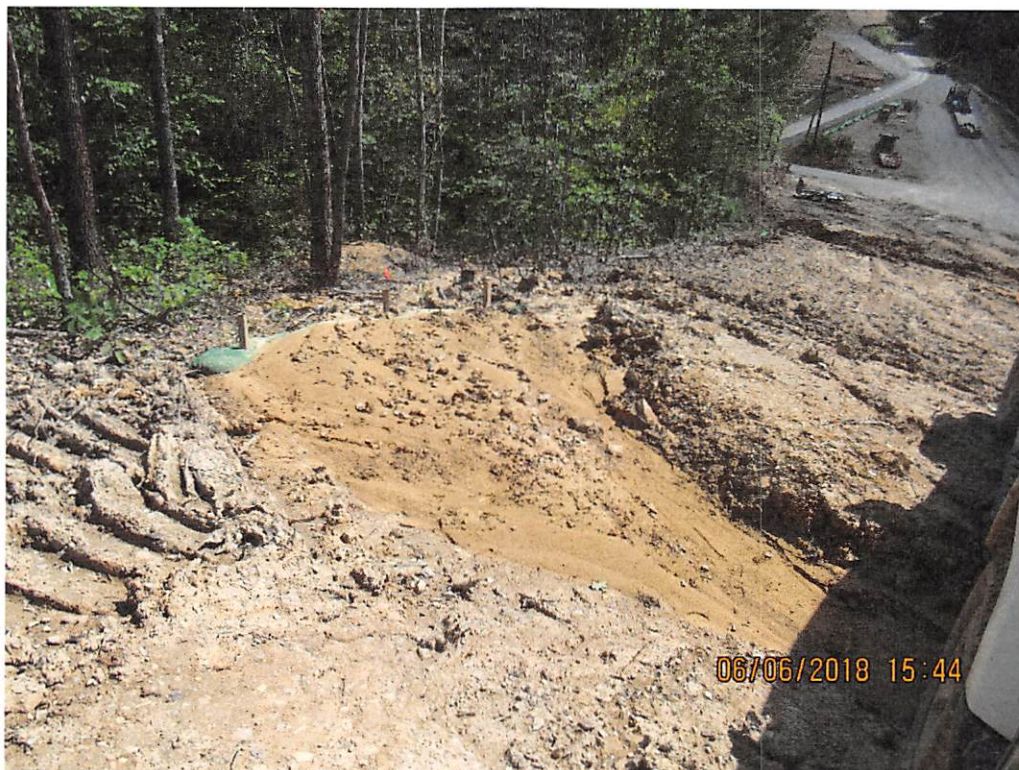
Photo 8: Control failure near station 6854+00 where sediment laden water left site.

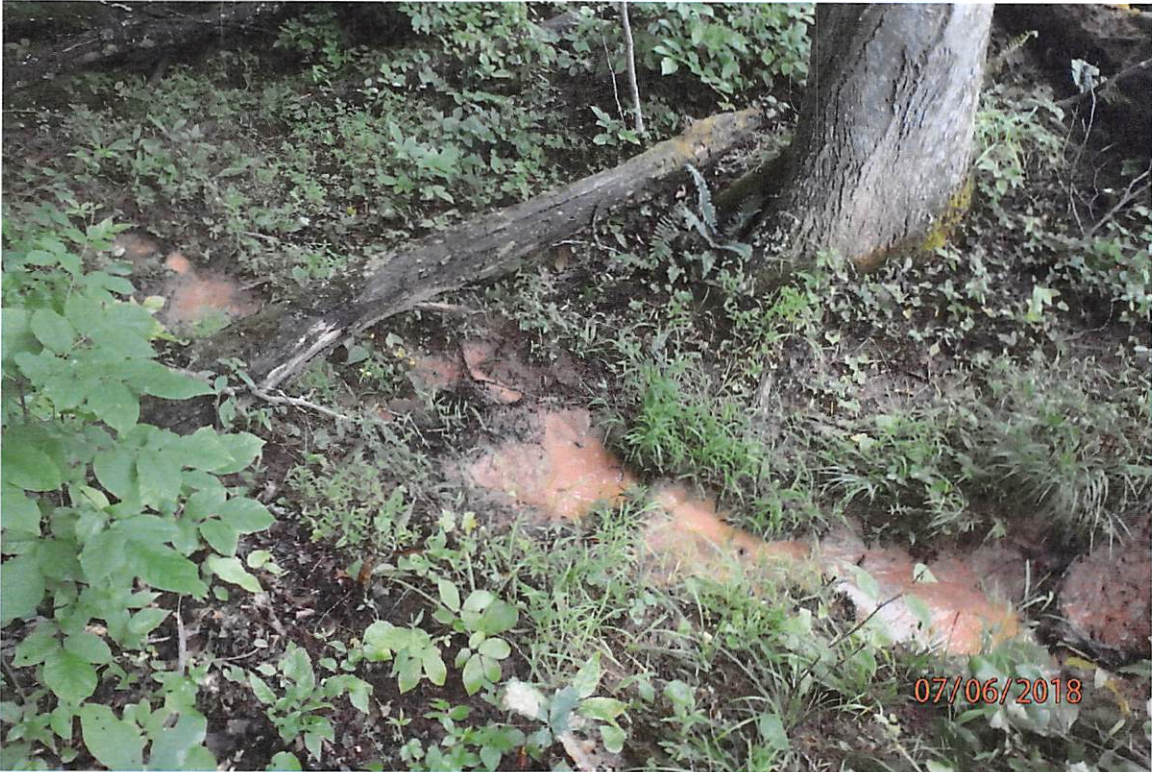
Sediment laden water in UNT Meathouse Fork (39° 11.891' X 80° 33.209') that originates from site.

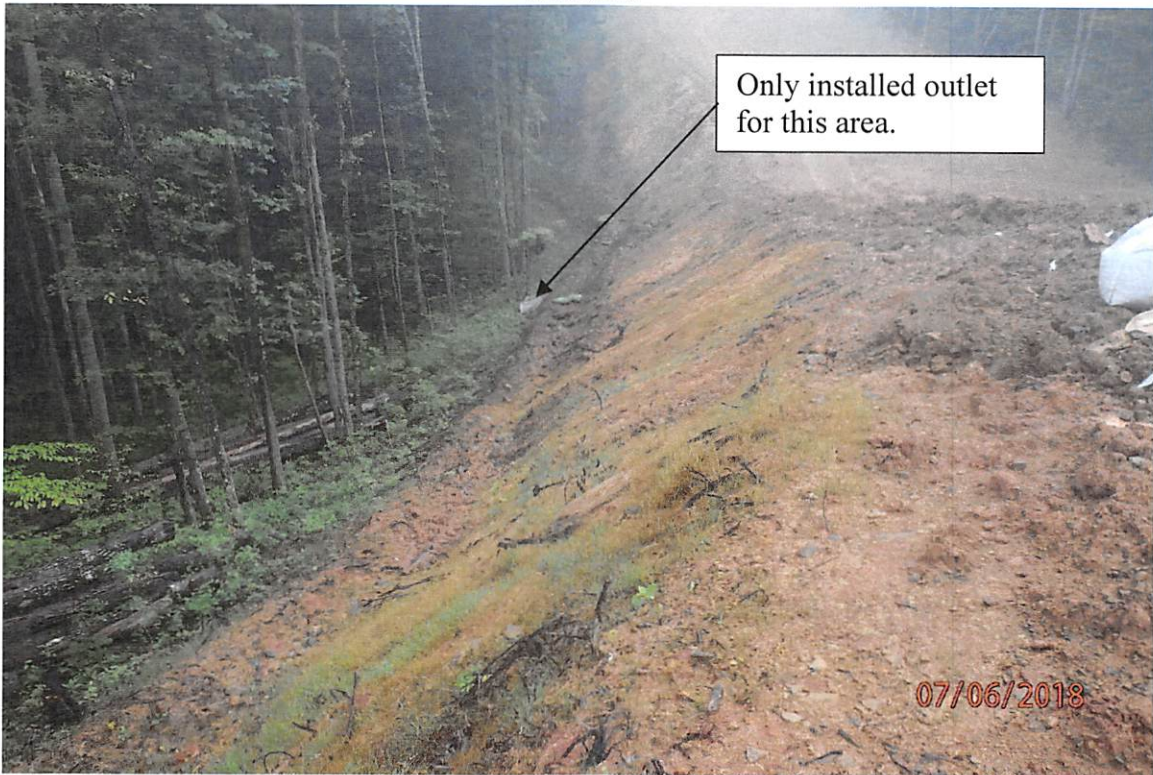
Installed temporary tight of way diversion and outlet that does not have adequate outlets adjacent to 1876+00. Evidence of the terminus BMP being overwhelmed in lower picture.

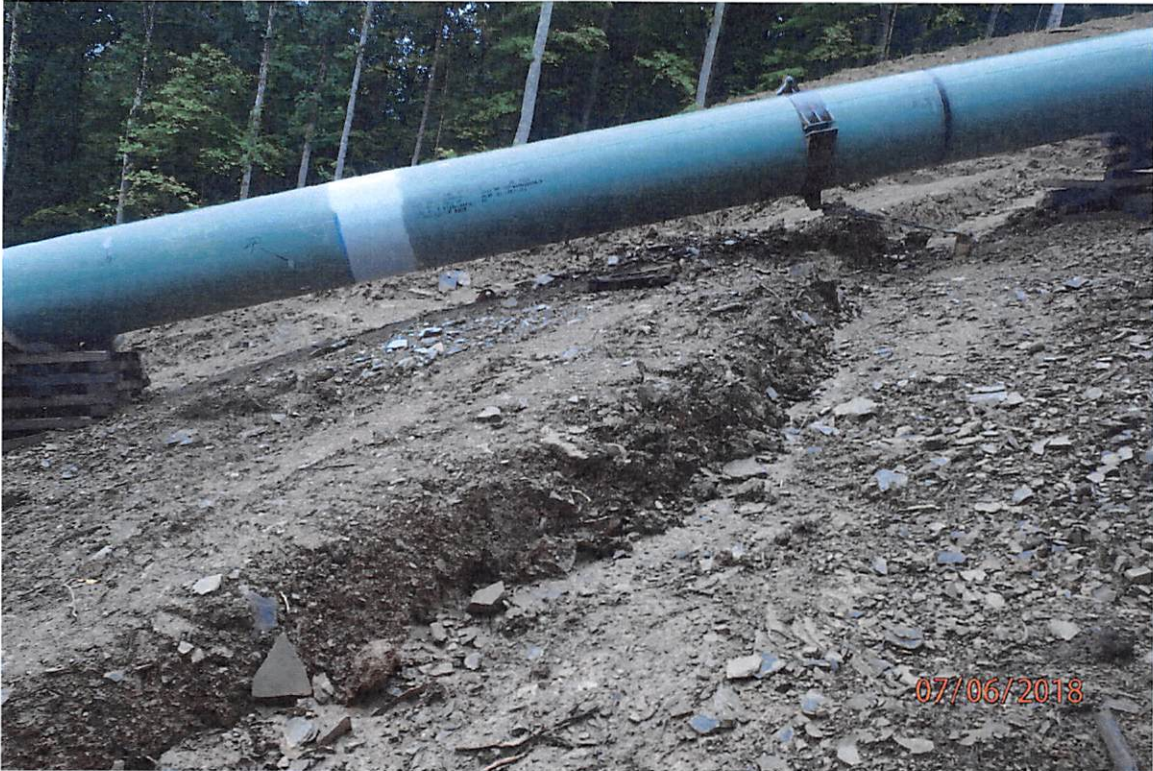
Water bar that has been installed at a steep angle with erosion and the associated offsite sediment deposits.

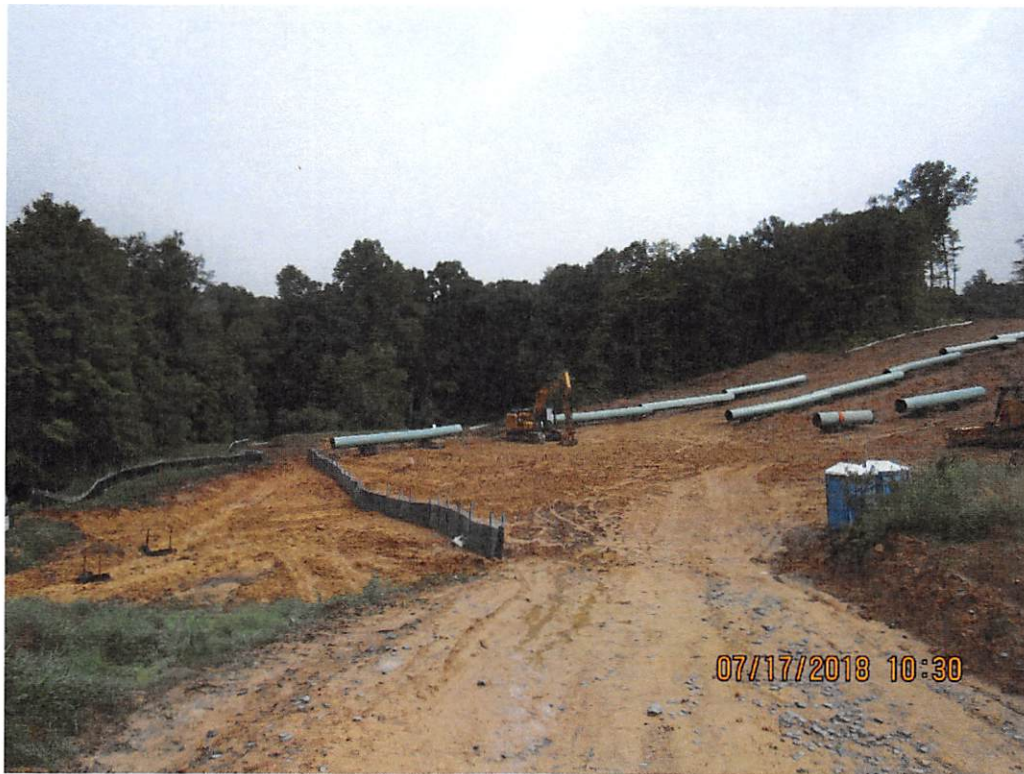
Photo 3: Drainage area where sediment laden water left site.

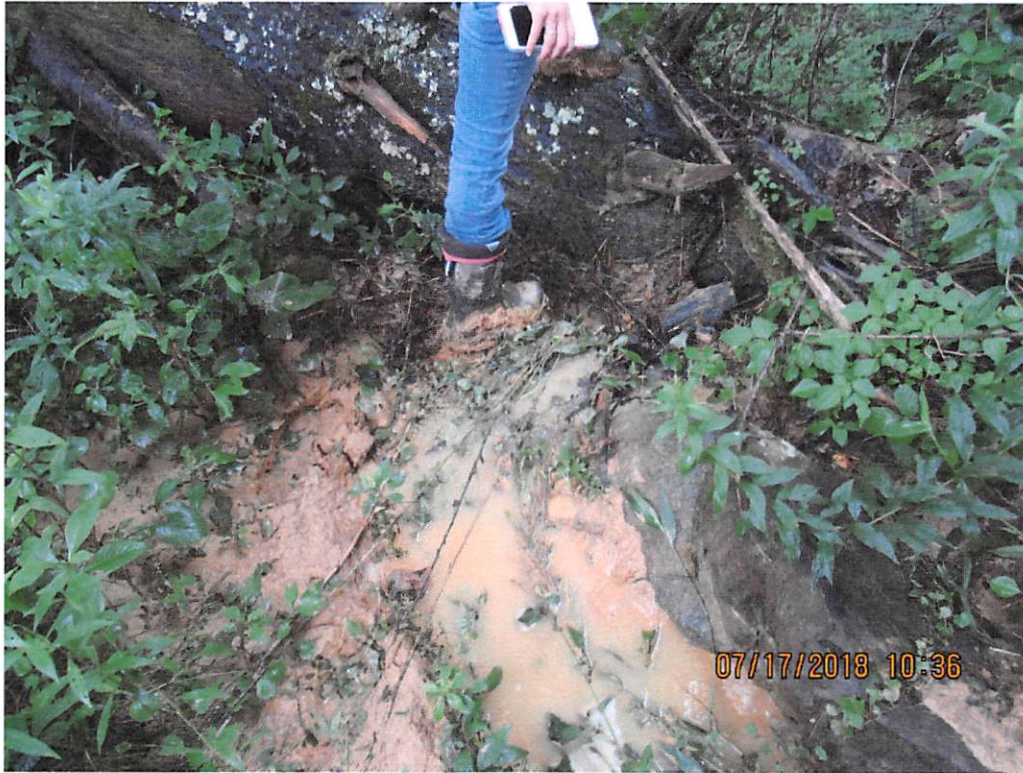
Photo 7: Sediment build up and muddy water temporarily stopped against downed tree.

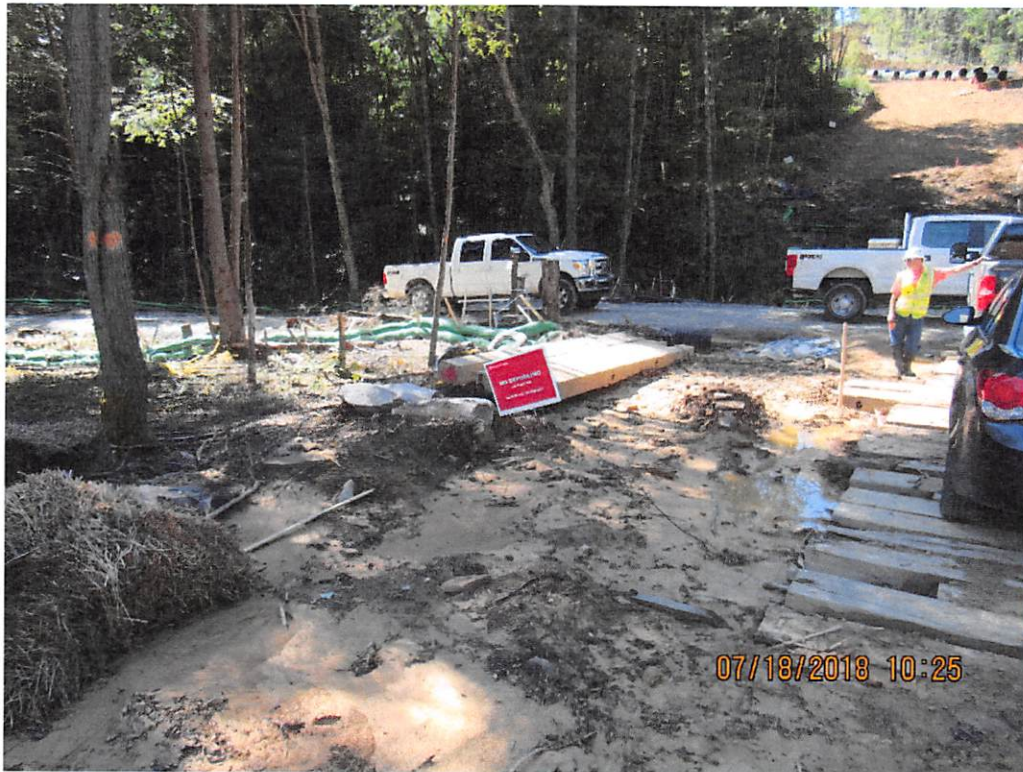
Photo 4: Sediment down gradient of straw bale pile (on right in above photo).

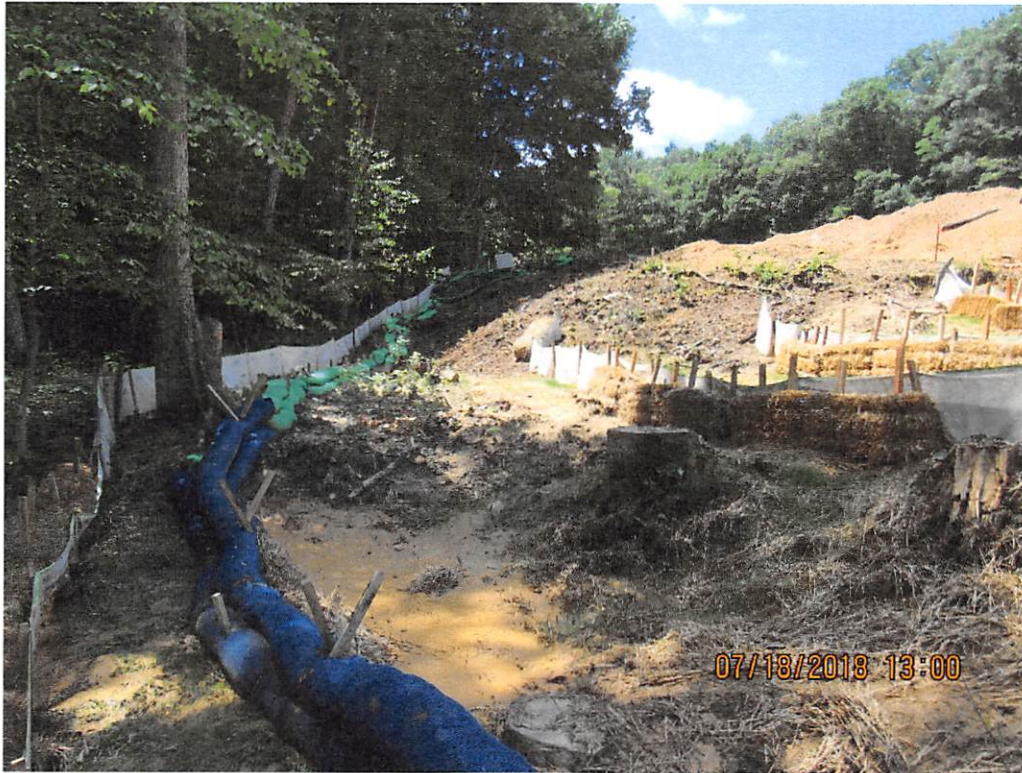
Photo 9: Control sequence near station 6781+87 with multiple control failure.

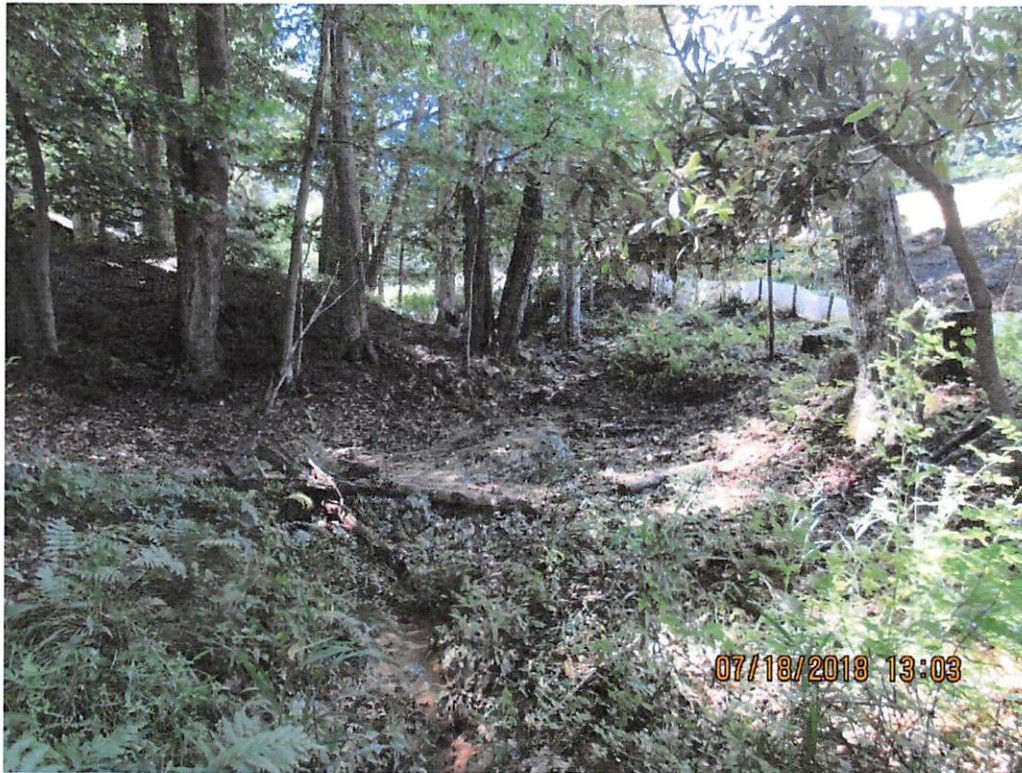
Photo 13: Up gradient of terminus of sediment laden water leaving site.

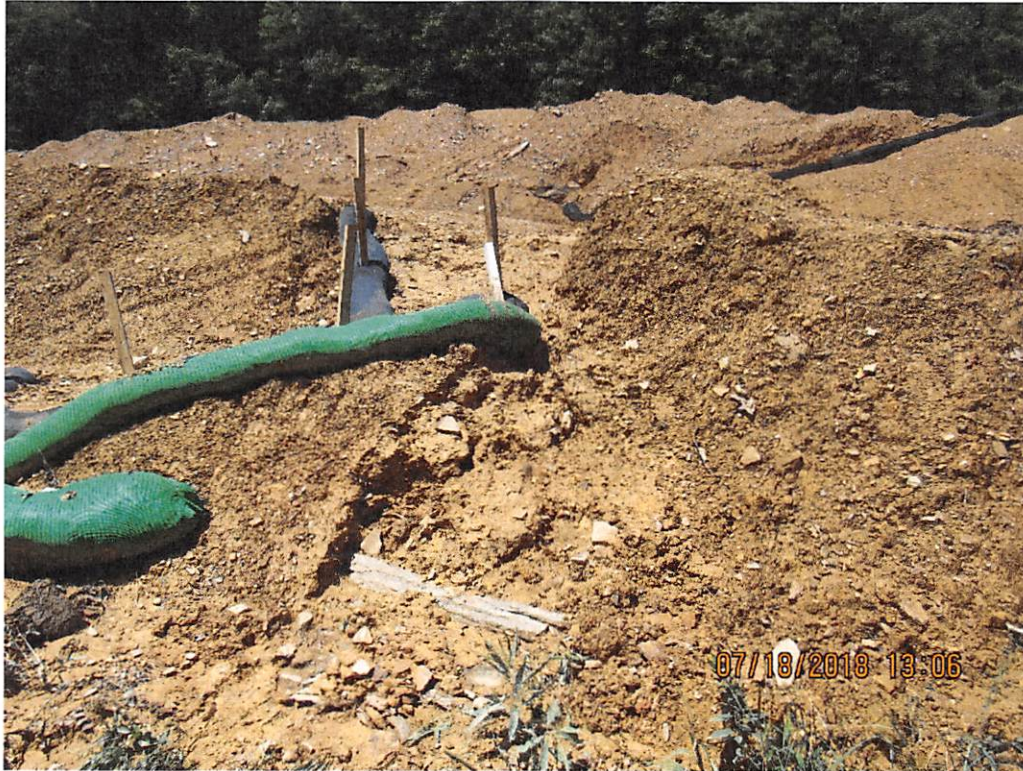
Photo 17: Erosion gullies from failed control at end of water bar near station 6785+50, which allowed sediment laden water to leave site.

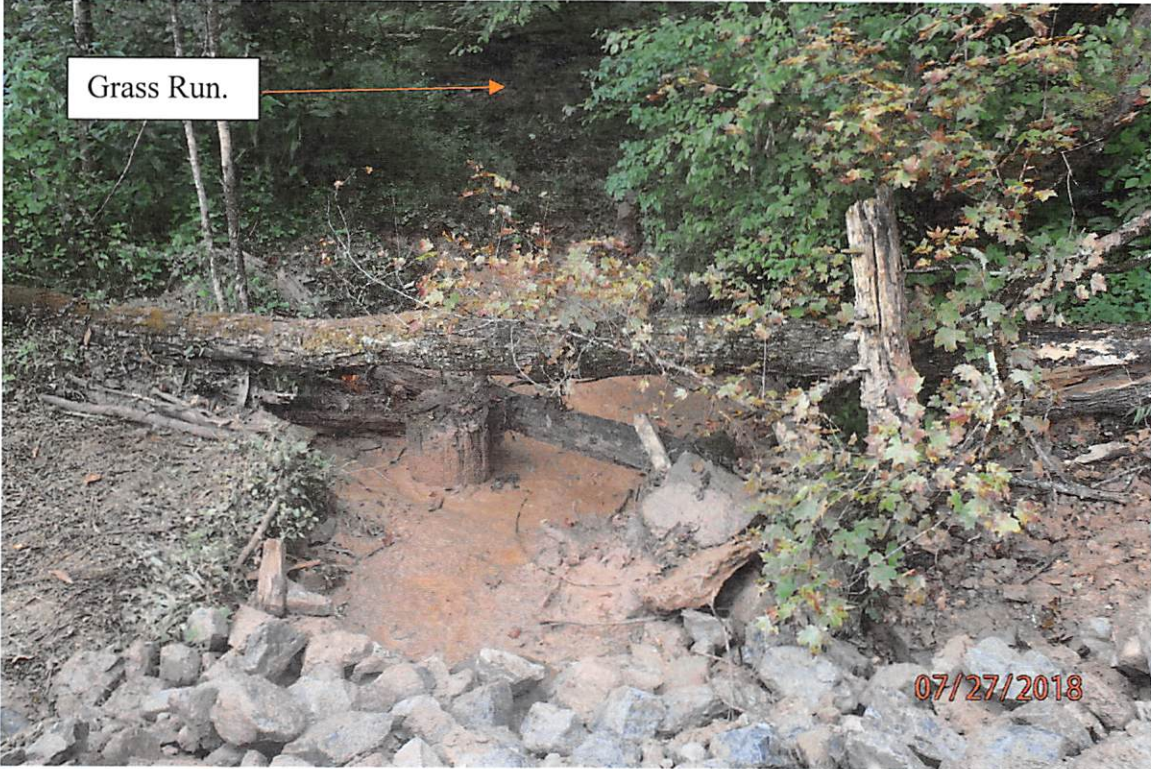
Point where sediment leaves the site.

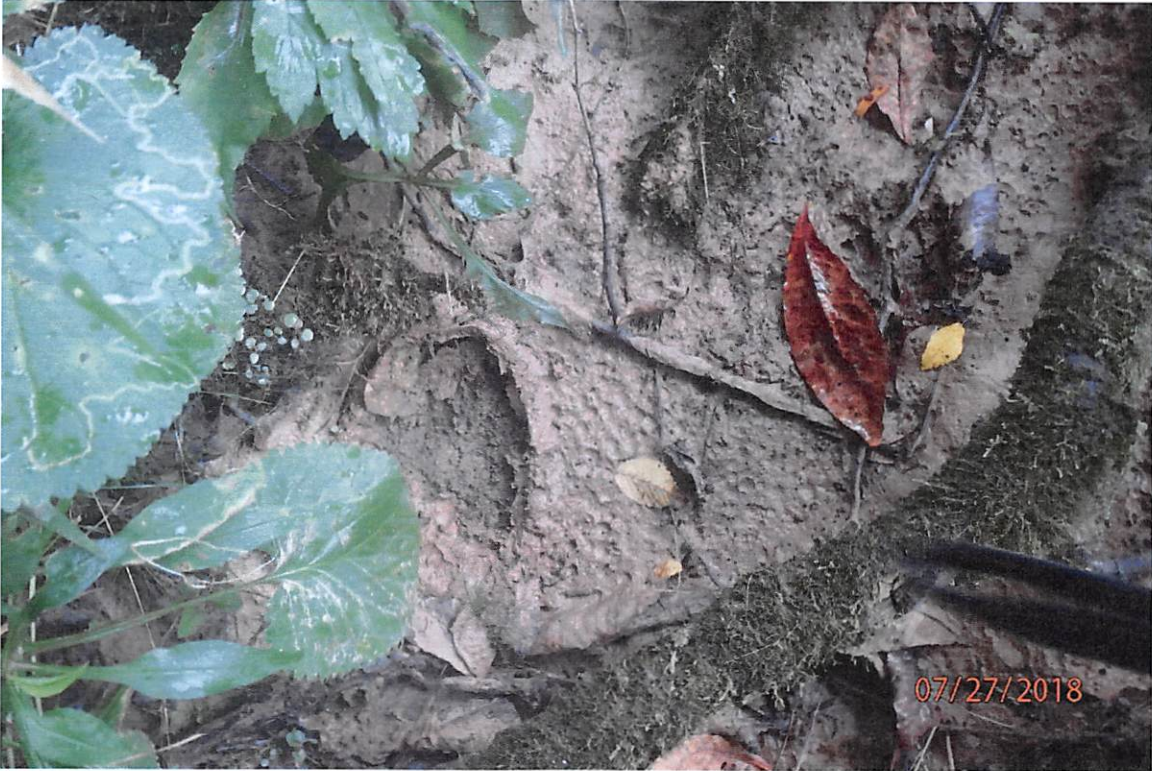
Offsite sediment deposits in Grass Run (S-A11a) that originate from site.

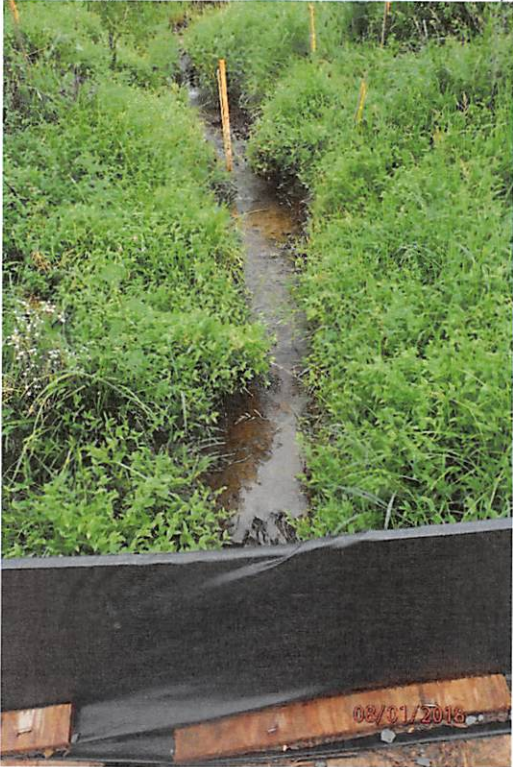
Goose Run water quality upstream of project.

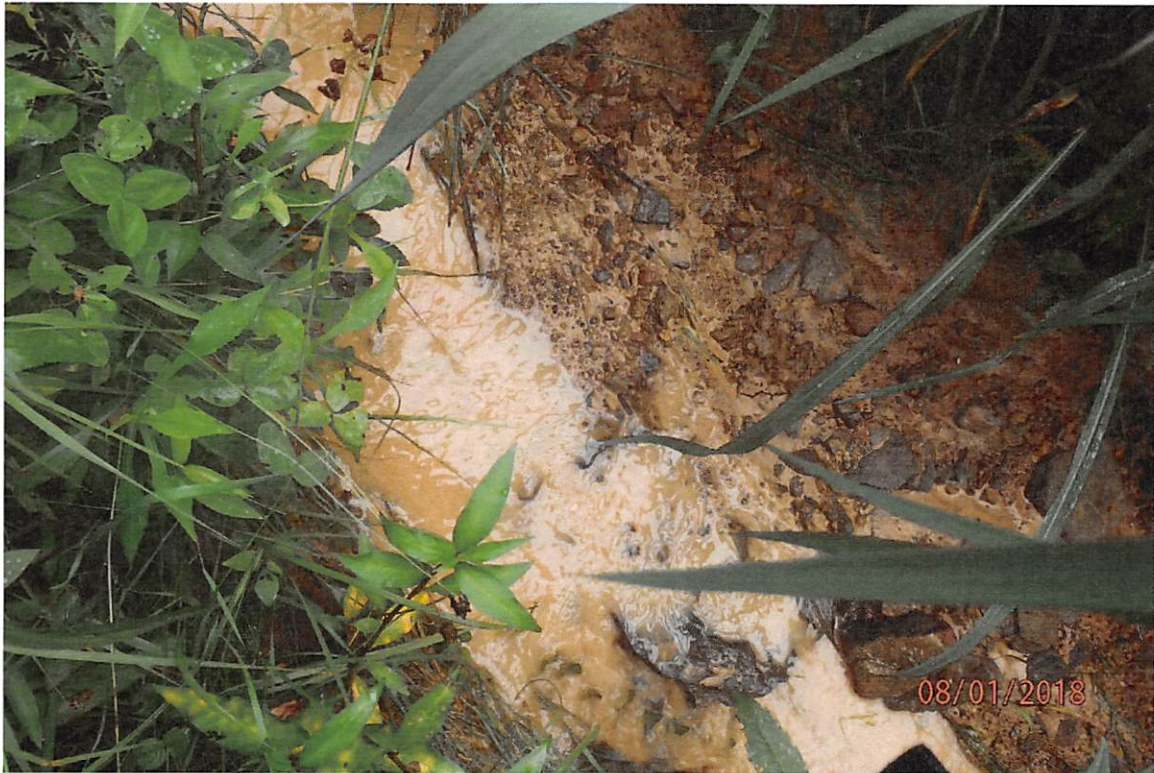
CNA offsite sediment deposits and visible plume in UNT Goose Run (39° 26.100' X 80° 28.4922')  
originating from site.

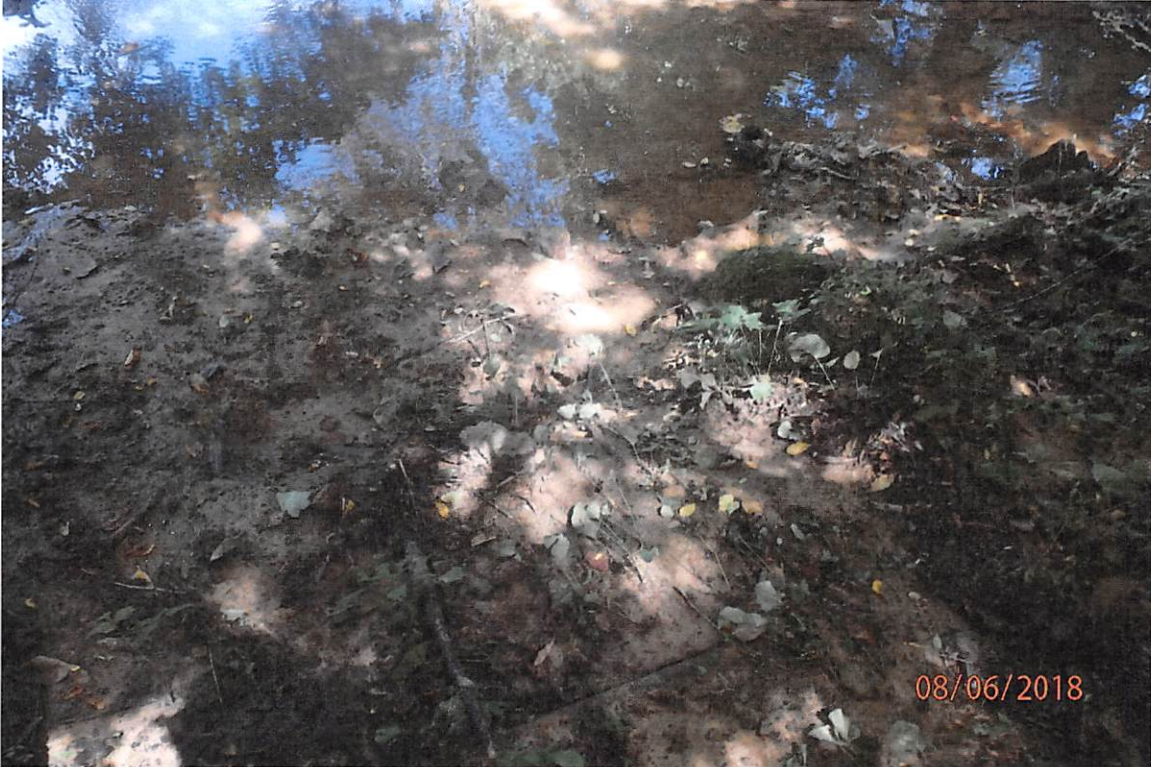
Offsite CNA deposits in Grass Run (39° 20.1127' X 80° 31.3233') that originate from site.

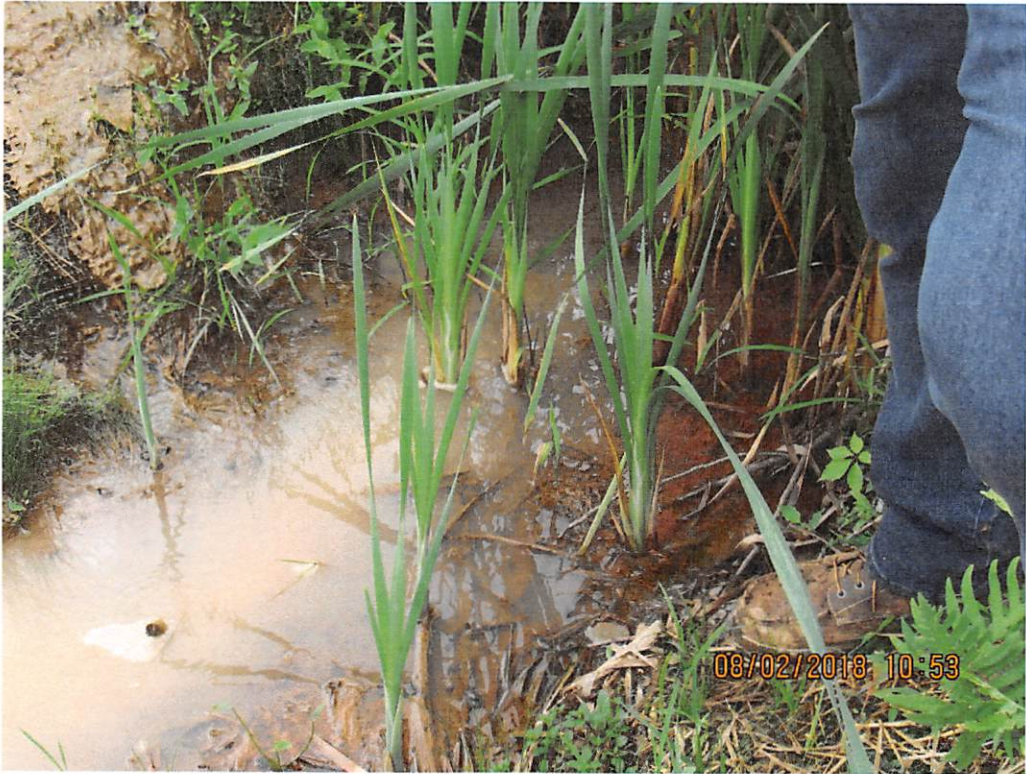
Sediment plume entering Stony Creek

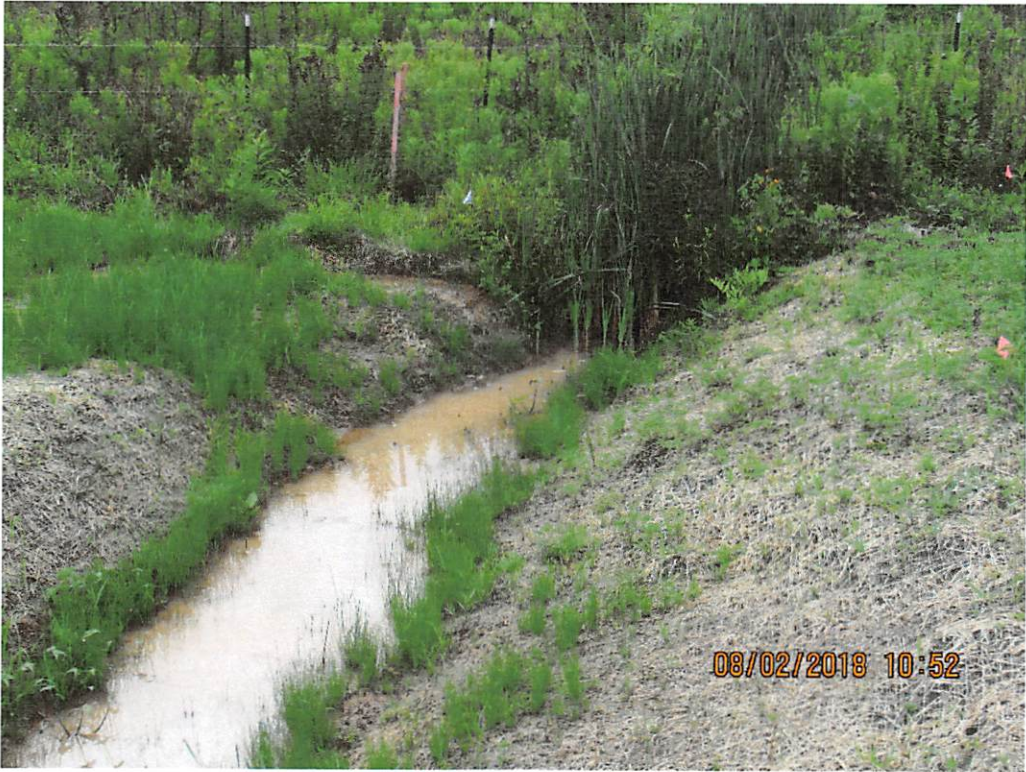
Stony Creek below sediment plume entering stream.

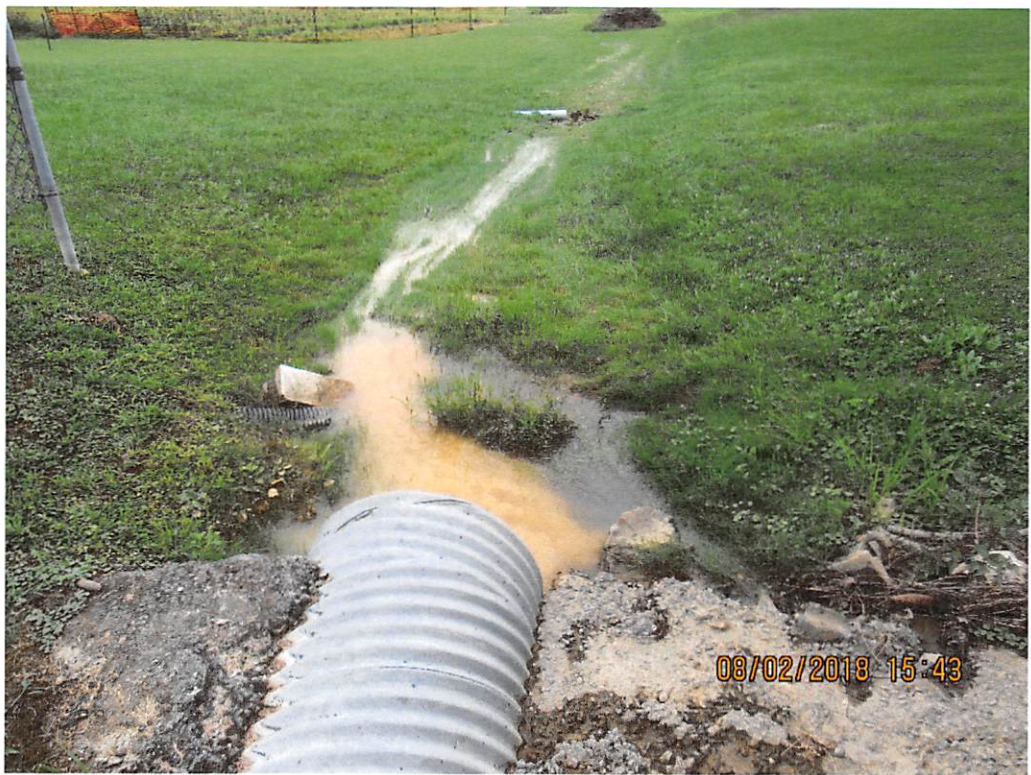
Sediment laden water near Lindsie Methodist Church.

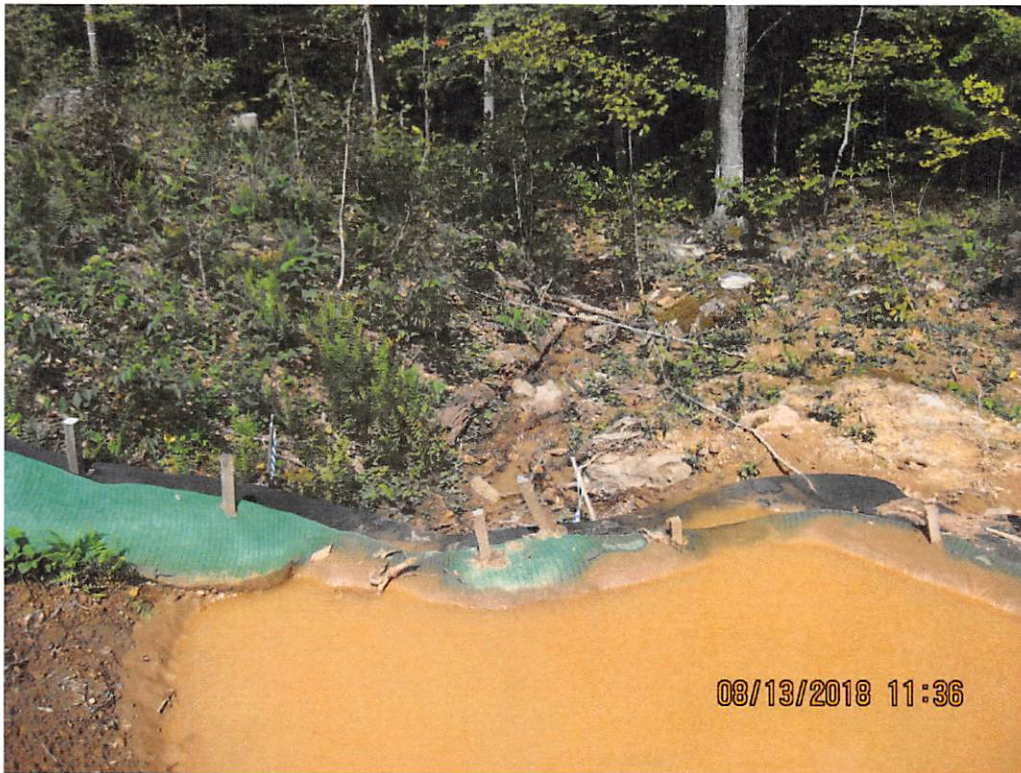
At St. 00+220 a series of perimeter controls used in a concentrated flow area had failed allowing sediment laden water to leave the site. Sediment deposits were noted in receiving stream A-104 creating Conditions Not Allowable in the Waters of the State.

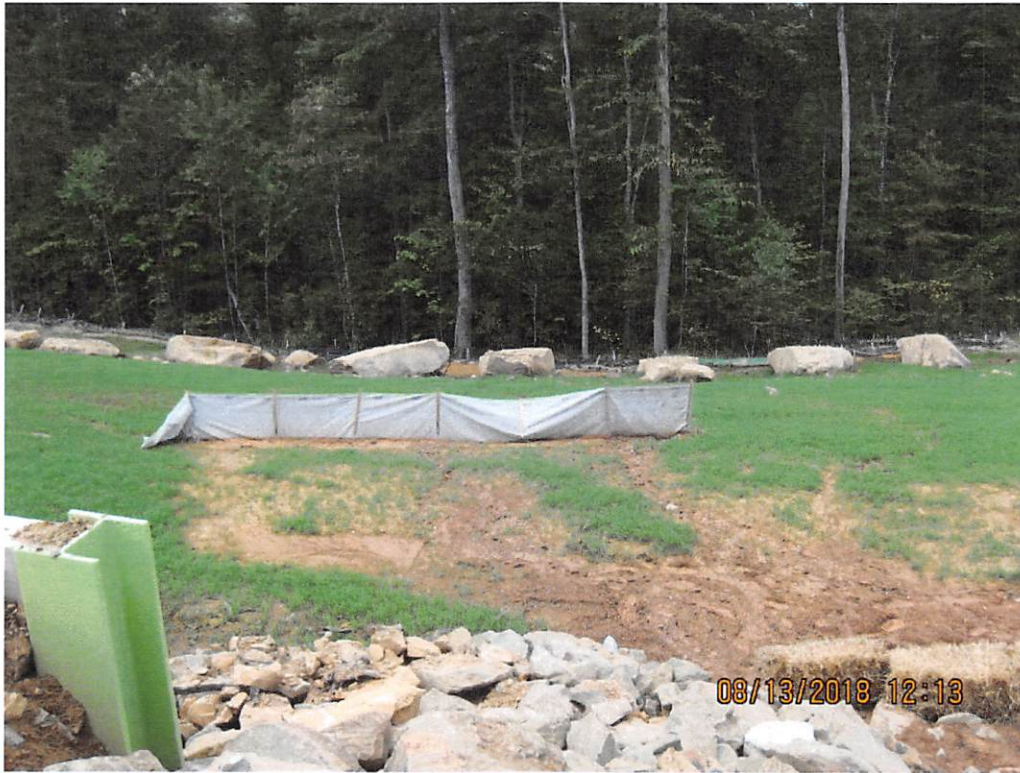
Maintenance needed for filter sock at Southwest wall.
