**CONSENT ORDER  
ISSUED UNDER THE  
WATER POLLUTION CONTROL ACT  
WEST VIRGINIA CODE, CHAPTER 22, ARTICLE 11**

TO: Mountain Valley Pipeline, LLC

DATE: April 19, 2019

ORDER NO.: 8951

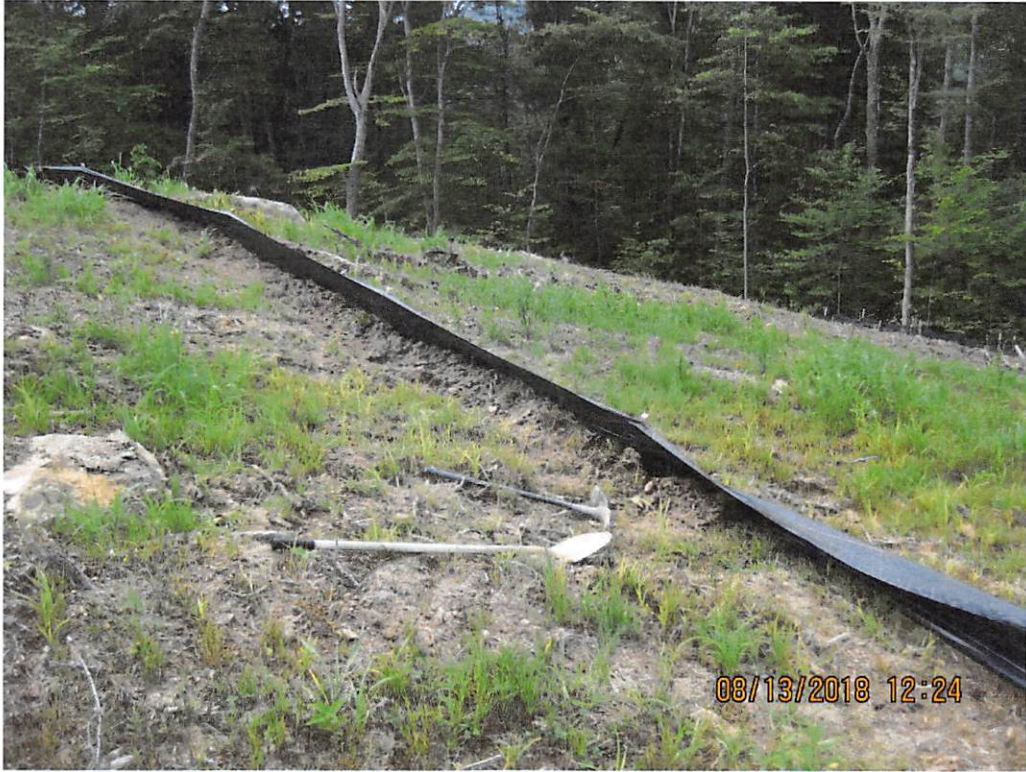
Silt fence being installed on the southern portion of the pad area was not joined or trenched in properly.

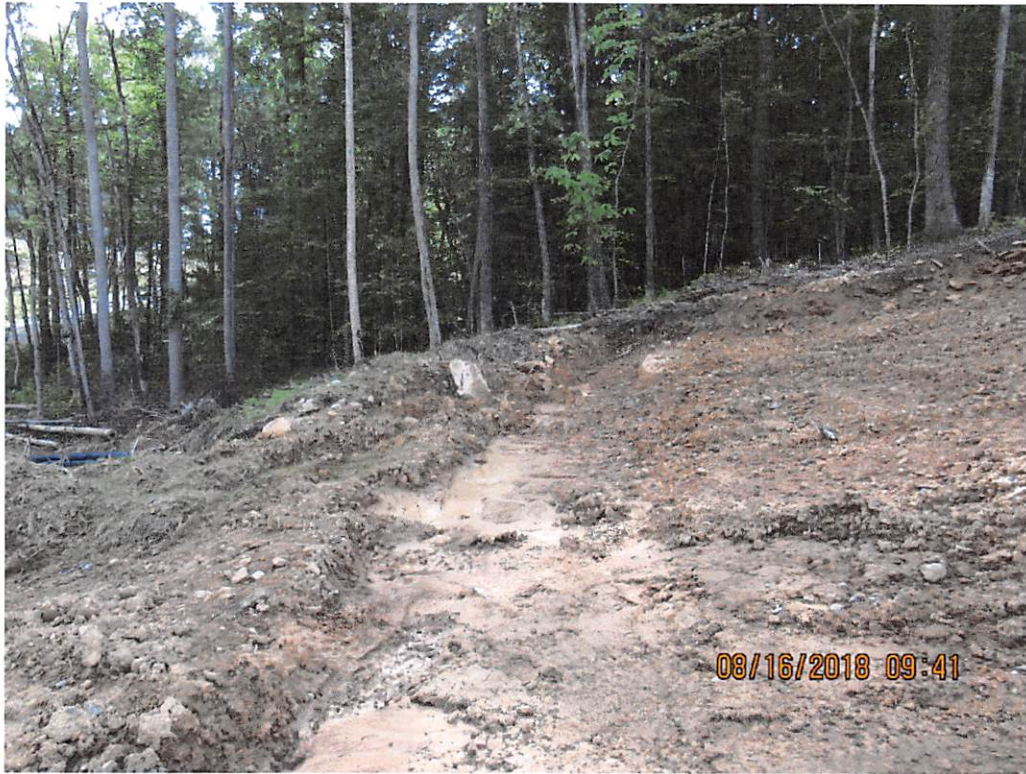
Photo 1: Eastern view of one of several incorrectly sloped water bars off Bingham Road station 7450+00.

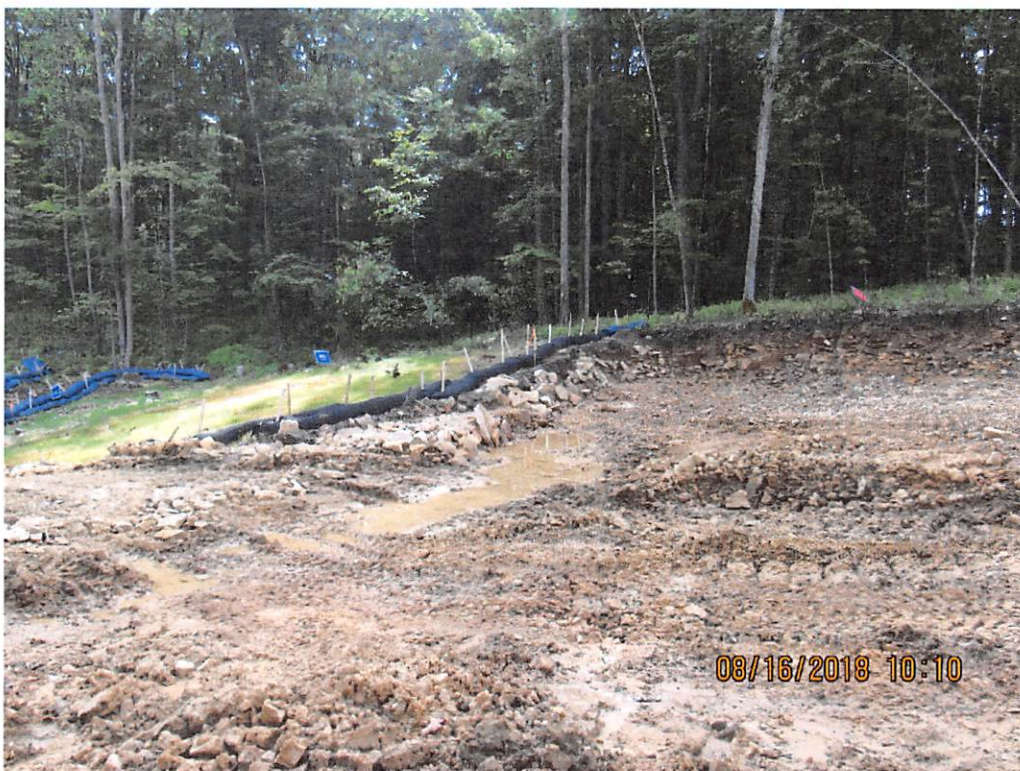
Photo 8: Eastern view of water bar without outlet near Bingham Road.

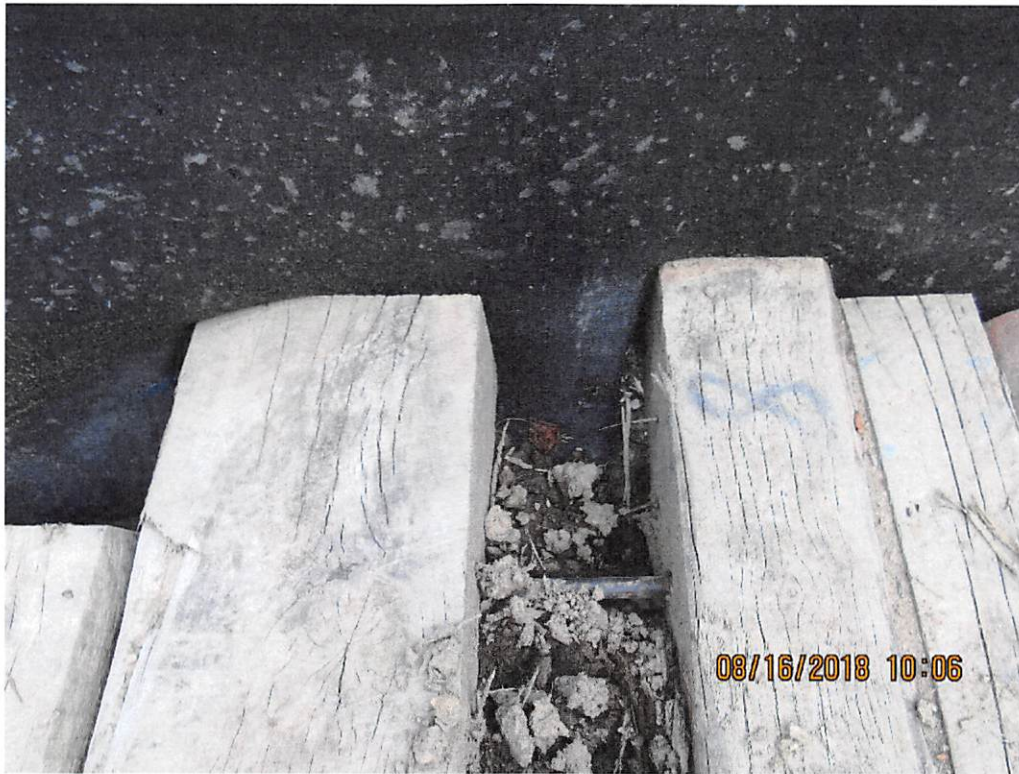
Photo 9: Timber bridge mat punctured filter fabric at station 7465+00.

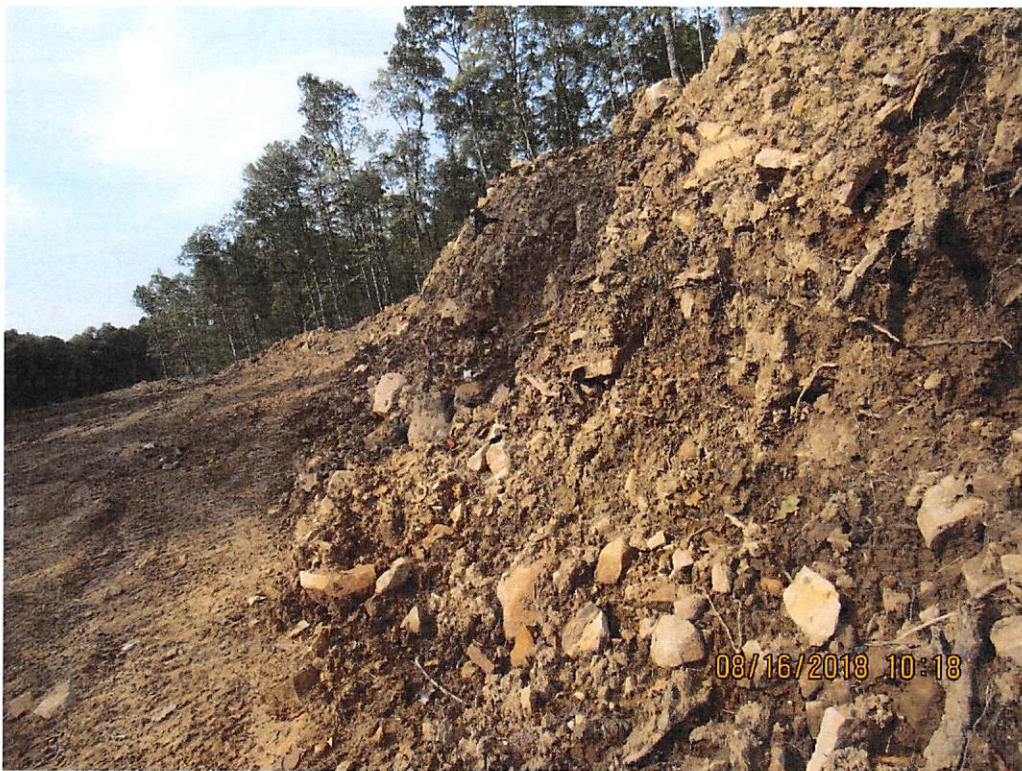
Photo 20: Southern view of waste pile with inadequate stabilization. (Photo taken near Bingham Road station 7450+00)

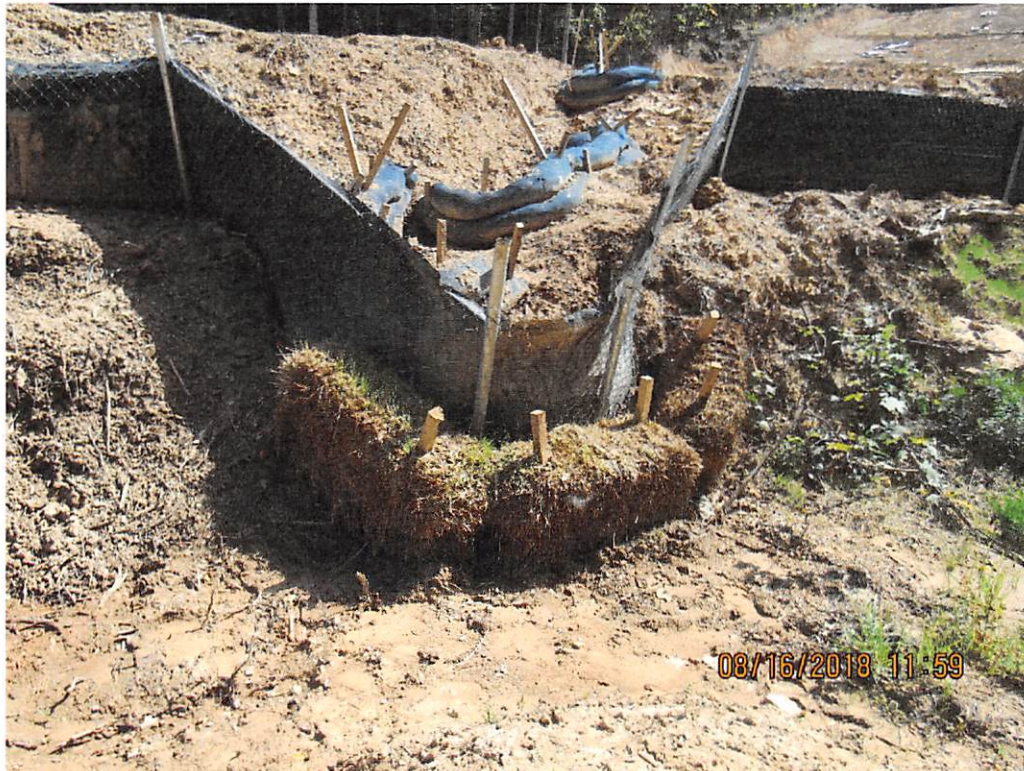
Photo 24: Water bar terminus at station 7084+00. Erosion channels observed at ends of CFS.

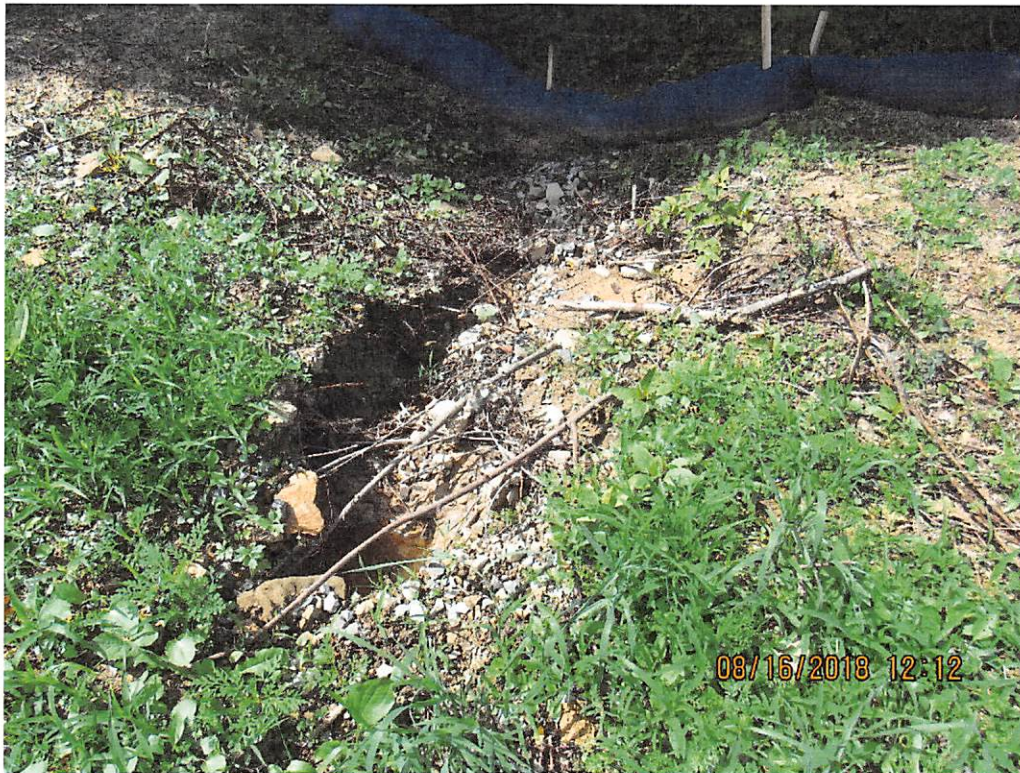
Photo 28: Relative distance of failed water bar terminus, culvert inlet and SR culvert outlet.

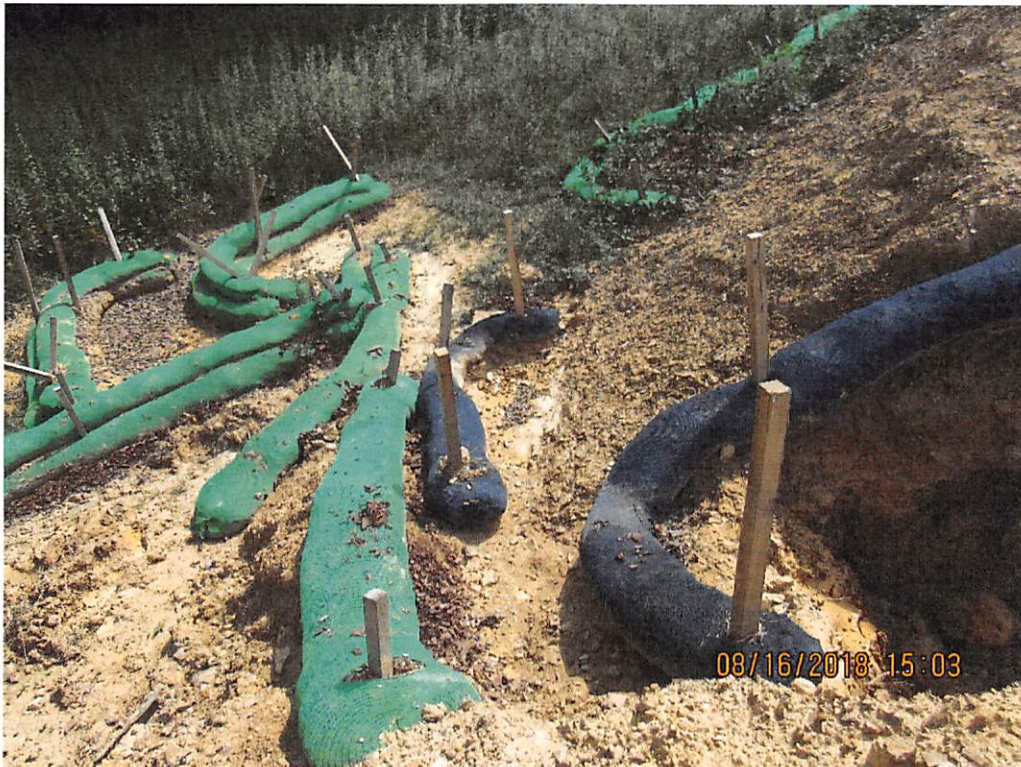
Photo 31: Sumps installed at terminus of water bars near Wahoo Road station 6781+51 which has reduced failure.

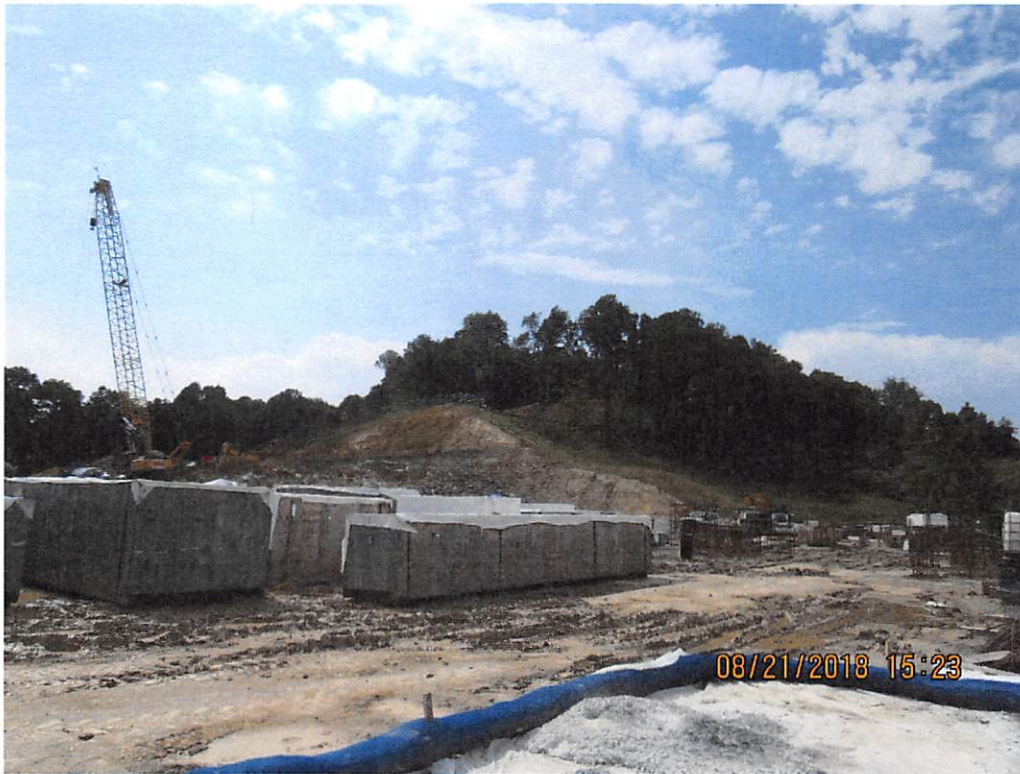
Photo 2: Unfinished underdrain installation.

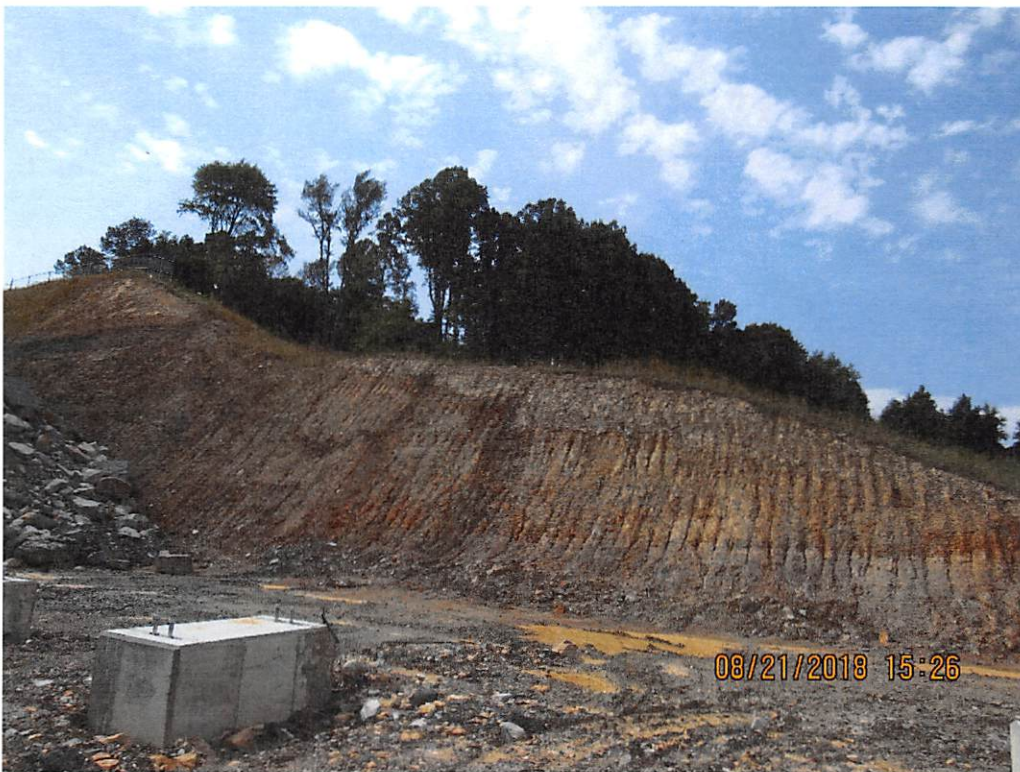
Photo 3: Slope on northwest side of site which has not been reseeded.

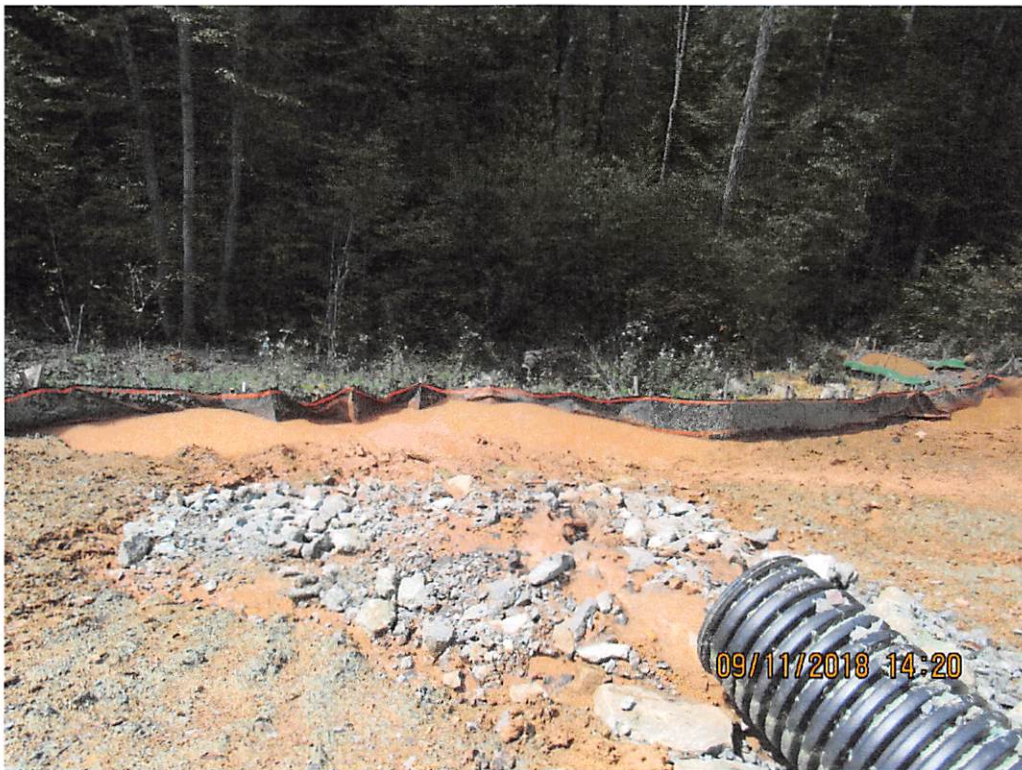
Photo 5: Station 150 (approximately)- controls maintained abating NOV issued 8/13/2018.

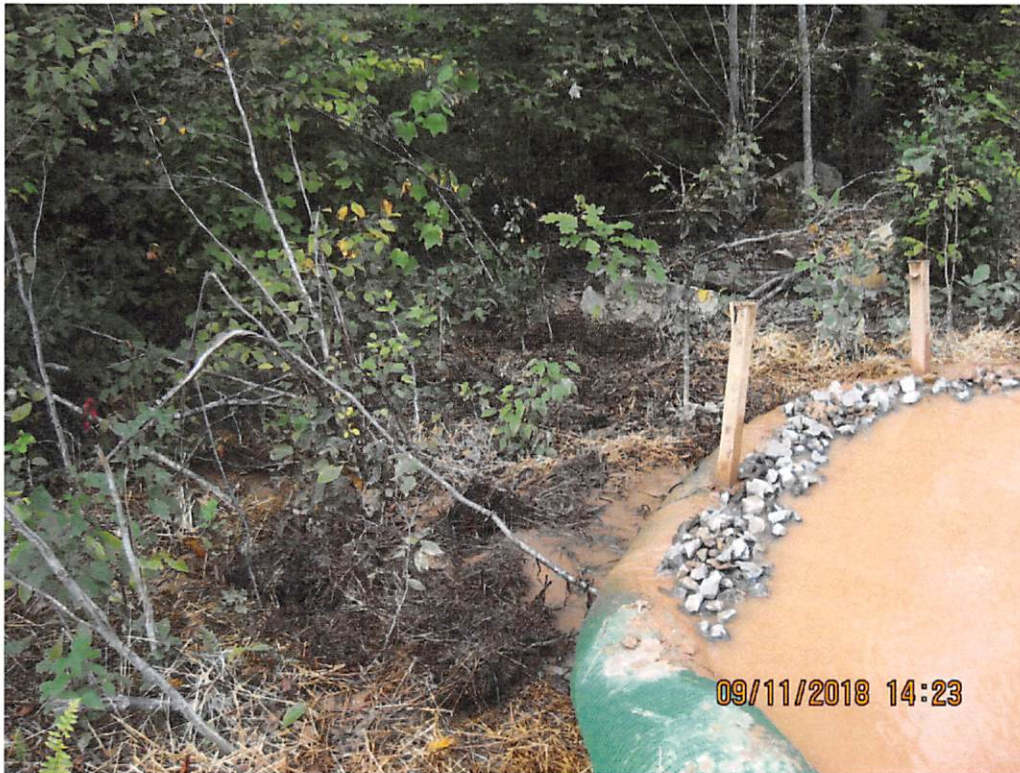
Photo 8: Station 900 (approximately)-Flow below silt fence into sump.

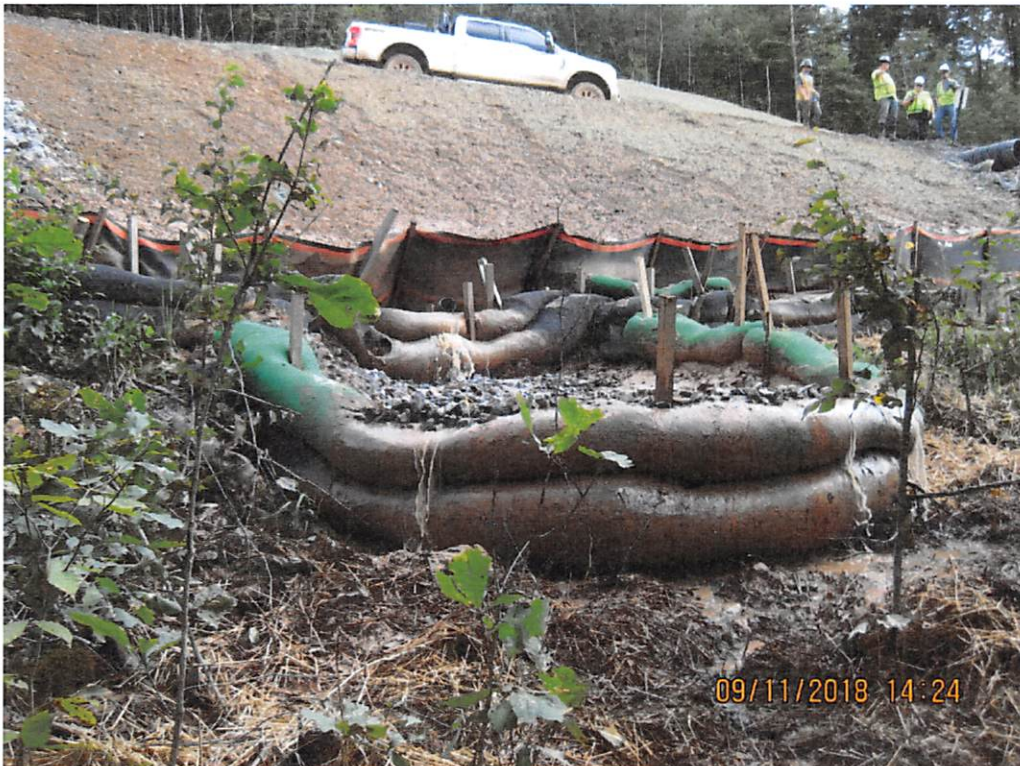
Photo 9: Station 900 (approximately)- outlet of sump below photo 8 with sediment laden water leaving site view down gradient.

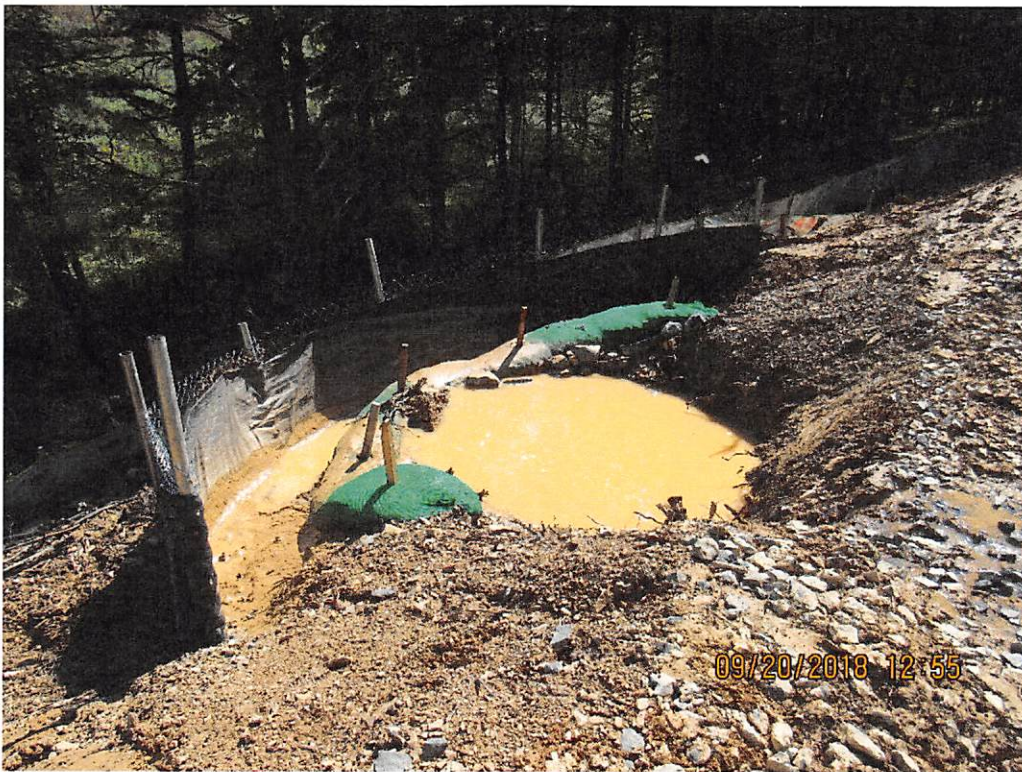
Photo 3: Sediment laden UNT of Painters Run down stream of control failure near station 10270+49

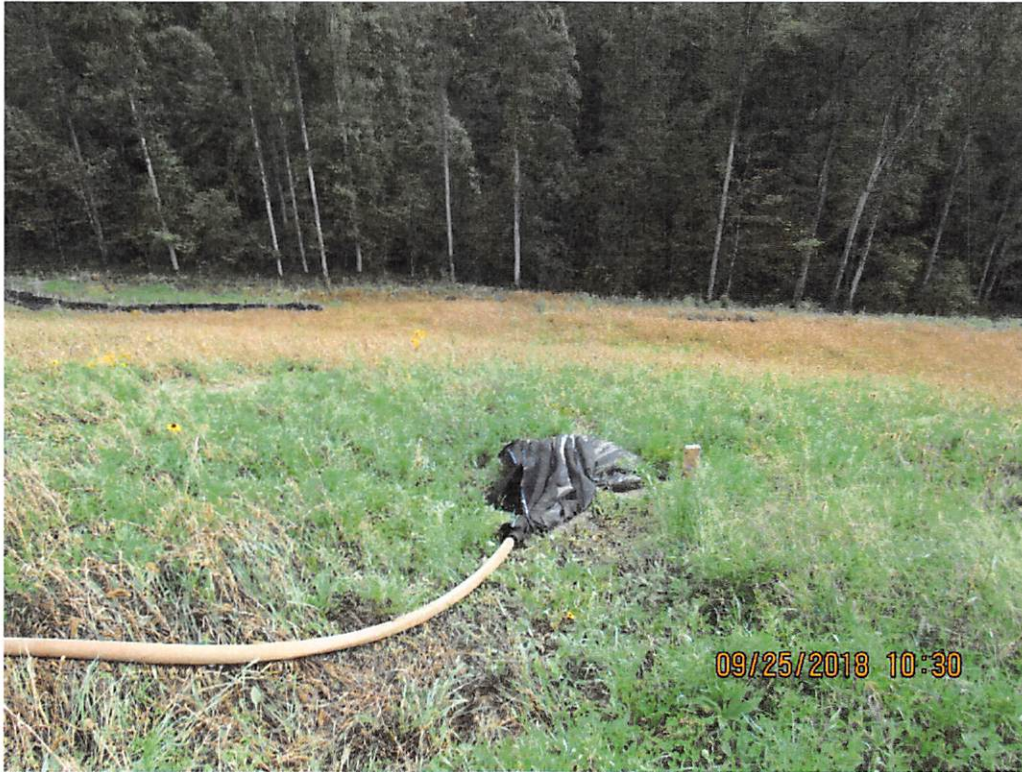
Photo 4: 1 of 3 improperly installed filter fabric bags still in use on north eastern side of site.

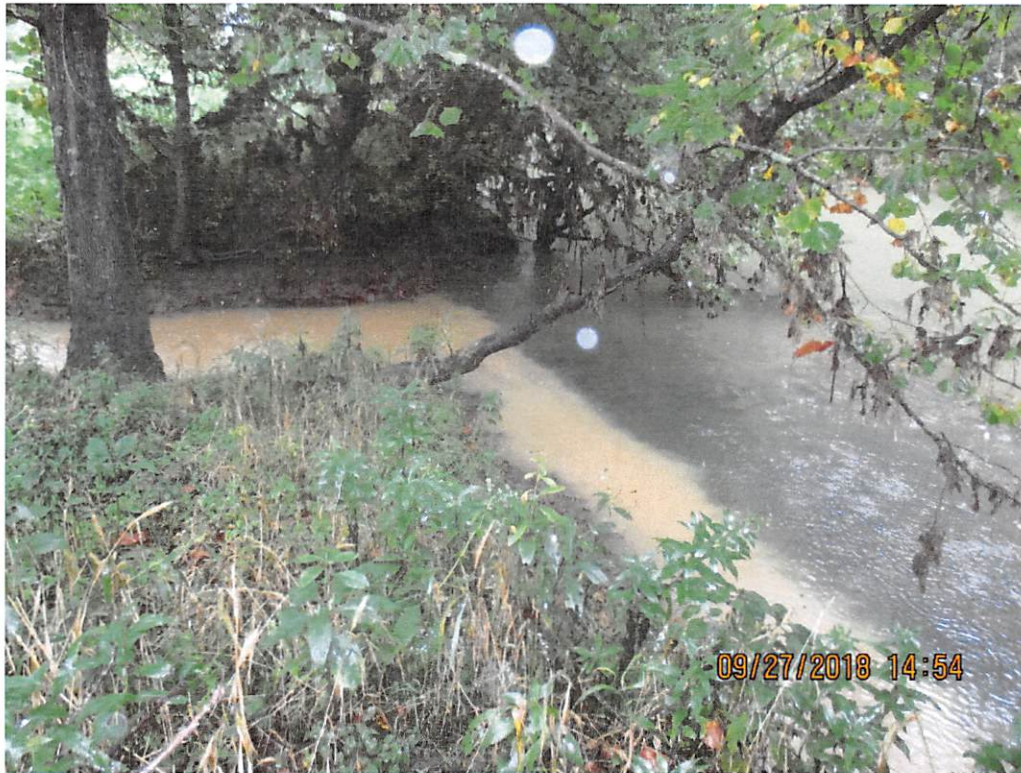
Location where sediment laden water was entering stream S-A60.

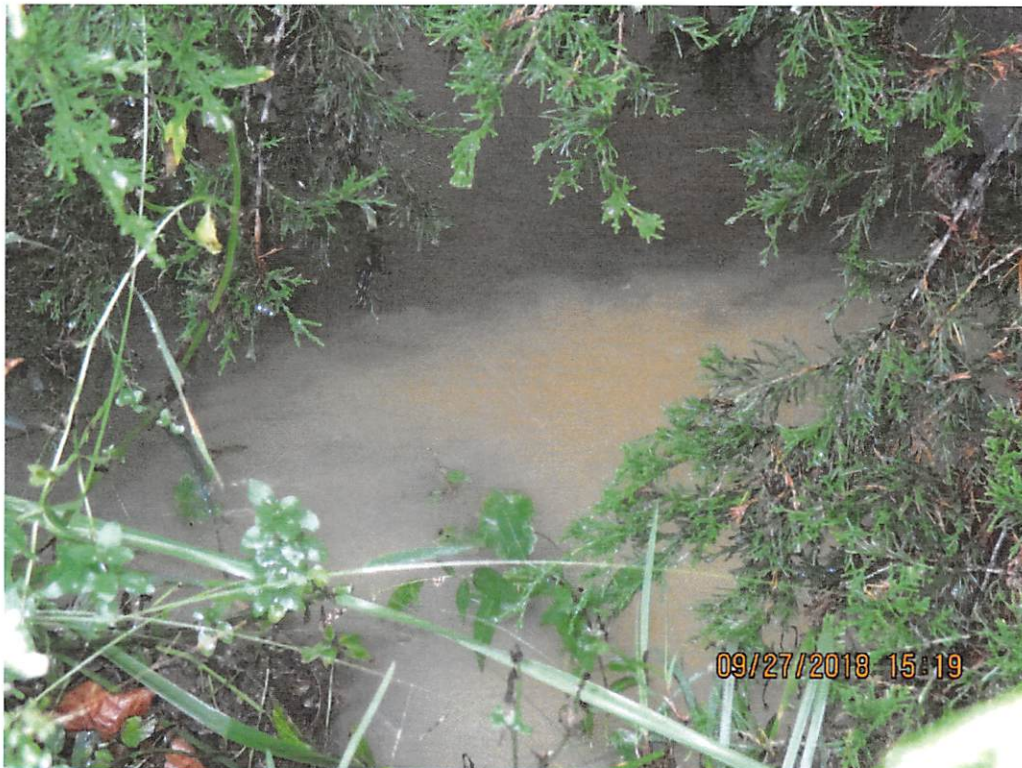
Lack of fill slope protection causing erosion and sediment laden water to accumulate and overwhelm BMP.

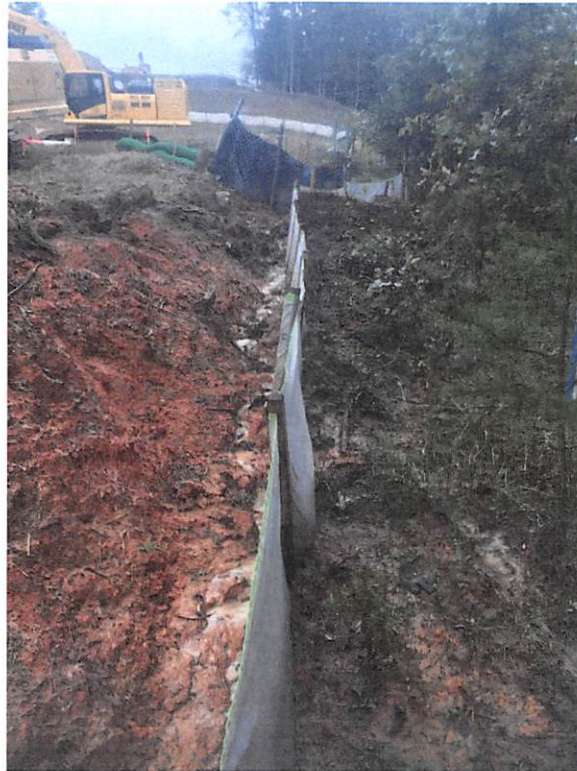
ROW near station numbers 9779+00 and 9778+00 where water bar outlets were being overwhelmed and sediment laden water was passing through and under and being transported past LOD.

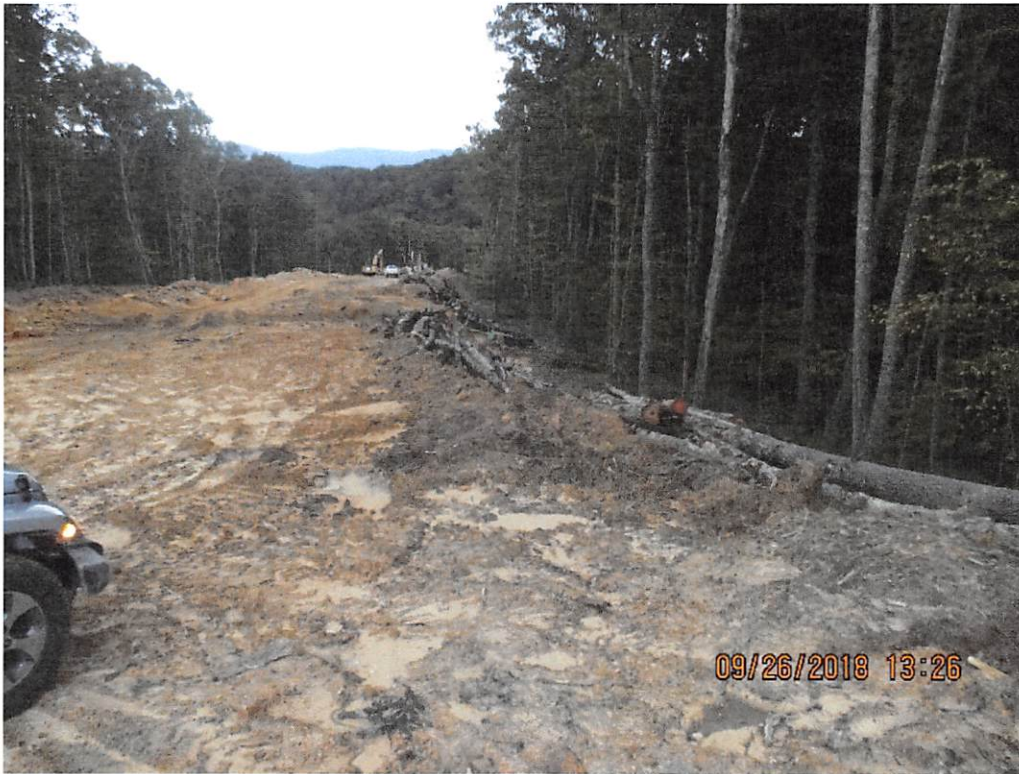
BMP near Station #9911+00 being overwhelmed and sediment flowing under and through control. Arrow depicts where sediment laden water was leaving BMP.

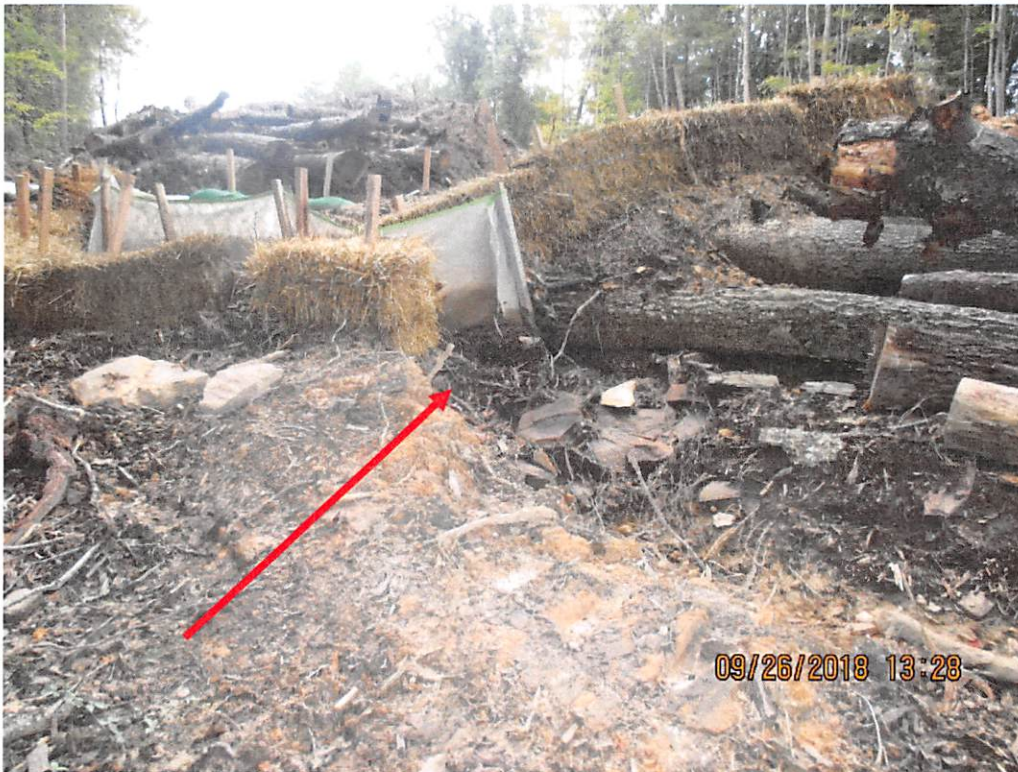
Off site sediment deposits located past LOD and being transported towards Streams S-H58 and TTWV-S-E58 near Station number 9899+00.

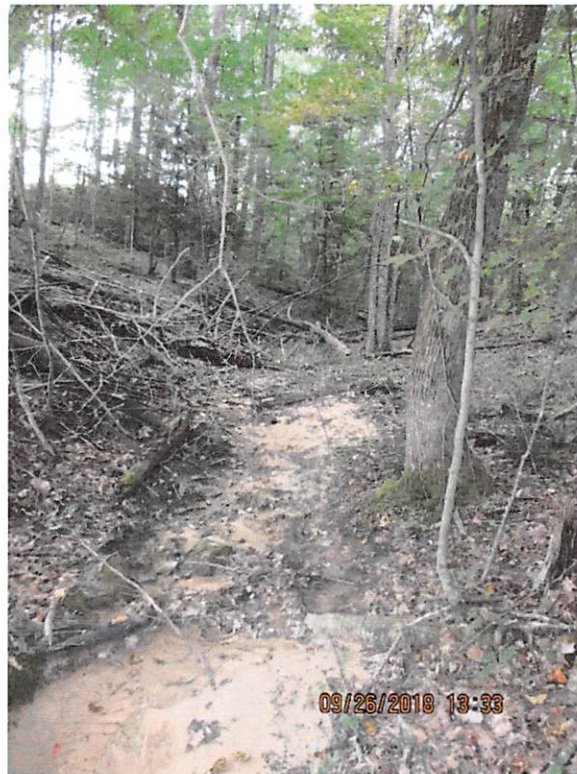
Stream S-H58/TTWV-S-E58 with sediment deposits heading towards Hans creek between Station number 9892+00 through 9899+00.

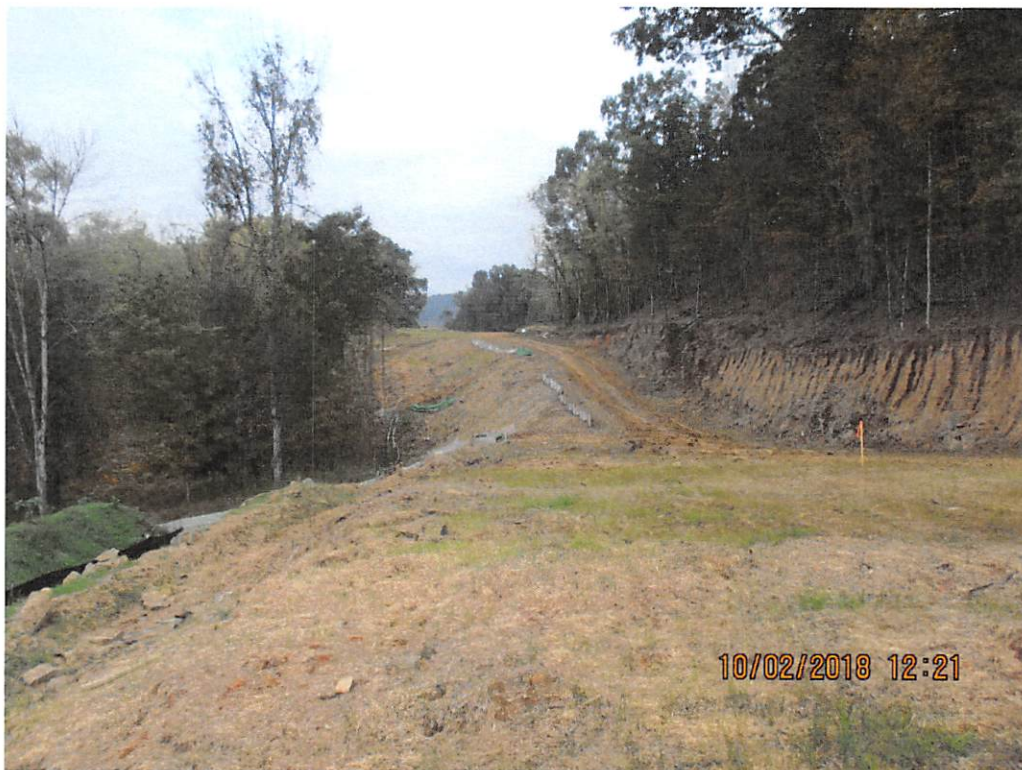
Pond (P-D1) impacted by visible settleable solids.

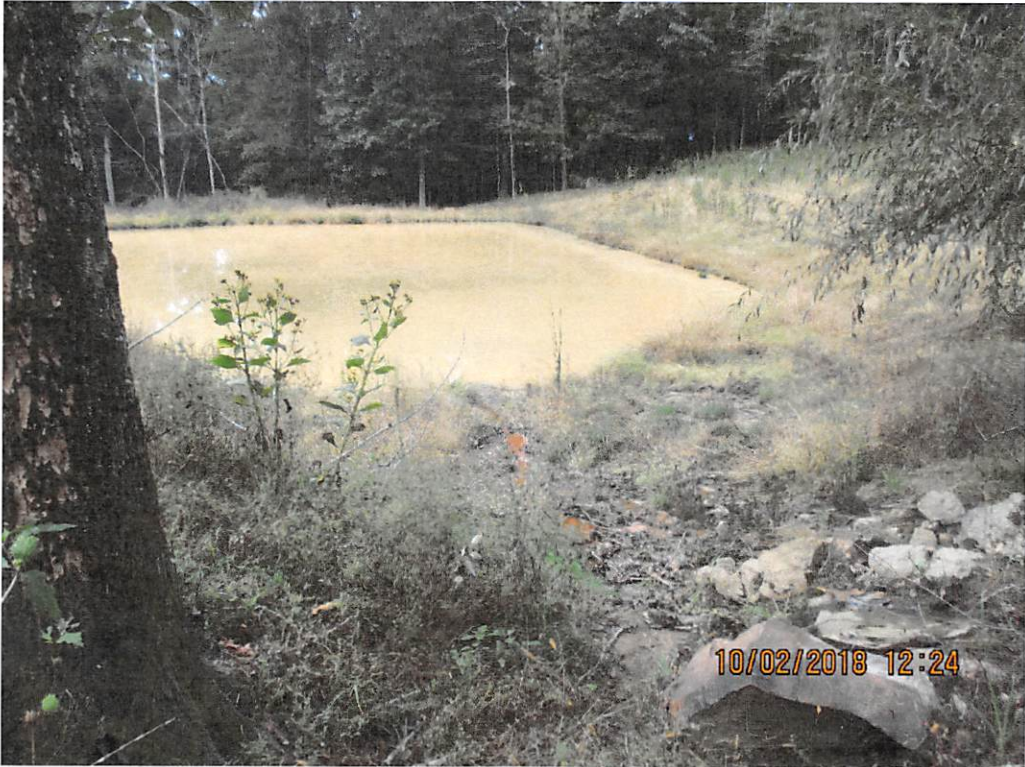
Lack of fill slope protection and channel stabilization enhancing erosion and causing BMP to be overwhelmed at station 9687.

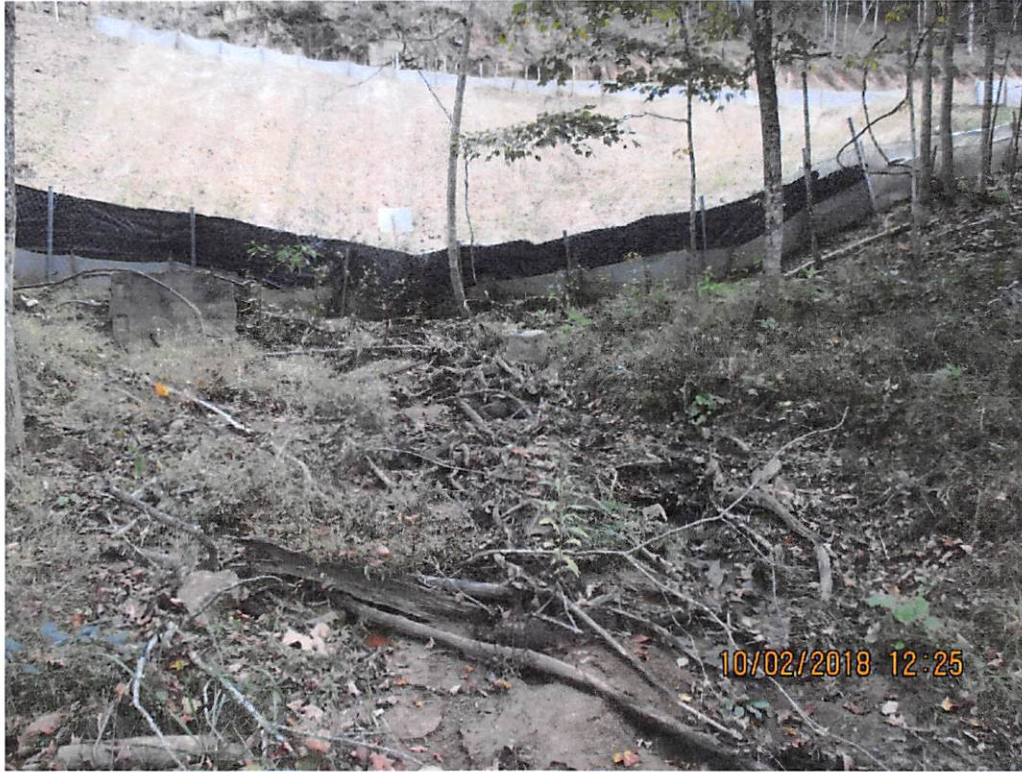
Stream S-D29 leading to Pond P-D1 facing down slope.

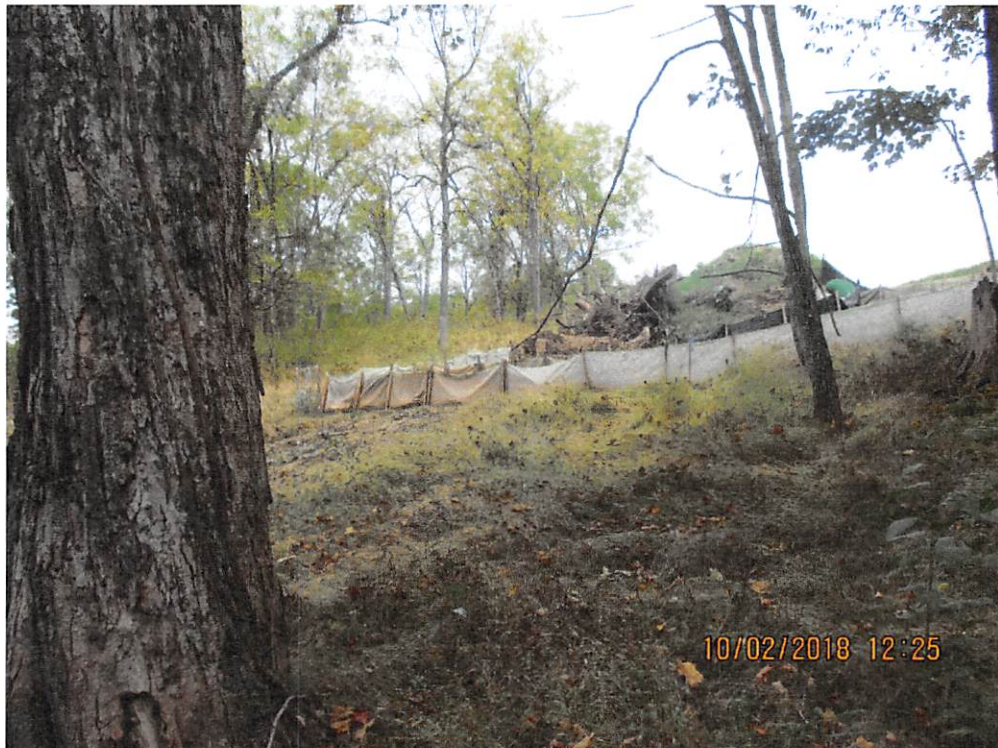
Looking upslope at Stream S-D29 and spring box.

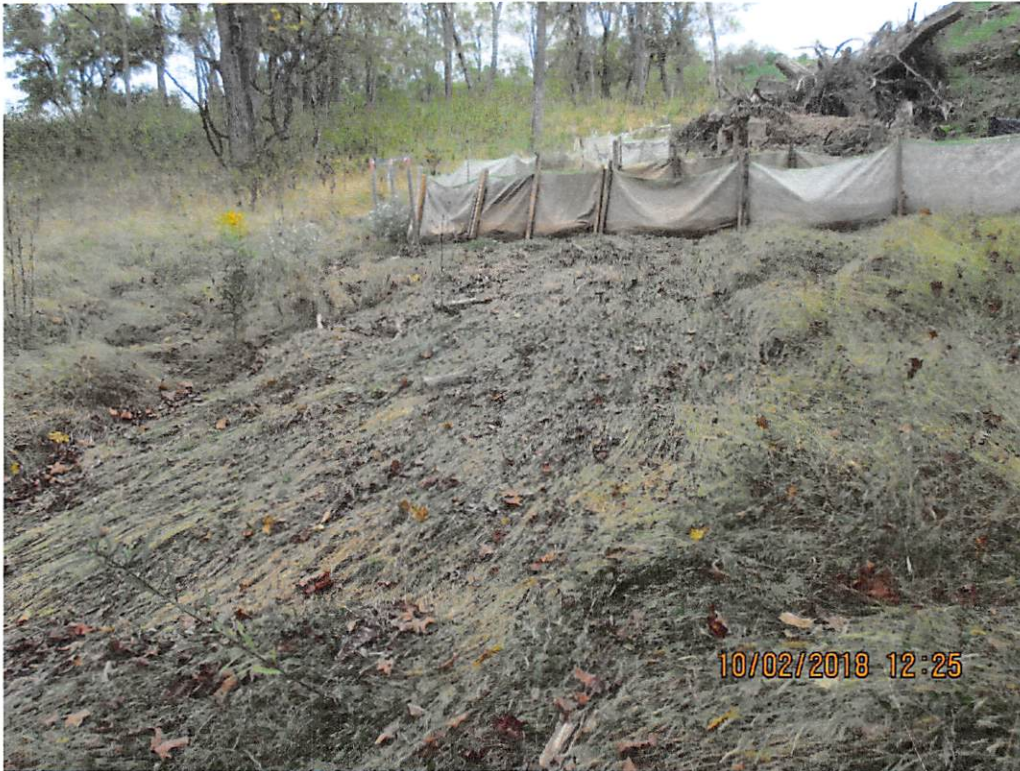
Opposite side of slope where BMP is being overwhelmed.

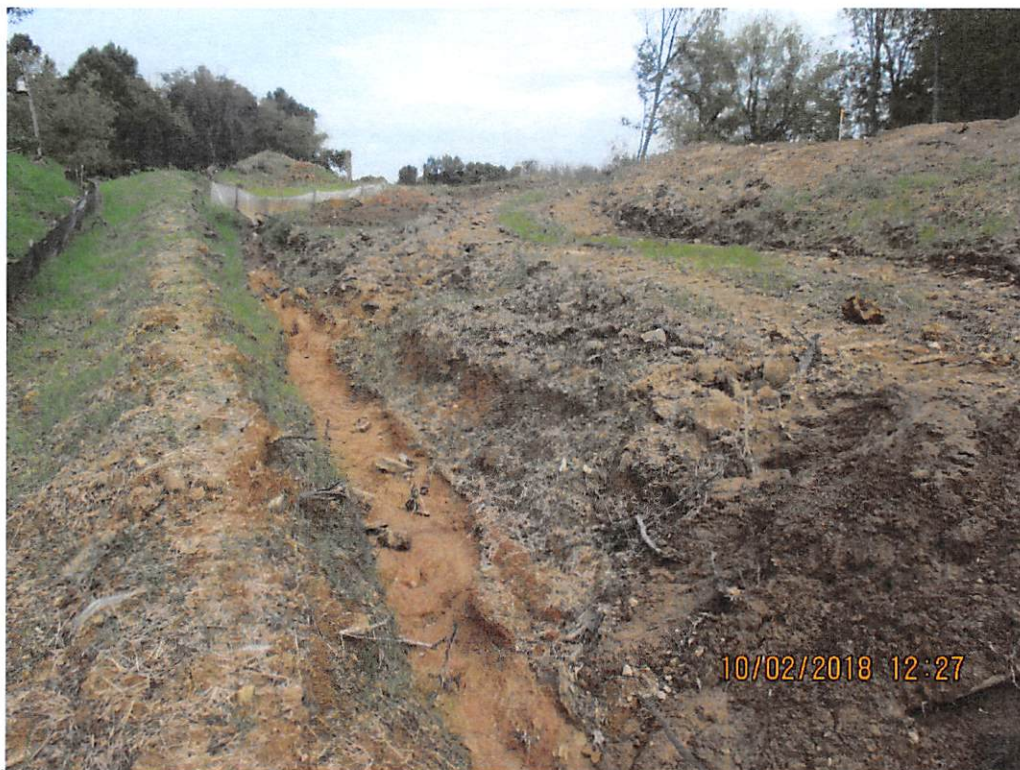
BMP above pond receiving concentrated flow.

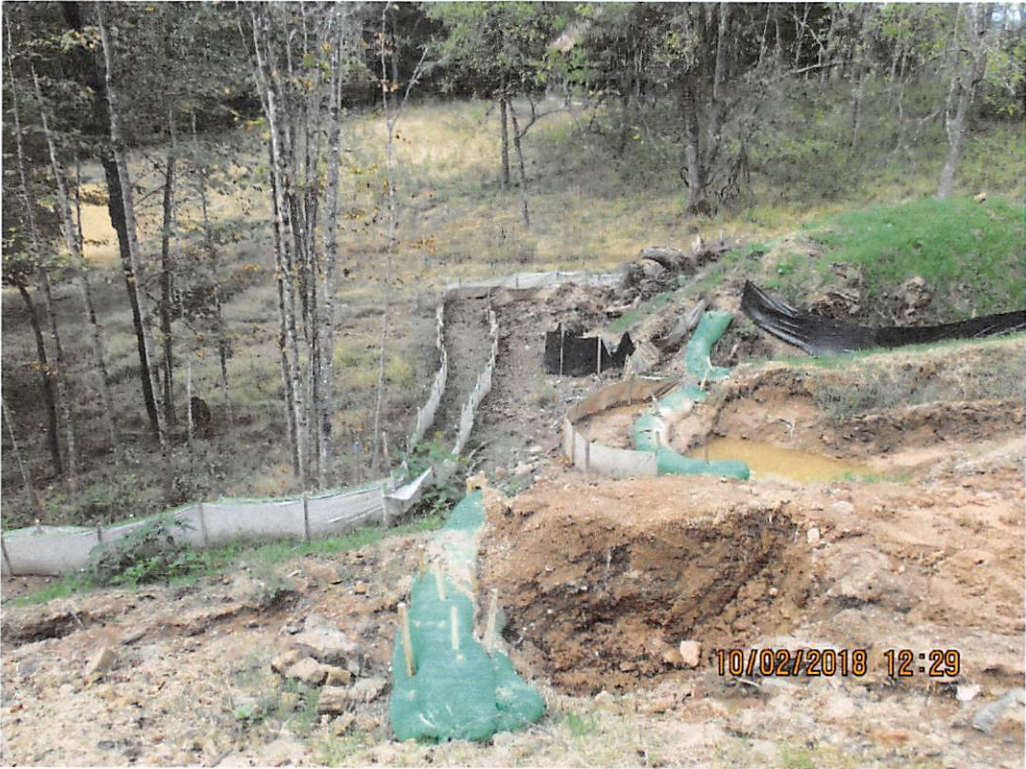
Lack of fill slope protection on opposite side of pond facing upslope near Station #9687.

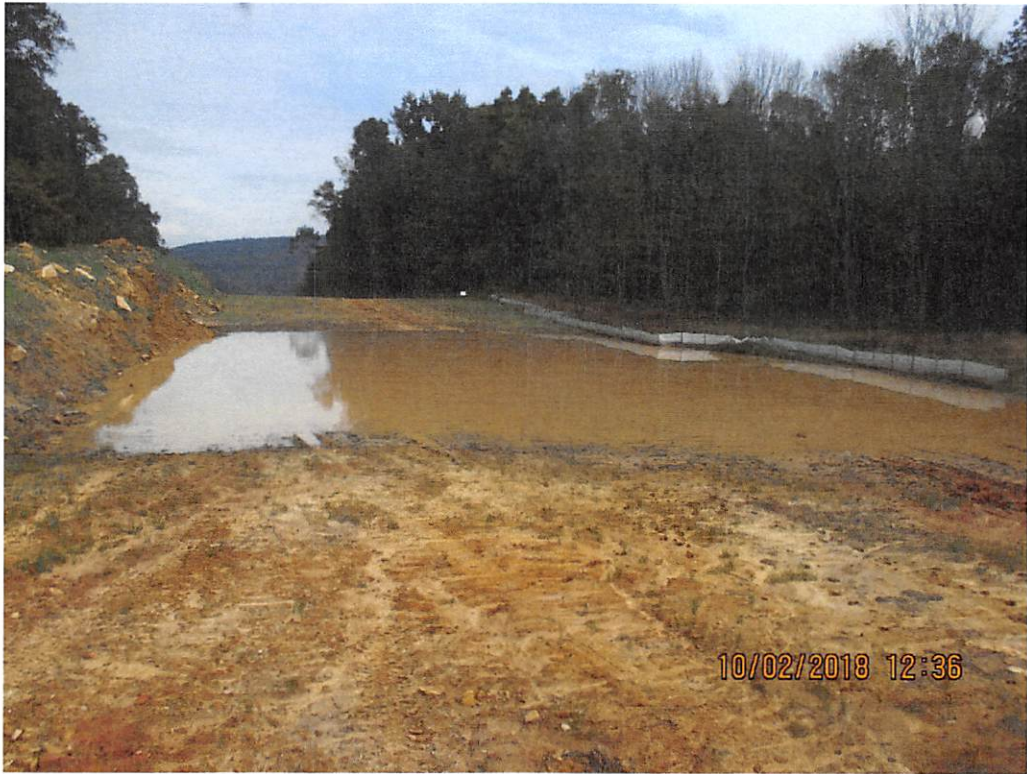
Overview of BMP's north of pond and near station # 9687.
