**CONSENT ORDER  
ISSUED UNDER THE  
WATER POLLUTION CONTROL ACT  
WEST VIRGINIA CODE, CHAPTER 22, ARTICLE 11**

TO: Mountain Valley Pipeline, LLC

DATE: April 19, 2019

ORDER NO.: 8951

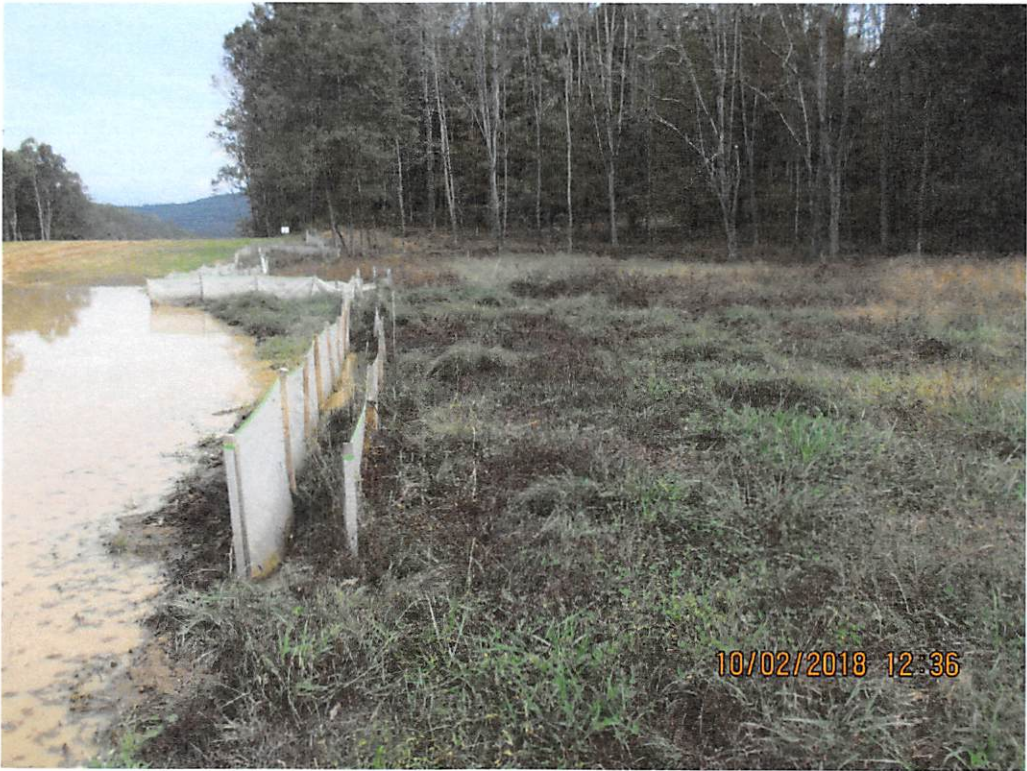
Pond (P-D2) near station number 9680.

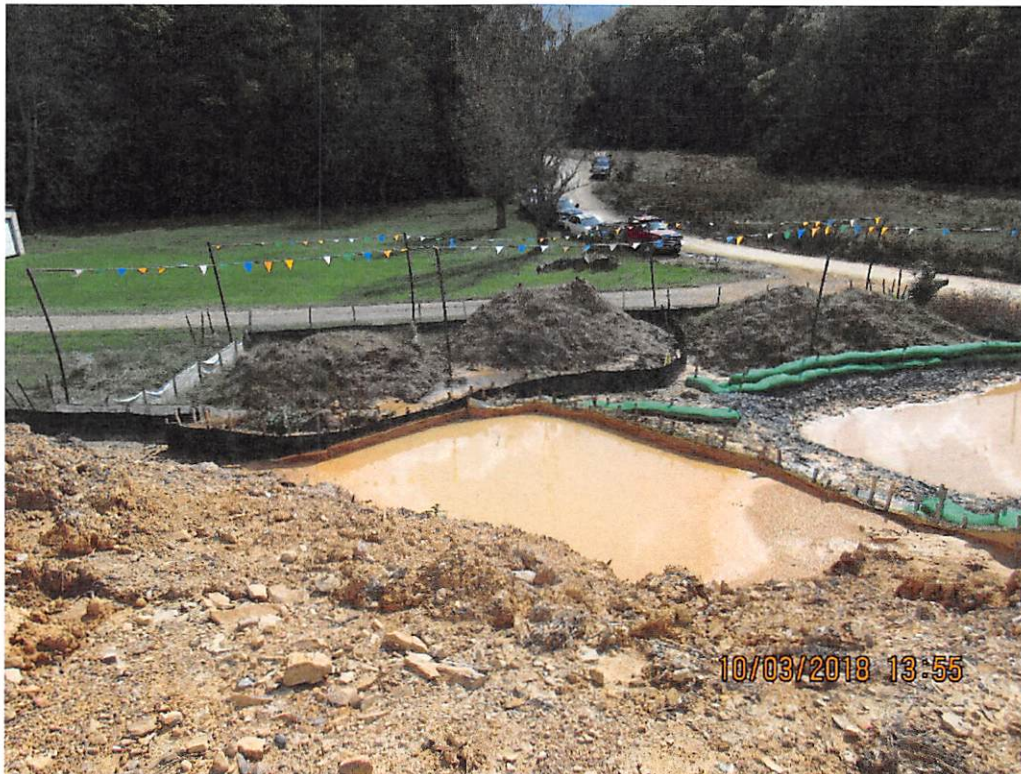
Waterbar outlet at station #9724+51 failing and off-site sediment deposits observed.

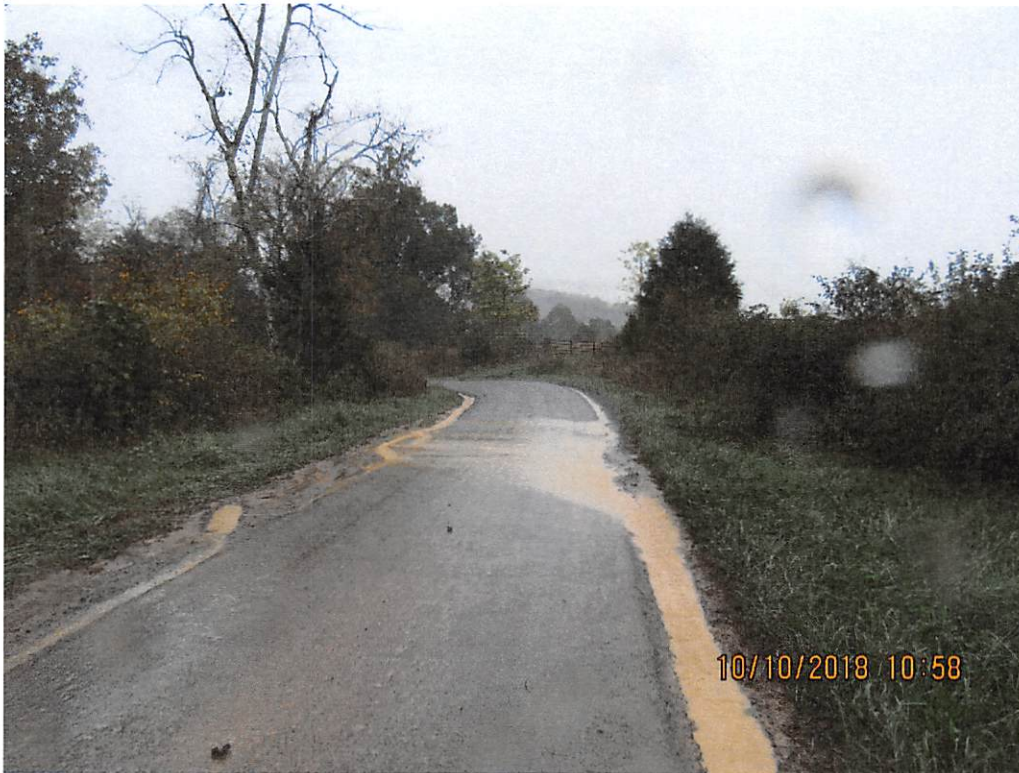
Photo 2: AR 210-sediment laden water leaving site entering county road- up gradient view.

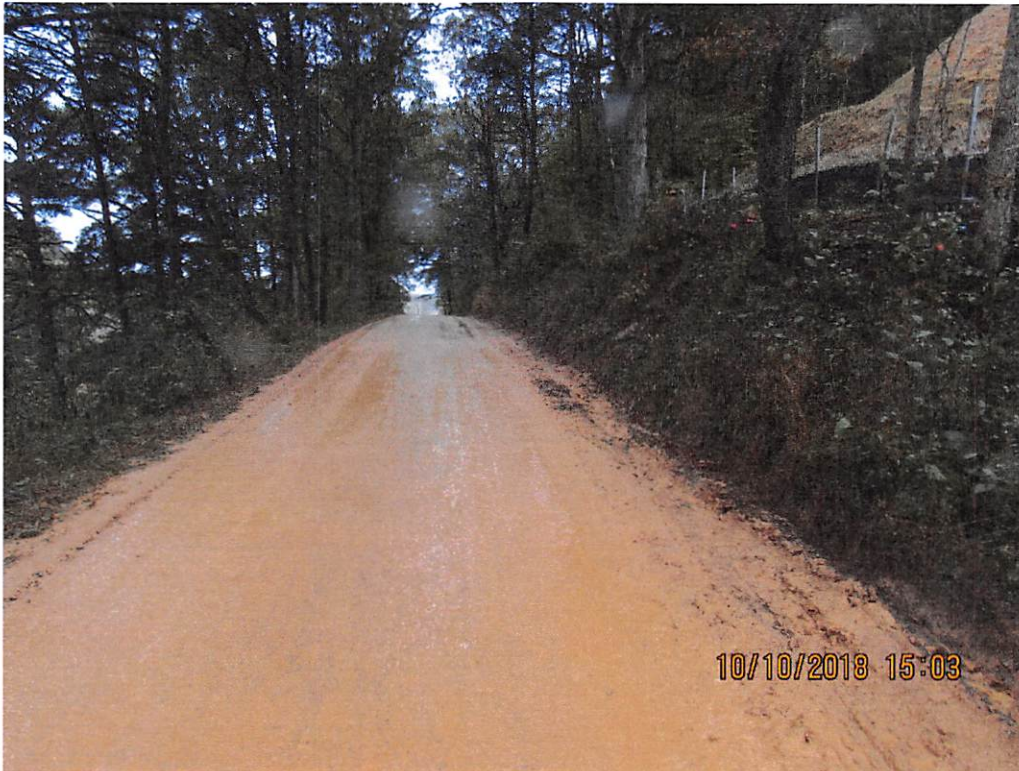
Photo 4: Painter's Run Road station 10270 at access road crossing.

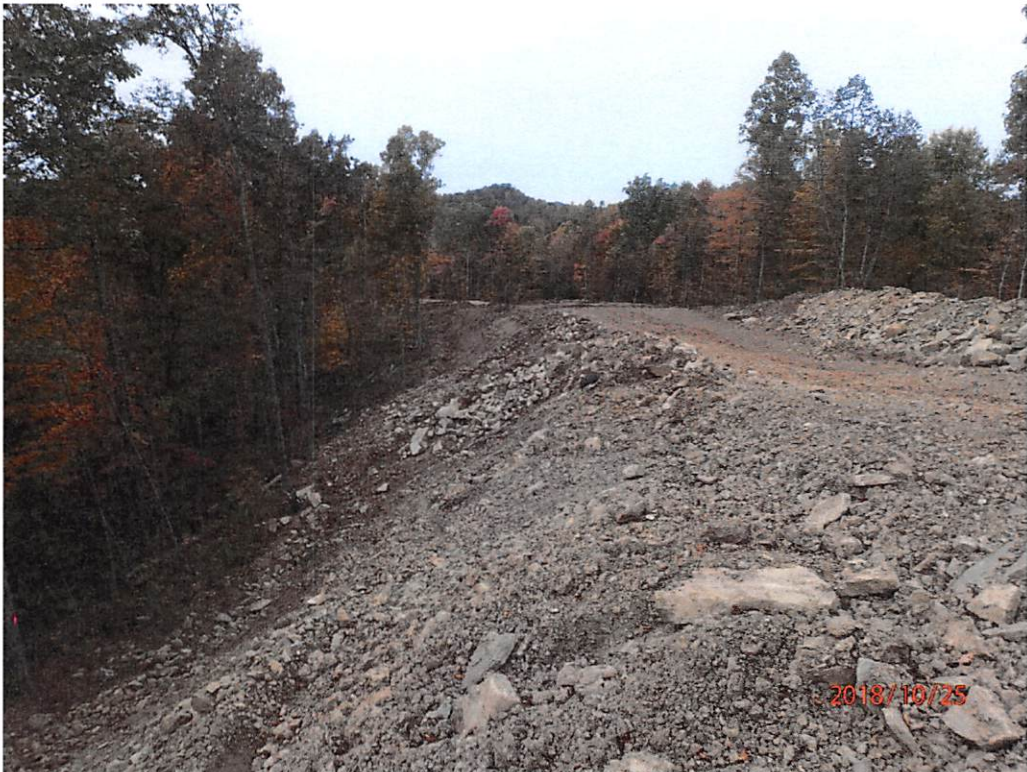
Slip at Station 489 entered the ditchline from a sideslope allowing sediment to leave the project ROW.

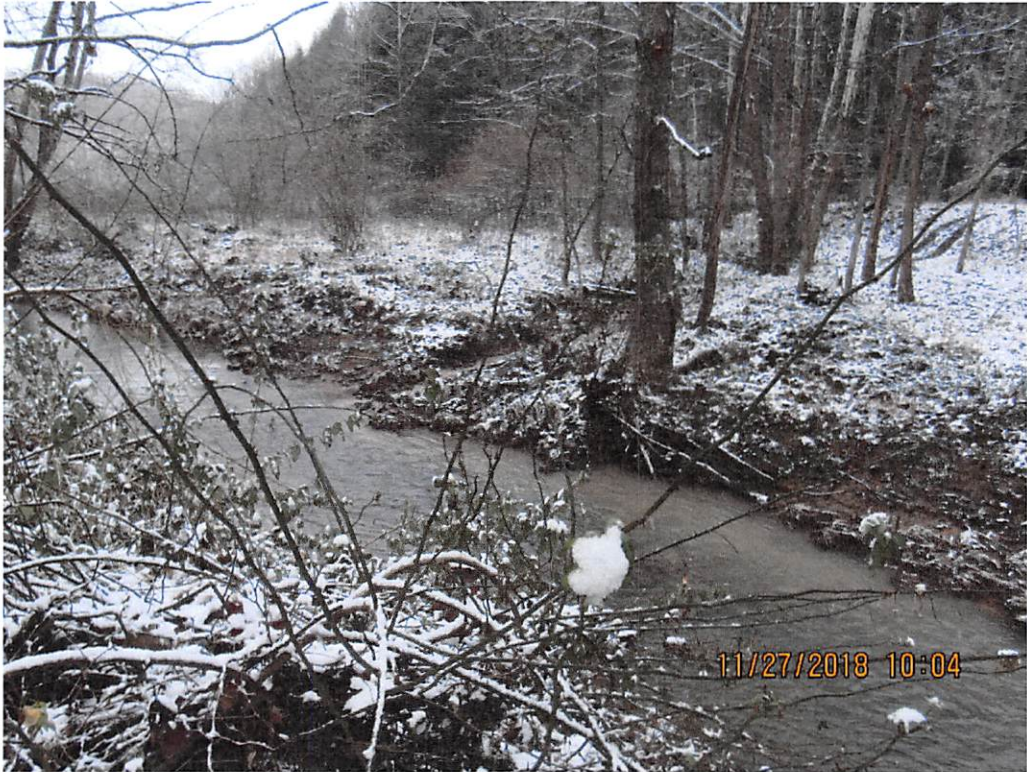
Convergence of UNT of Knawl's Creek into Knawl's Creek below release point

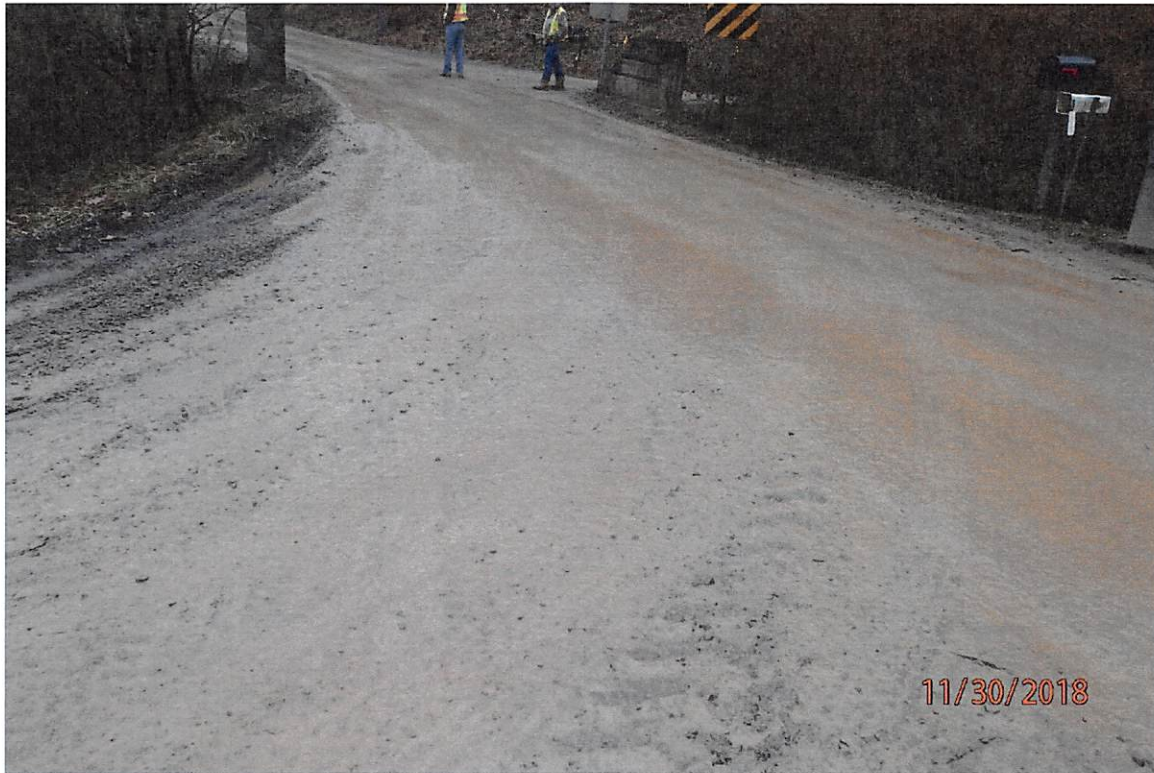
Access Road WV-HA - 29.04 off CR 50/5 showing the lack of an adequately stable construction entrance and the associated track out onto the public road.

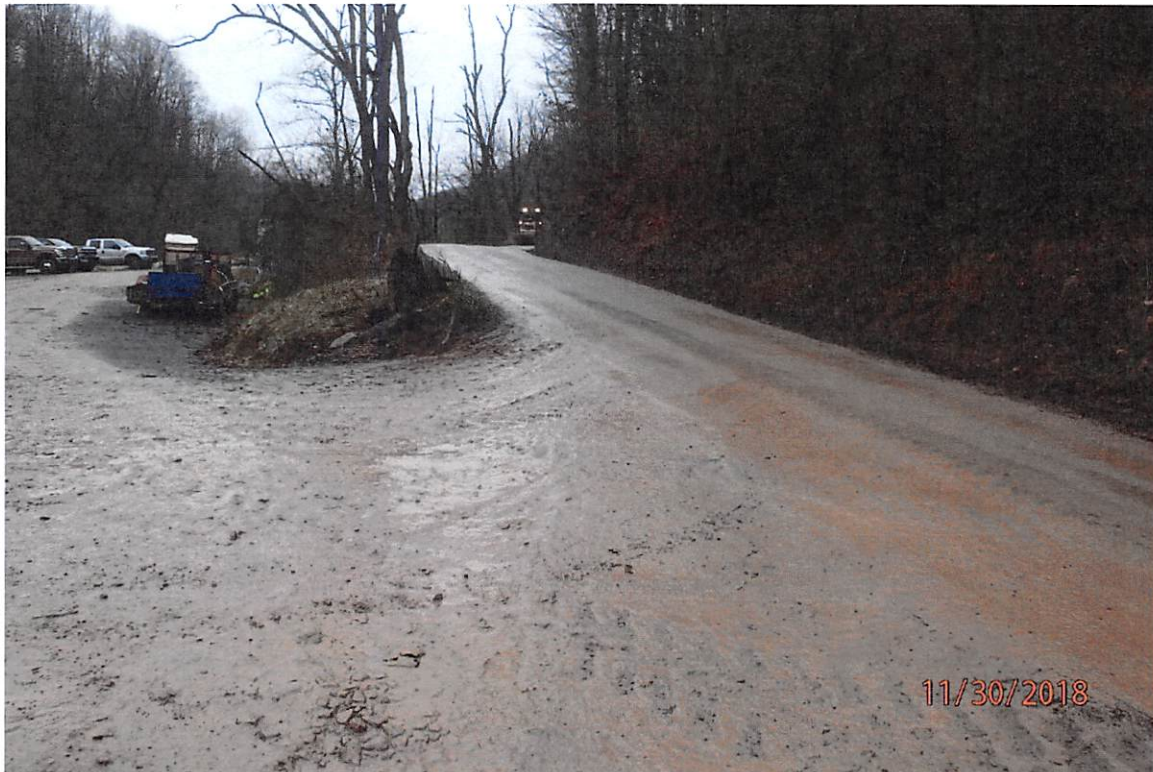
Access Road WV-HA - 29.5 off CR 50/5 showing the lack of an adequately stable construction entrance and the associated track out onto the public road.
